Vulnerability of the north Alaska Highway to permafrost thaw

Design options and climate change adaptation

Northern Climate Exchange
YUKON RESEARCH CENTRE • Yukon College

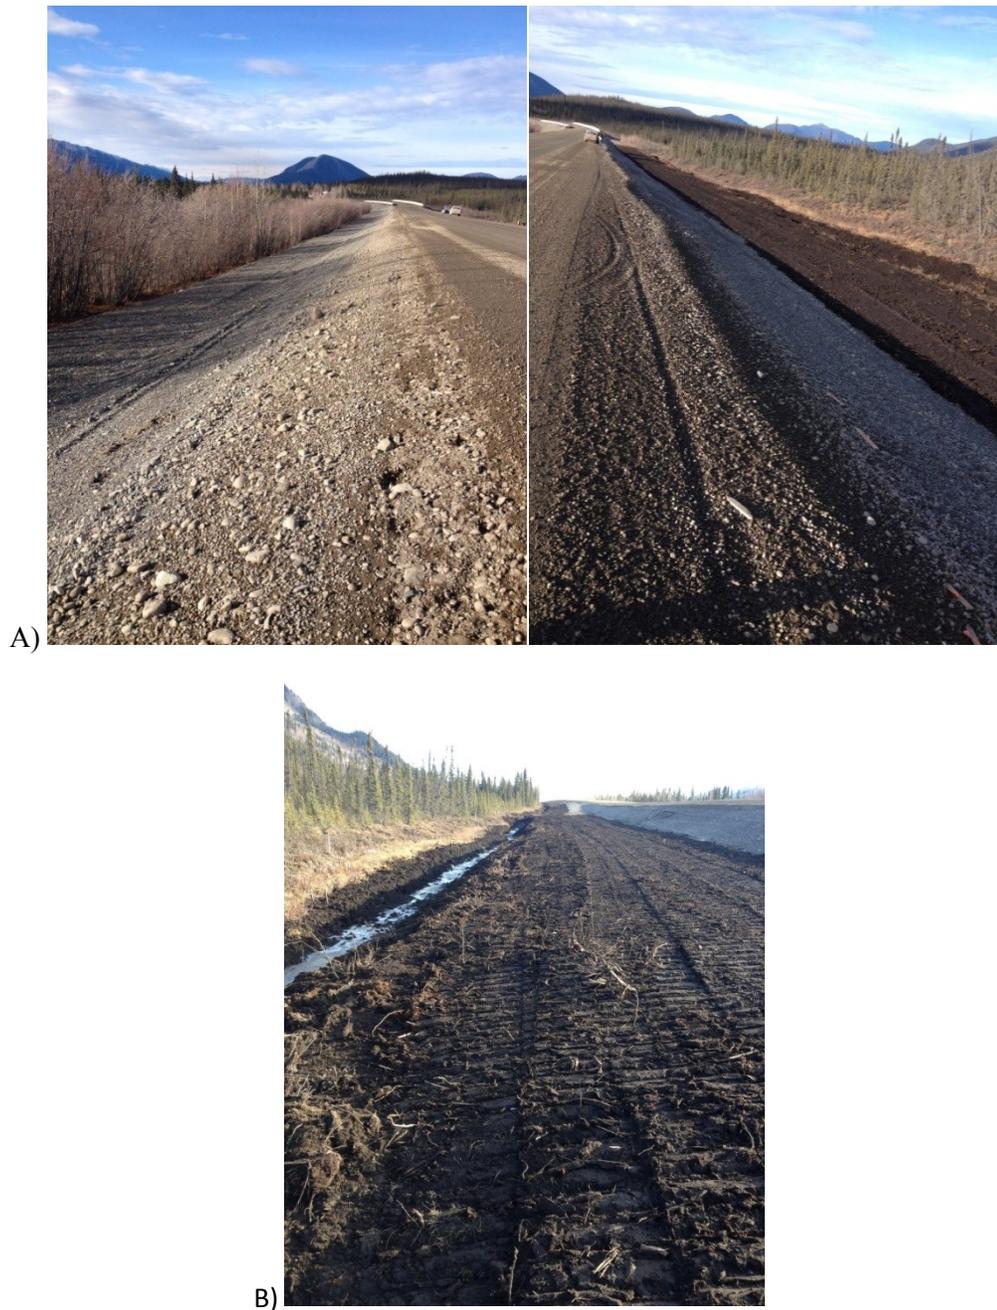
The black topsoil on the right side of embankment was laid in September 2015 using the material removed from the ditch (Figure 4.1.8.). While this topsoil will increase heat intake in the ground at the toe of the embankment during the few first years, vegetation cover will develop and progressively contribute to ground cooling along the embankment.

Figure 4.1.8. Koidern No. 2 adaptation site, km 1810.2 for A) Left and right sides of the embankment, facing north; B) Right side of the embankment, facing south.

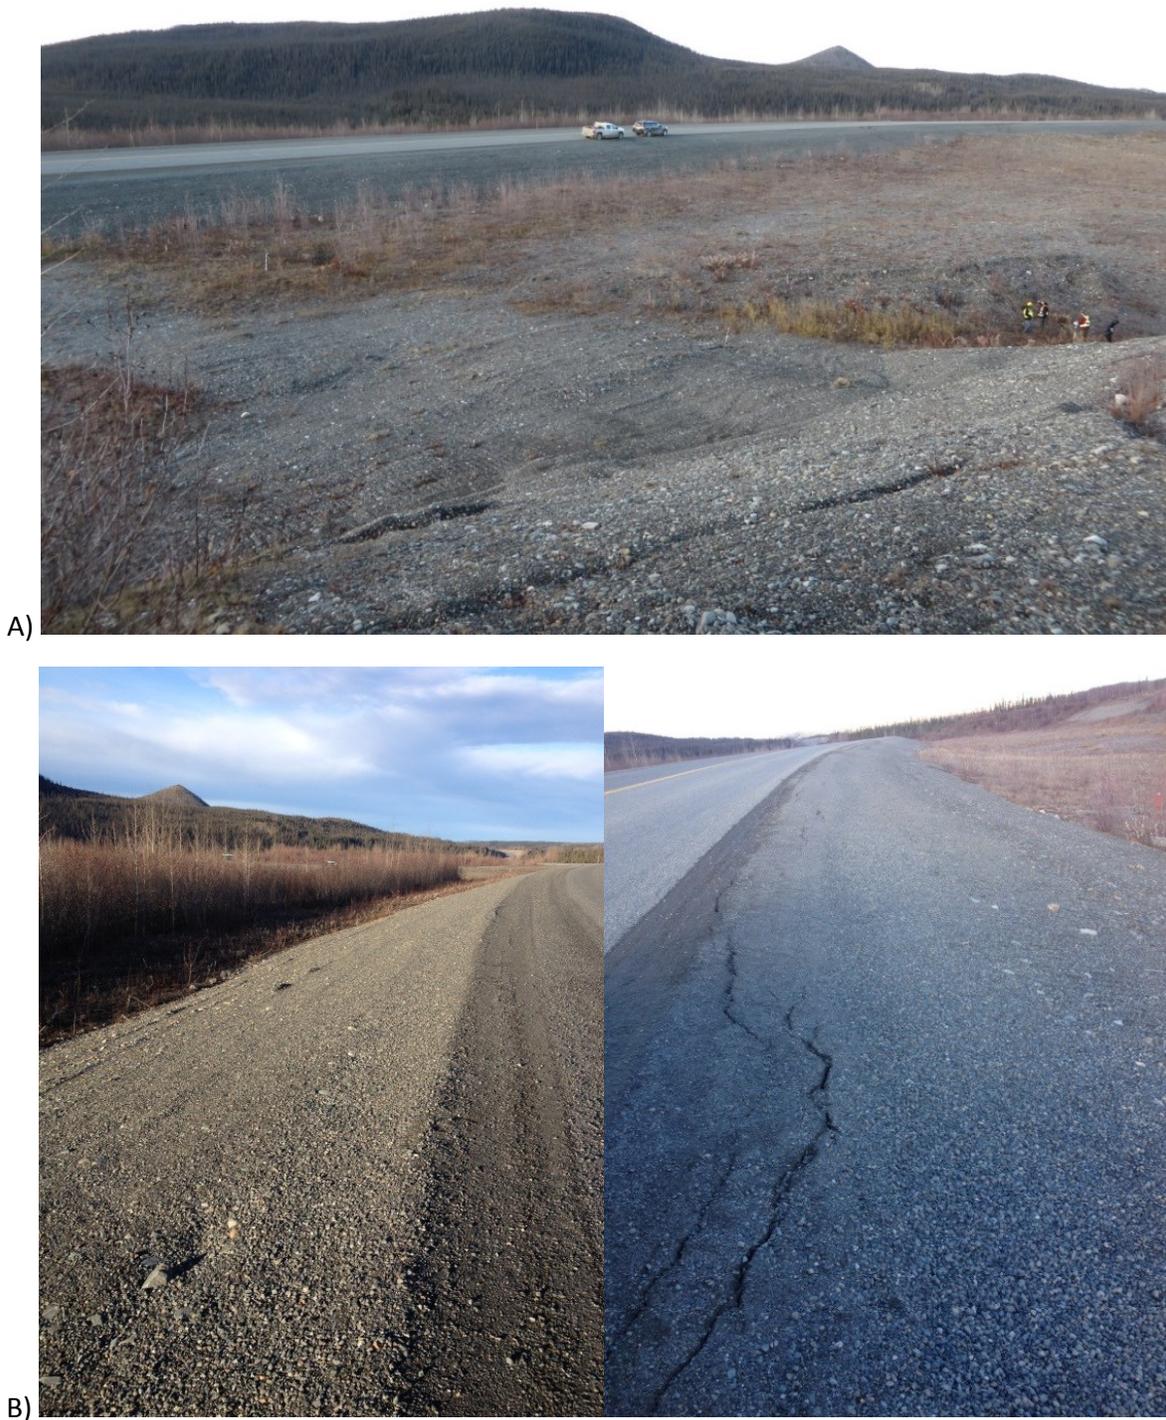
A large thermokarst pond is present on the Left Hand Side of the road. Its formation is attributable to the melting of a substantial amount of ground ice thaw following the construction activities.

Figure 4.2.11. Dry Creek adaptation site, km 1841.3 for A) General view of the site, facing west; and B) Left and right hand sides of the embankment, facing north

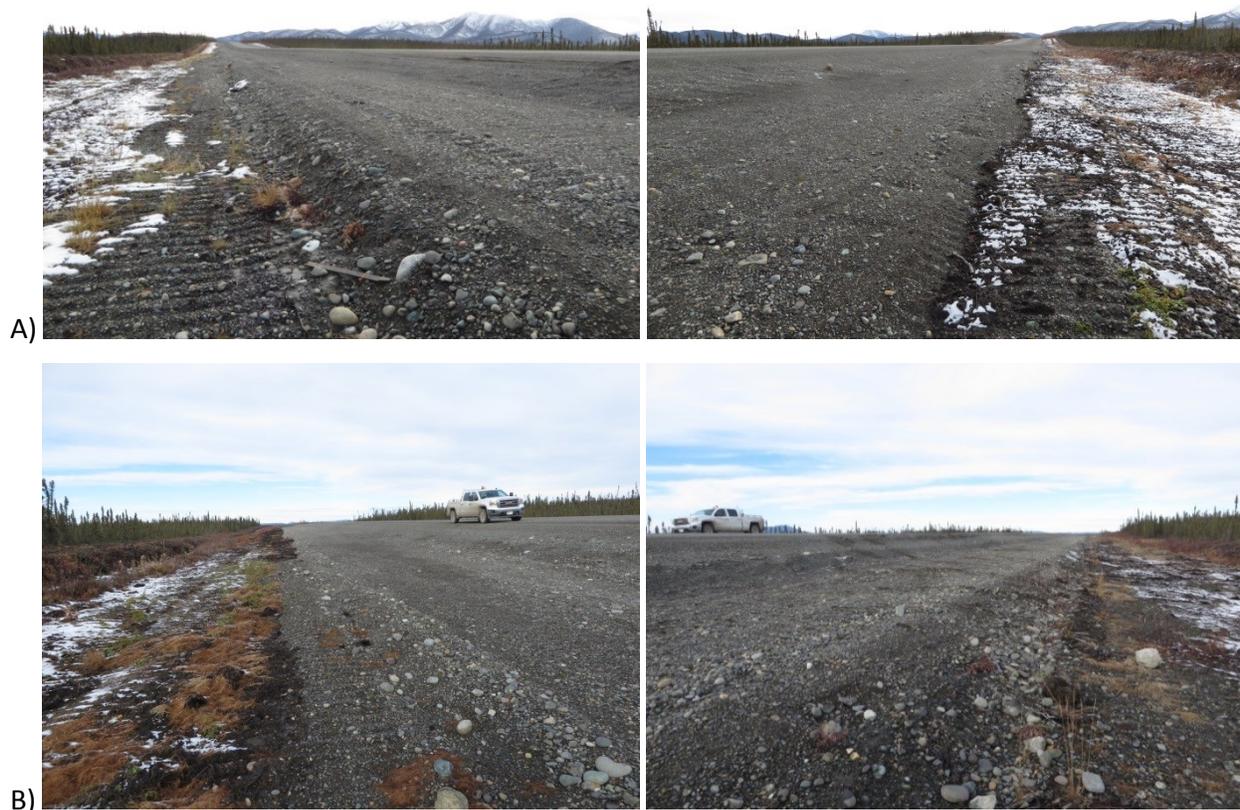
This road passes through a forested area and only the areas along the road are vegetation-free (Figure 4.3.8). Specifically, between the toe of the embankment and the ditches on both sides, the only vegetation is scarce grass, while the tree coverage outside the ditches is relatively thick.

Figure 4.3.8. Enger Creek adaptation site for A) Left and right sides of the embankment facing south; and B) Right and left sides of the embankment facing north.

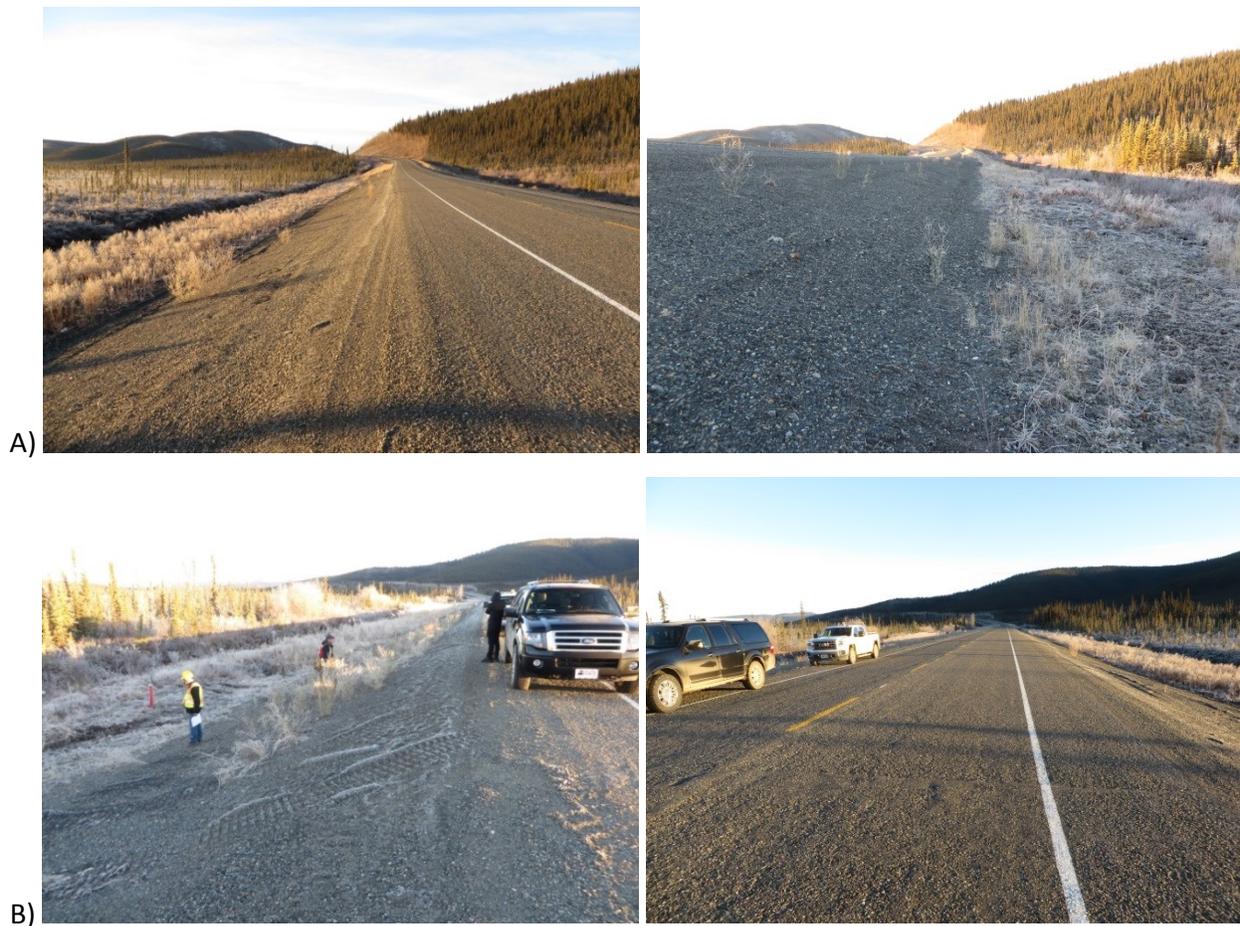
The areas between the toe of the embankment and the ditches are partly covered by grass, shrubs and other plants. Outside the ditches, the site is characterized by a higher concentration of trees and shrubs. The trees have lower density than the shrubs.

Figure 4.4.10 North to Beaver Creek adaptation site, km 1896 for A) Left side and right sides of the embankment, facing south; and B) Right side and left sides of the embankment, facing north.

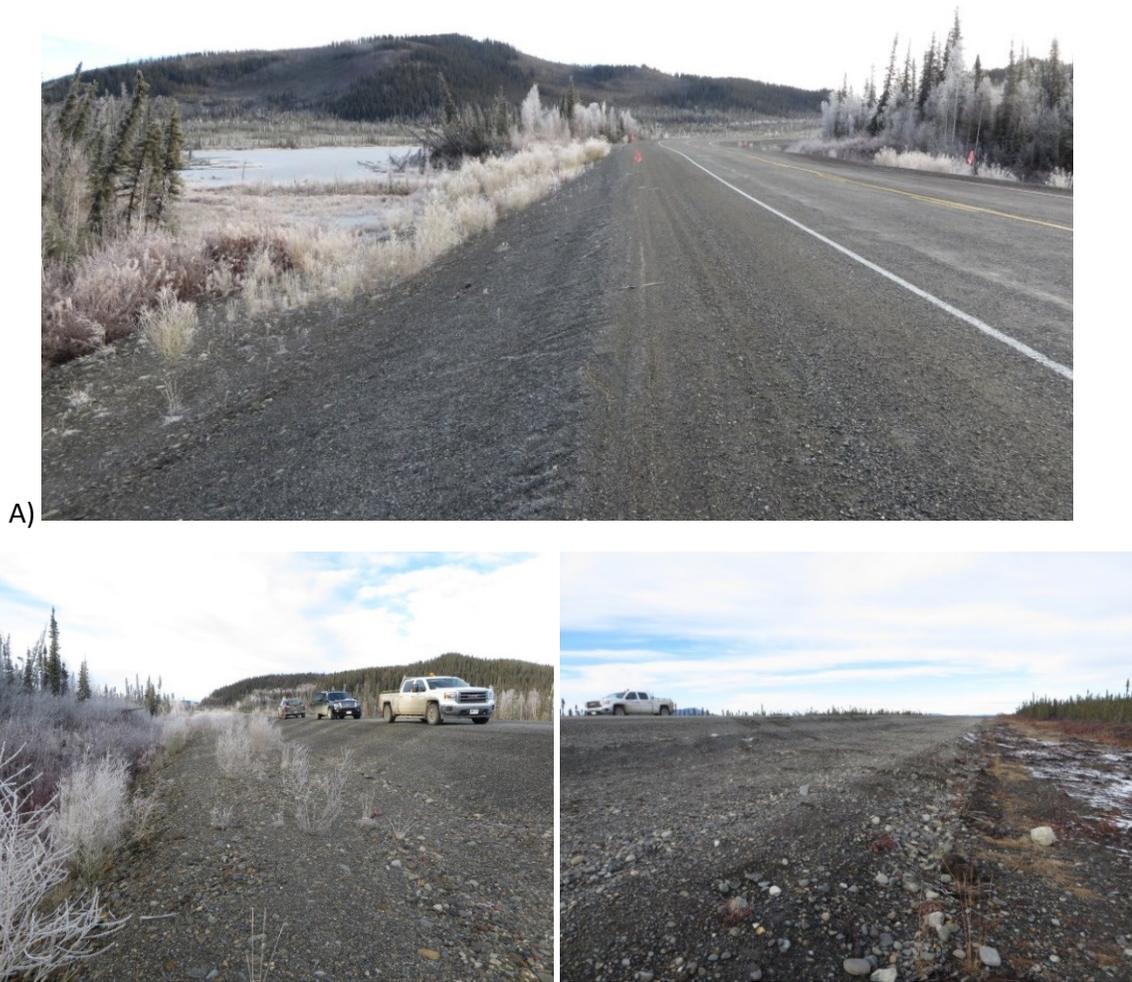
Bogs are present along the left side, they developed in the meanders of a relict fluvial system. Most of the terrain of this site is covered by vegetation, except in the areas along the road where sparse grass and shrubs can be observed (Figure 3.5.11).

Figure 3.5.11 Mirror Creek adaptation site, km 1886 for A) Right side of the embankment, facing south; and B) Left and right sides of the embankment, facing north.

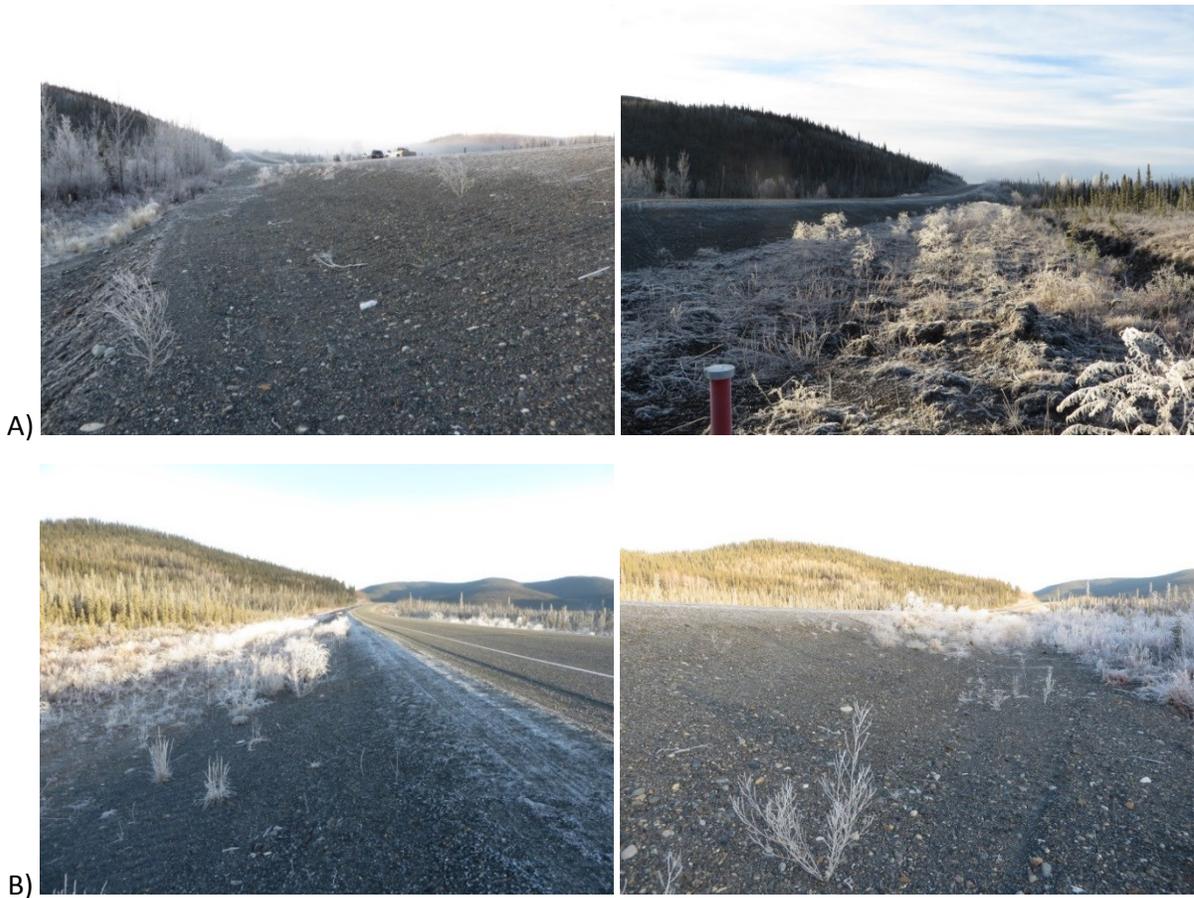
Some notable features of this site are two ditches that were dug in 2013, parallel to the road. The distance between the toe of the embankment and the ditches, are about 12 m at the left hand side, and 10 m at the right hand side. They are 4 m wide and 1.5 m deep, the shortest one being at the right hand side (Figure 4.6.9). A camera has been fixed near the long ditch to monitor the development of the ditch slump. The result shows that this ditch is strongly affected by thermal erosion and is becoming wider (Figure 4.6.10). A stream (① in Figure 4.6.9A) is intercepted by the ditch at the left hand side, flowing perpendicular to the ditch. Yet the ditch cut an ice wedge, at the same level as the stream that is also perpendicular to the ditch and the embankment. From spring to fall, the stream is fed by runoff water, and erodes the ice wedge. Now, thermal erosion has developed and is incising the terrain starting from the ditch to the west, exposing additional ice-rich permafrost and wedge ice. Besides stream (①), water also was flowing through culverts (② and ③ in Figure 4.6.9A) at the time of site visit in October 2015.

Figure 4.6.10. North of Beaver Creek adaptation site, km 1895 for A) Right and left sides of the embankment, facing south; and B) Left and right sides of the embankment, facing north

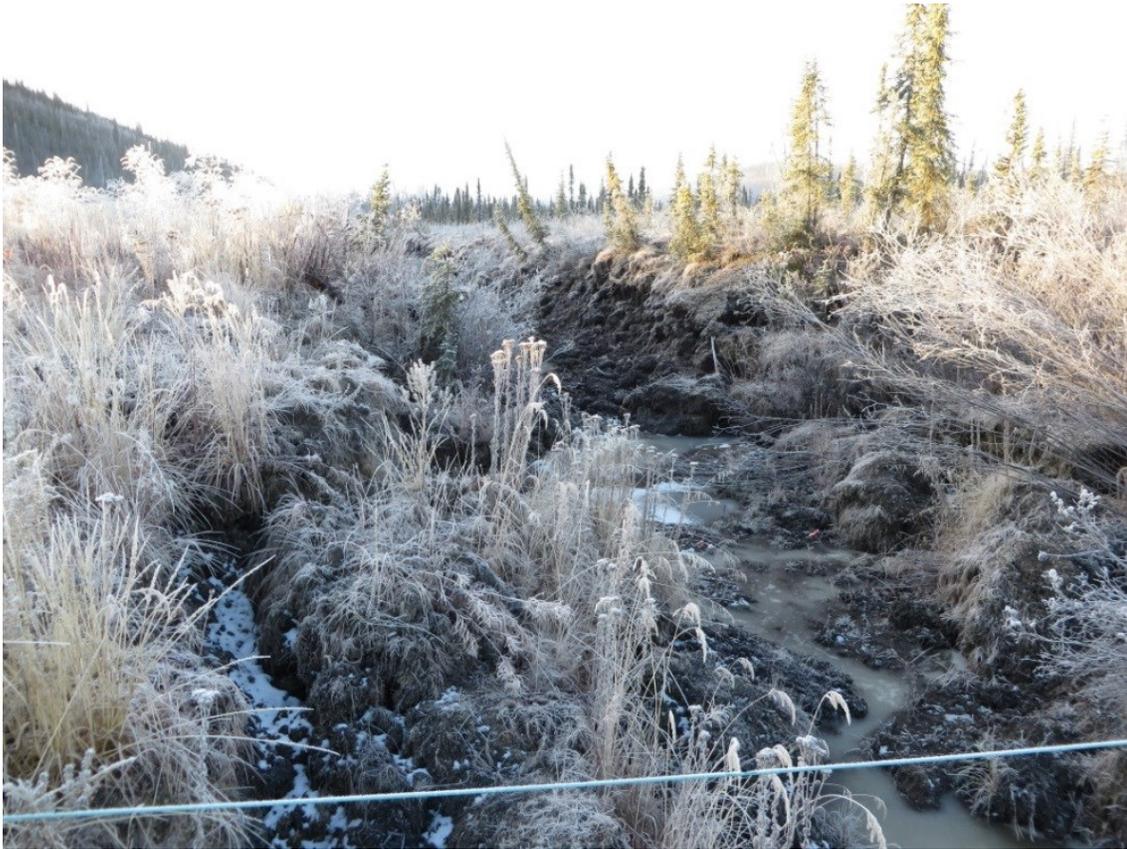
Figure 4.6.11. Thermal erosion in the ditch, facing southwest.
