# Enhancing Yukon Trade Corridor Resilience to Northern Geohazards:

## Hydrology Report 3 - Erosion Assessment, Monitoring, and Mitigation

Final | September 2026

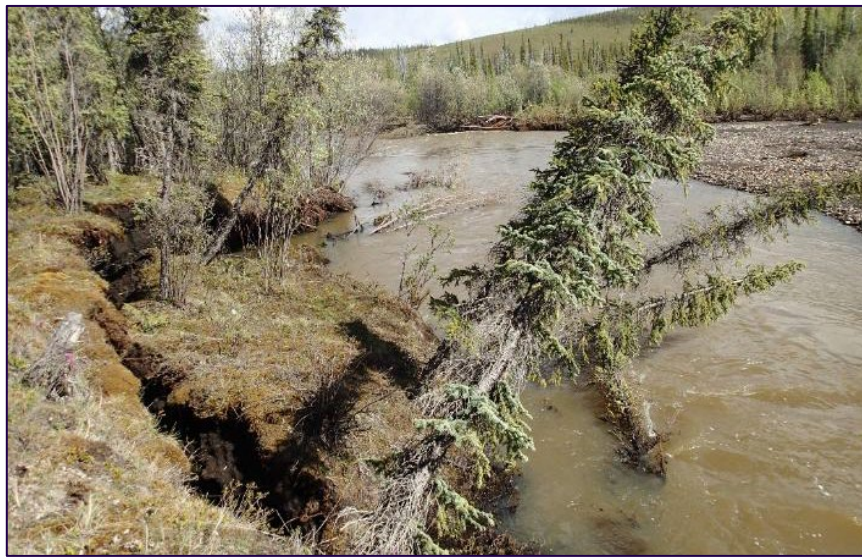
**FIGURE 2.1. COLLAPSE OF UNDERCUT RIVERBANK ALONG ENGINEER CREEK DUE TO THAWING AND EROSION OF PERMAFROST.**

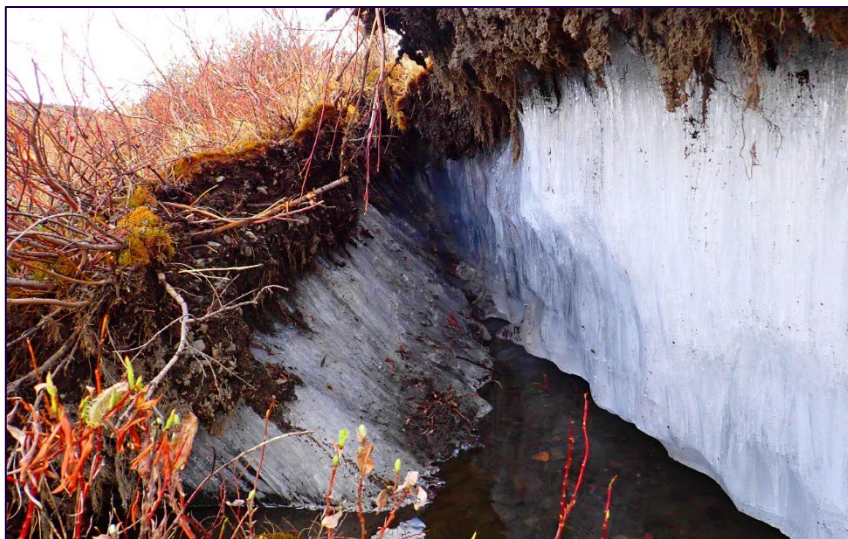
**FIGURE 2.3. INJECTED ICE UNDER ORGANIC LAYER AND RIPARIAN VEGETATION THAT LATER COLLAPSE INTO THE SPRING FLOW, EAST BLACKSTONE RIVER.**

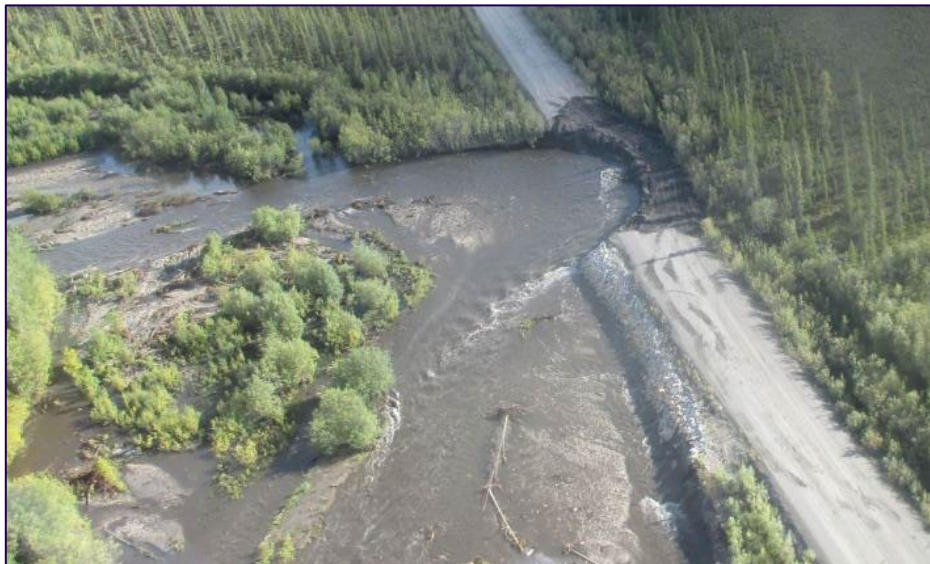
**FIGURE 2.4. EROSION OF THE DEMPSTER HIGHWAY EMBANKMENT AT KM 166.5 FOLLOWING A HIGH-INTENSITY, MID-SUMMER RAIN EVENT IN AUGUST 2016 (PHOTO CREDIT: HPW).**

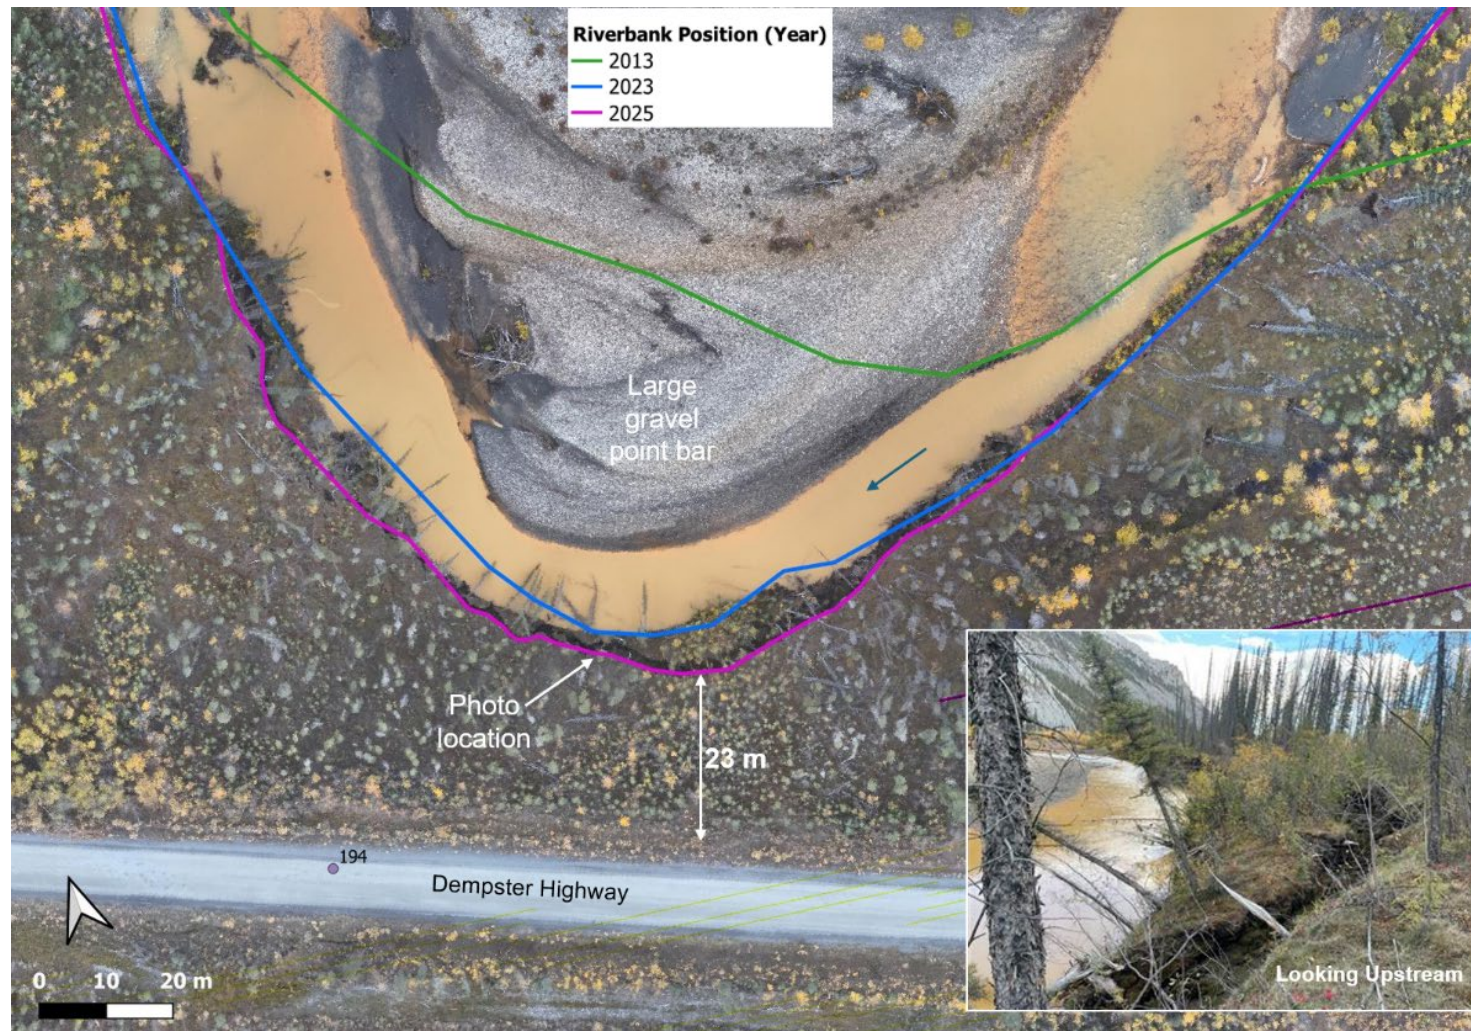
**FIGURE 4.3. PROGRESSIVE MEANDER MIGRATION OF ENGINEER CREEK AT DEMPSTER HIGHWAY KM 194.0. THE LARGE GRAVEL BAR GROWTH FURTHER PUSHES THE CHANNEL THALWEG AGAINST THE ERODING OUTER BANK. PERMAFROST THAW MAY BE CONTRIBUTING TO INSTABILITY. A CHANNEL AVULSION IS POSSIBLE THAT WOULD INCREASE THE SEPARATION DISTANCE AND LOCALLY REDUCE THE RISK TO THE HIGHWAY.**

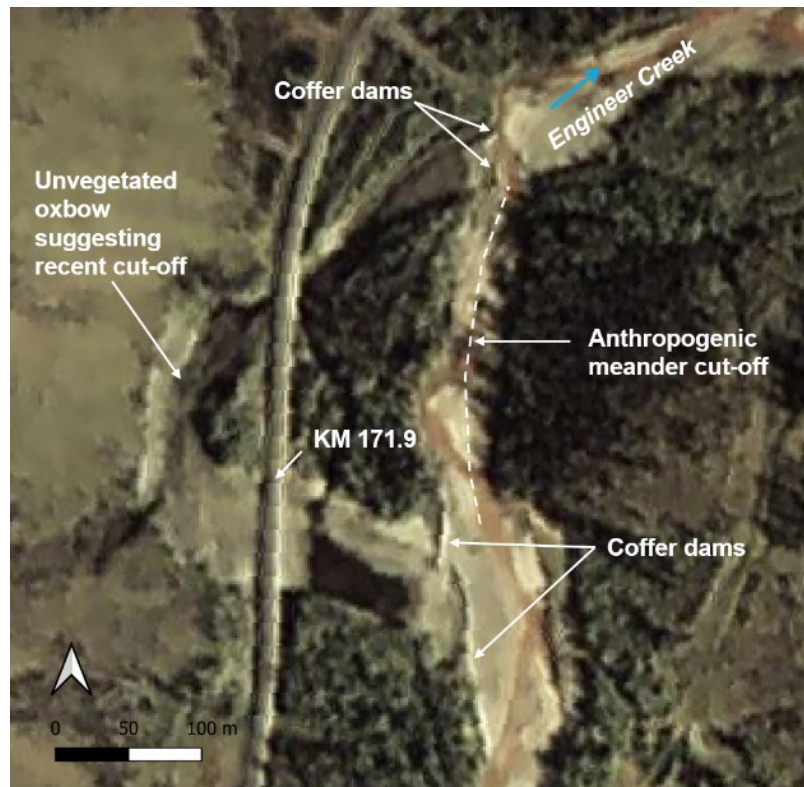
**FIGURE 4.5. AN EXAMPLE OF AN ANTHROPOGENIC CUT-OFF ALONG ENGINEER CREEK OBSERVED IN THE 1977 AERIAL PHOTOGRAPHS. SINCE 1977, THE CHANNEL HAS WIDENED AND HAS MIGRATED RAPIDLY TOWARDS THE HIGHWAY AT KM 171.9. NUMEROUS OTHER SIMILAR CUT-OFFS ARE OBSERVED ALONG ENGINEER CREEK, WHICH WOULD HAVE LED TO A NOTABLE REDUCTION IN CHANNEL LENGTH AND, CONSEQUENTLY, AN INCREASE IN SEDIMENT TRANSPORT AND EROSION CAPACITY.**

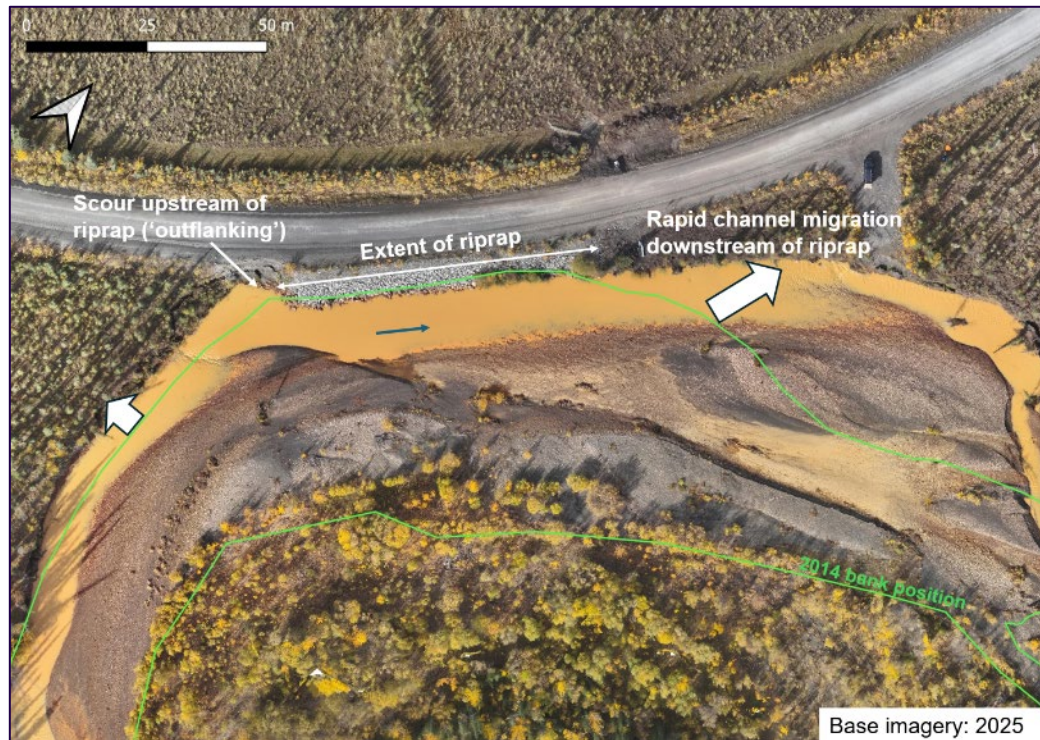
**FIGURE 6.2. AERIAL IMAGERY FROM 2025 ILLUSTRATES SCOUR UPSTREAM OF A RIPRAP EMBANKMENT, INITIATING OUTFLANKING OF THE REVETMENT, AND ACCELERATED CHANNEL MIGRATION DOWNSTREAM ALONG THE DEMPSTER HIGHWAY. THE GREEN LINE IS THE 2014 BANK POSITION. RIPRAP WAS INSTALLED IN 2010 AND AGAIN IN 2015.**

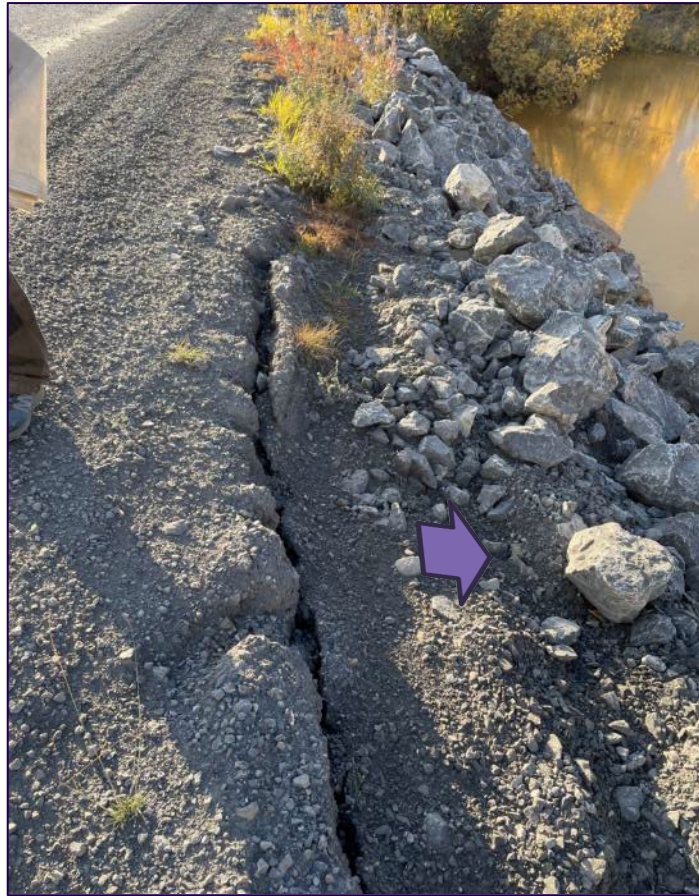
**FIGURE 6.4. NEWLY INSTALLED RIPRAP AT DEMPSTER HIGHWAY KM 193.4 WAS LIKELY NOT SUFFICIENTLY EMBEDDED, WHICH HAS CAUSED TENSION CRACKS AND THE RIPRAP TO ‘SLIP’ DOWNWARD BY APPROXIMATELY 25 CM.**

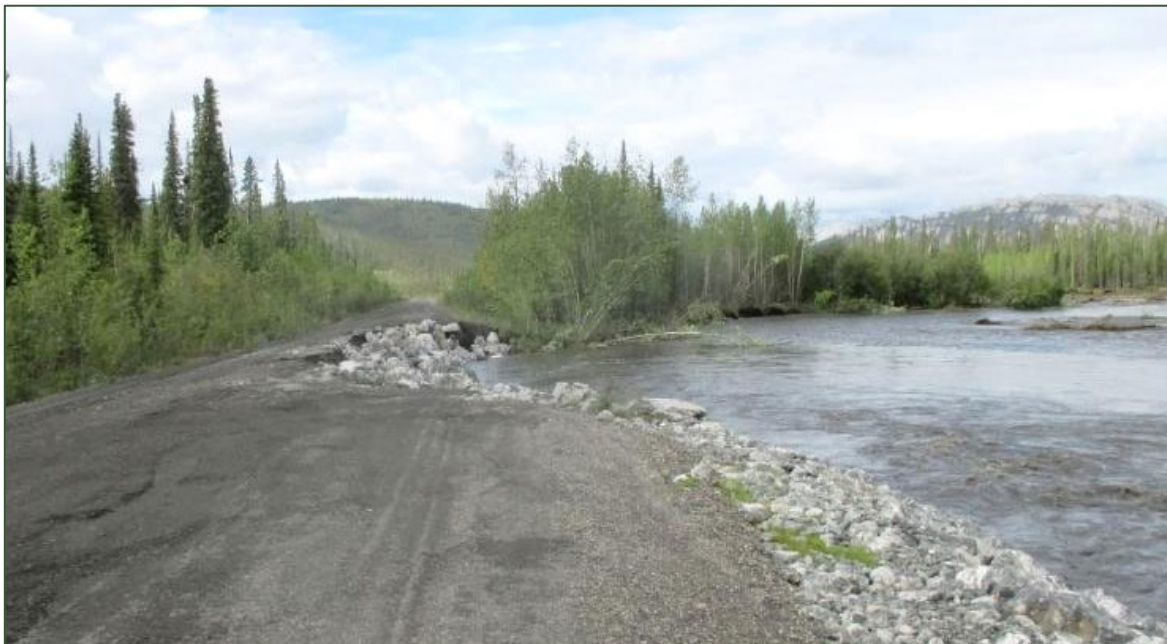
**FIGURE 6.7. TEMPORARY EROSION MITIGATION FOLLOWING A ROAD WASHOUT AT DEMPSTER HIGHWAY KM 180.3 DURING THE AUGUST 2016 FLOOD (PHOTO CREDIT: HPW). THE TEMPORARY MEASURE DOES NOT NEGATE THE NEED TO RECONSTRUCT THE HIGHWAY, BUT IT MINIMIZES THE SERVICE DISRUPTION BY ALLOWING ALTERNATING TRAFFIC TO PASS UNTIL THE HIGHWAY IS RECONSTRUCTED.**

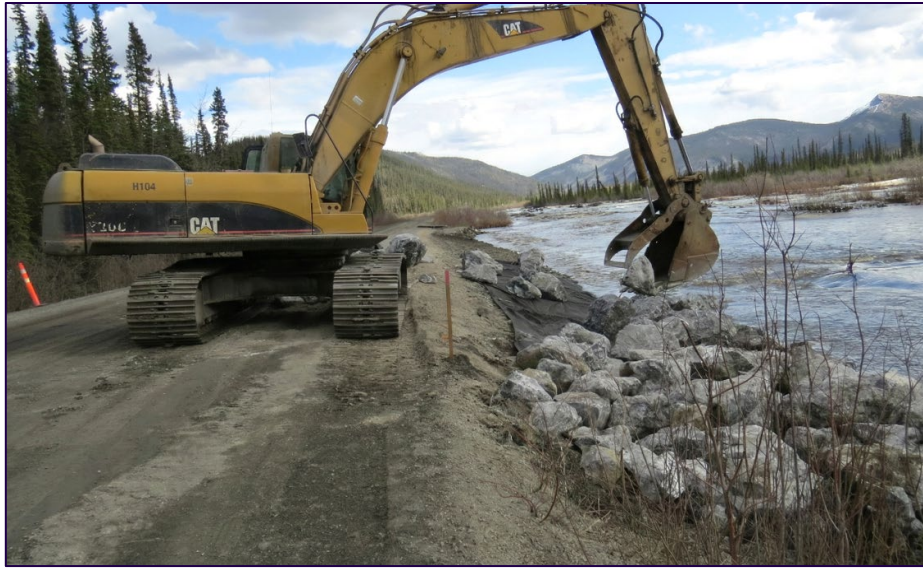
**FIGURE 6.8. CAREFUL PLACEMENT OF RIPRAP ON AN EMBANKMENT USING SPECIALIZED EQUIPMENT LEADS TO BETTER LONG-TERM RESULTS (PHOTO CREDIT: HPW). NOTE THAT IN THIS PHOTO, THE RIPRAP IS CAREFULLY BEING PLACED ATOP GEOTEXTILE, WHICH CAN FORM A SLIP-SURFACE AND CONTRIBUTE TO REVETMENT FAILURE. A PROPERLY GRADED STRUCTURE WITH A SUBSTRATE MADE OF SAND AND GRAVEL REPRESENTS A SUITABLE ALTERNATIVE. LOCATION: DEMPSTER HIGHWAY KM 179.6.**

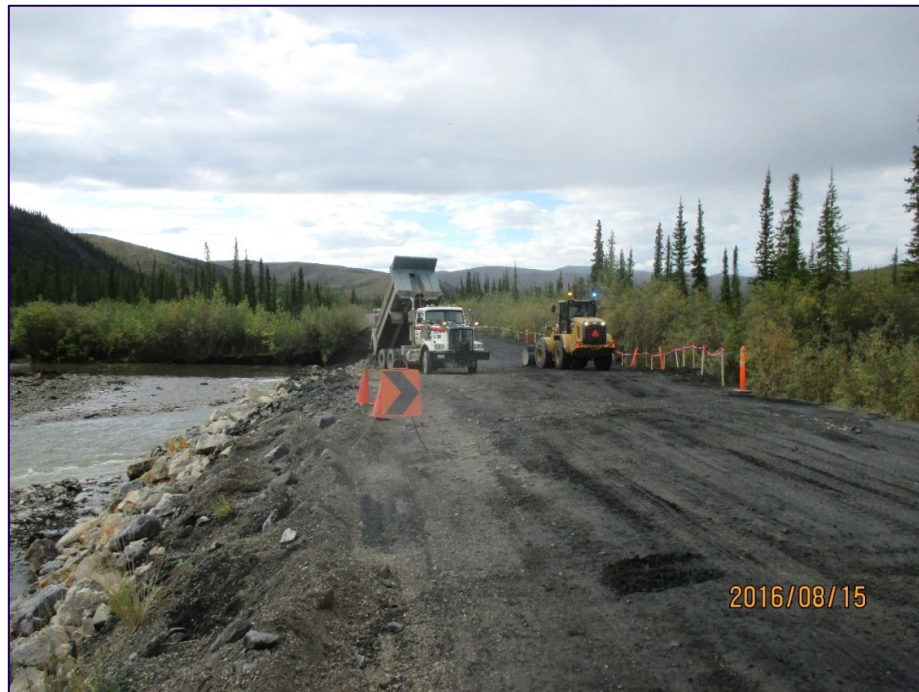
**FIGURE 6.9. EMERGENCY RIPRAP INSTALLATION UTILIZING END-DUMPING METHODS FOLLOWING THE AUGUST 2016 FLOOD AT DEMPSTER HIGHWAY KM 165.5 (PHOTO CREDIT: HPW). WHILE EXPEDIENT FOR RAPID RESPONSE, THE LACK OF KEYED PLACEMENT AND MATERIAL SEGREGATION TYPICALLY RESULTS IN POOR STRUCTURAL INTERLOCKING AND LIMITED LONG-TERM RESILIENCE.**

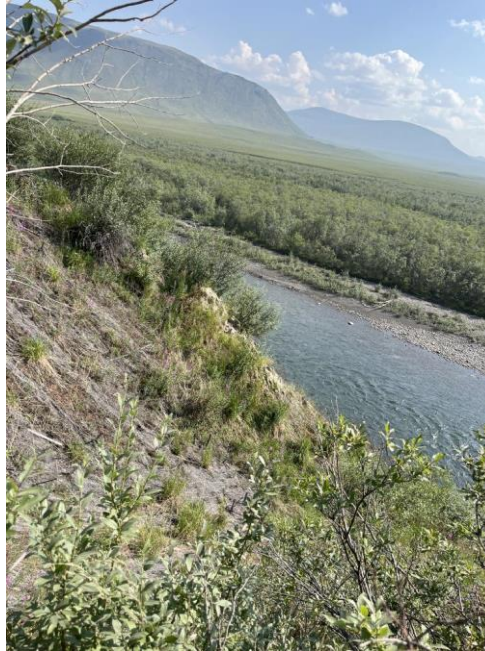
- **KM 182.1 (ID # 45) Engineer Creek** – Approximately 60 m of riprap was installed along the highway embankment prior to 2013. Erosion has occurred both upstream and downstream of the riprap. Observed erosion in the June 2023 satellite imagery and field photos suggest the highway embankment is already failing at the upstream end of the riprap (see photo below).

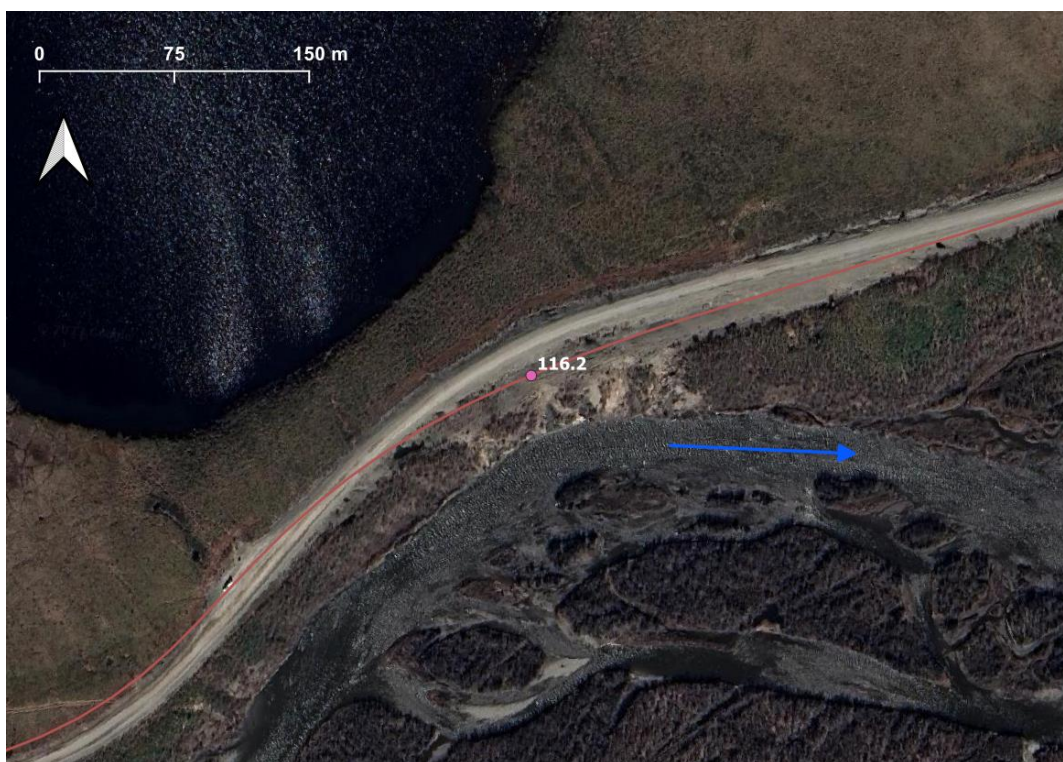
**Figure 2. KM 116.2 of Dempster Highway. Separation distance = 16 m, risk rating = High, imagery date: June 2, 2023.**

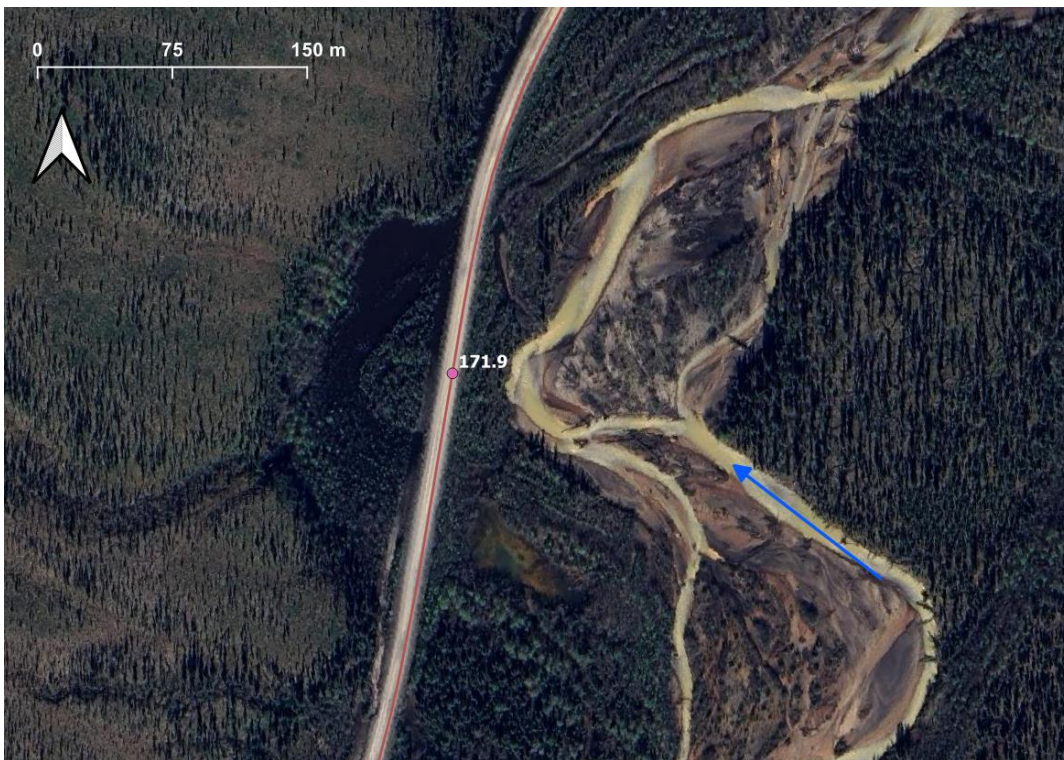
**Figure 4. KM 171.9 of Dempster Highway. Separation distance = 23 m, risk rating = High, imagery date: June 4, 2023.**

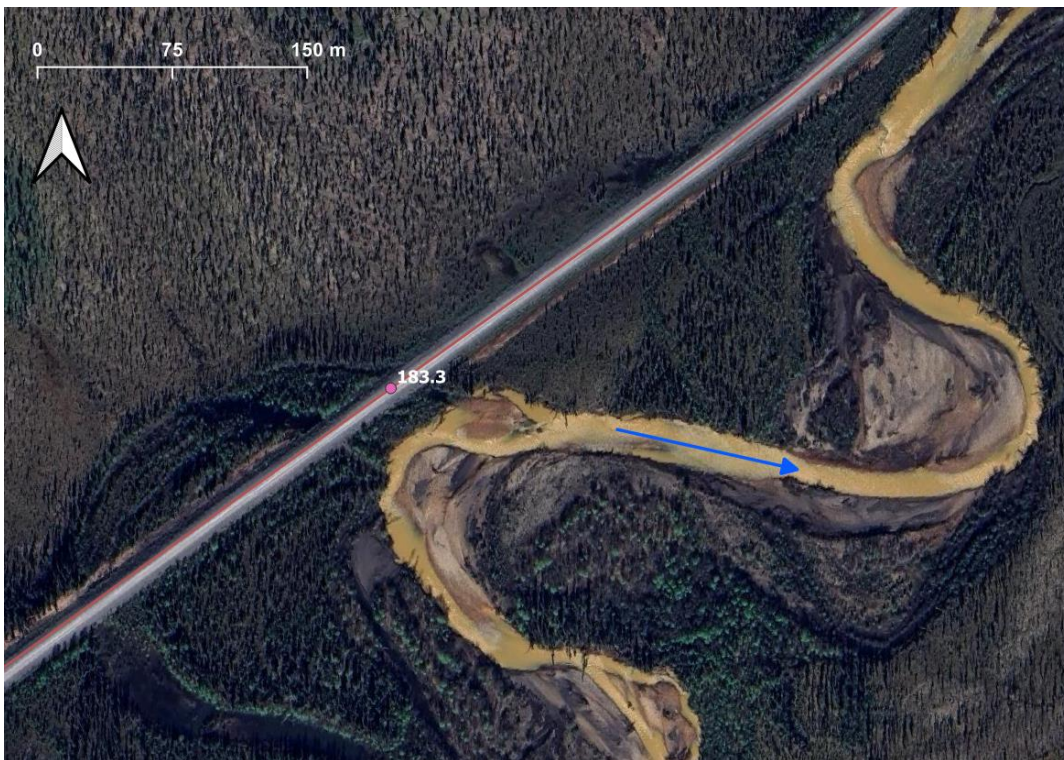
**Figure 6. KM 183.3 of Dempster Highway. Separation distance = 18 m, risk rating = High, imagery date: June 4, 2023.**

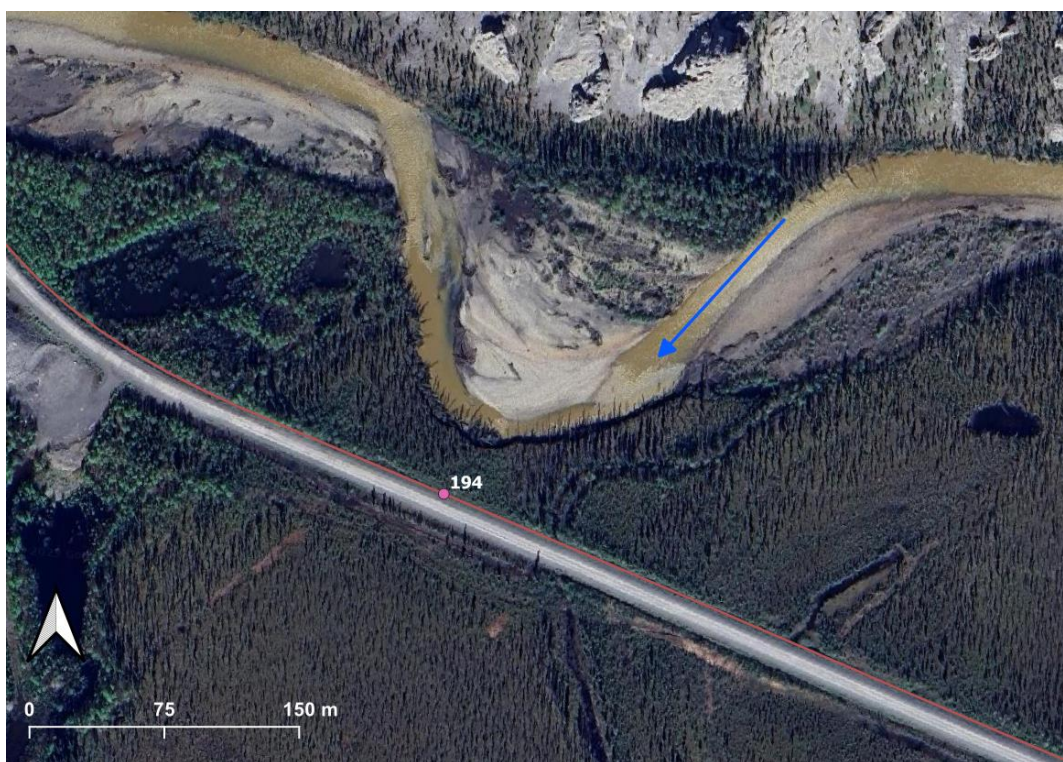
**Figure 8. KM 194.0 of Dempster Highway. Separation distance = 28 m, risk rating = High, imagery date: June 4, 2023.**

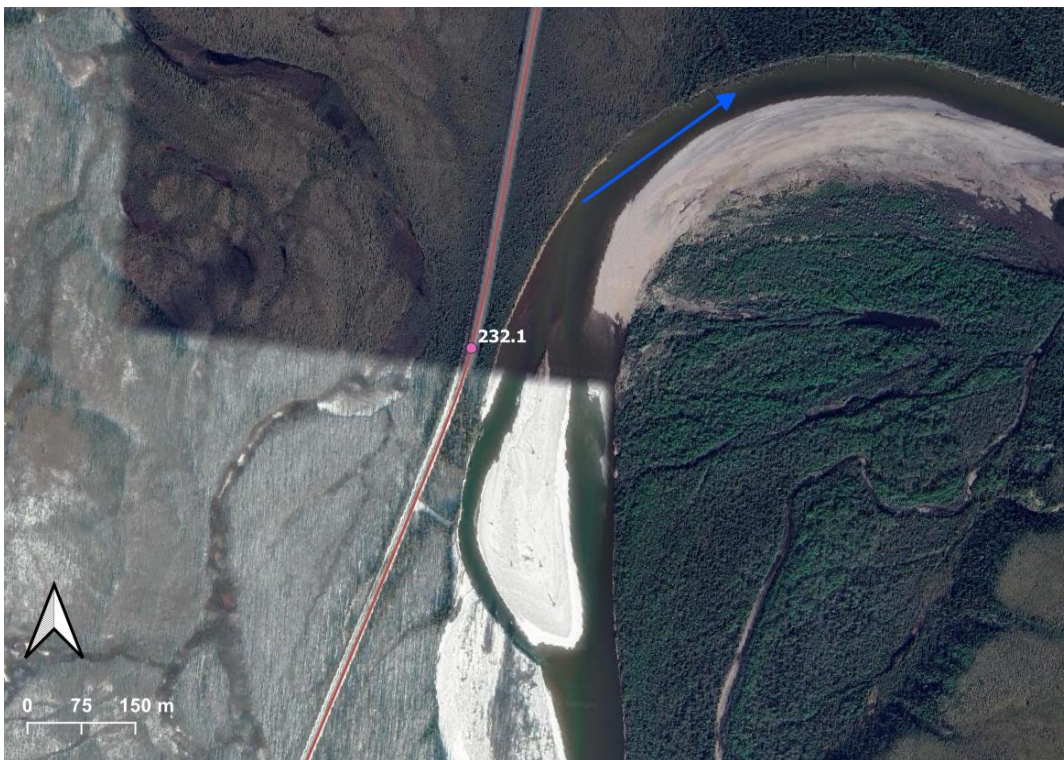
**Figure 10. KM 232.1 of Dempster Highway. Separation distance = 23 m, risk rating = High, imagery date (top half): June 7, 2023.**

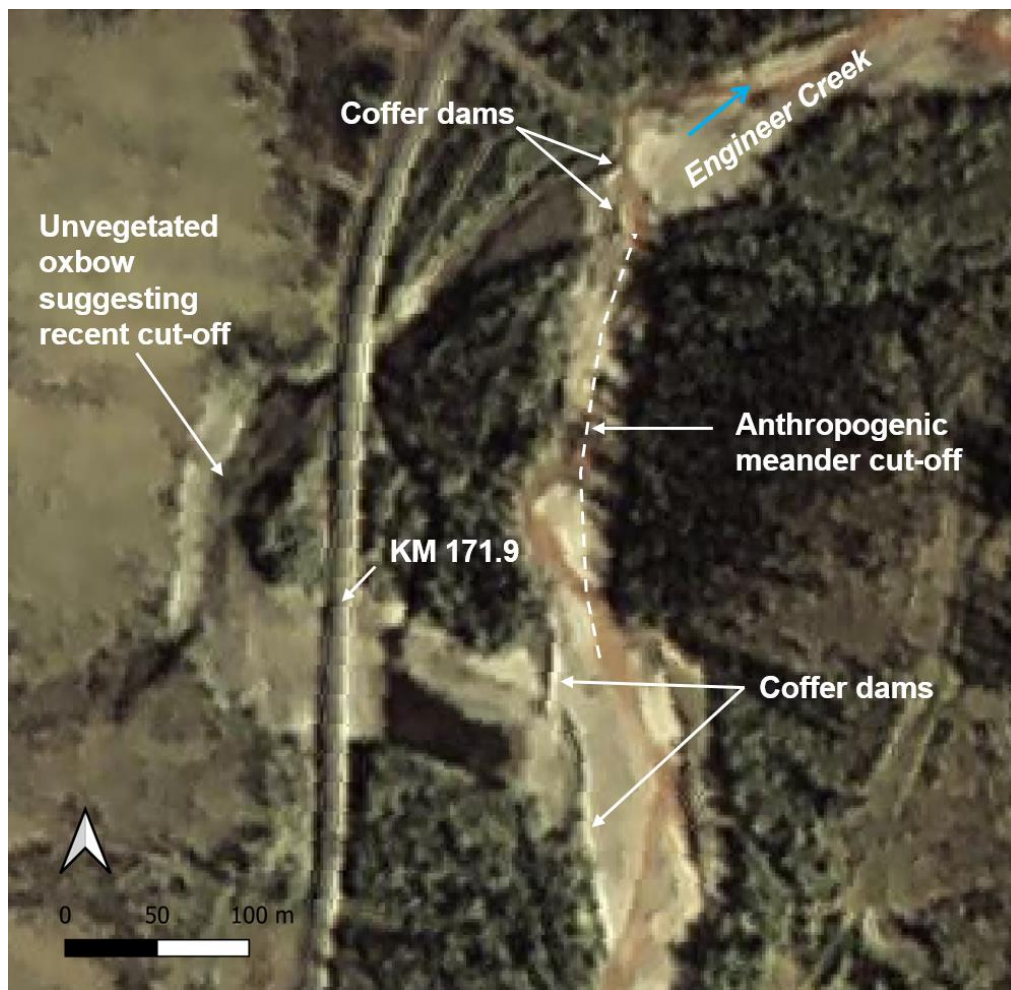
**Figure 4.** *An example of an anthropogenic cut-off along Engineer Creek observed in the 1977 aerial photographs. Since 1977, the channel has widened and has migrated rapidly towards the highway at KM 171.9 (Appendix A). Numerous other similar cut-offs are observed along Engineer Creek, which would have led to a notable reduction in channel length.*

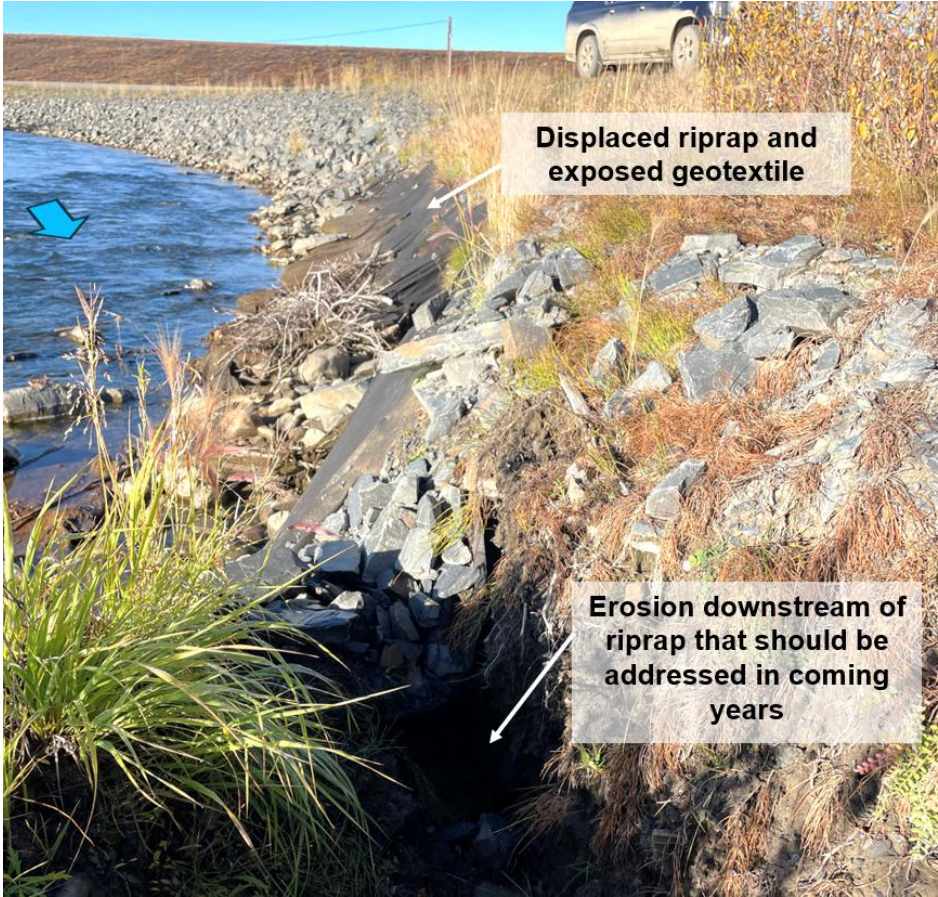
| <b>Representative Visual</b> | <p>Displaced riprap and exposed geotextile</p> <p>Erosion downstream of riprap that should be addressed in coming years</p> |

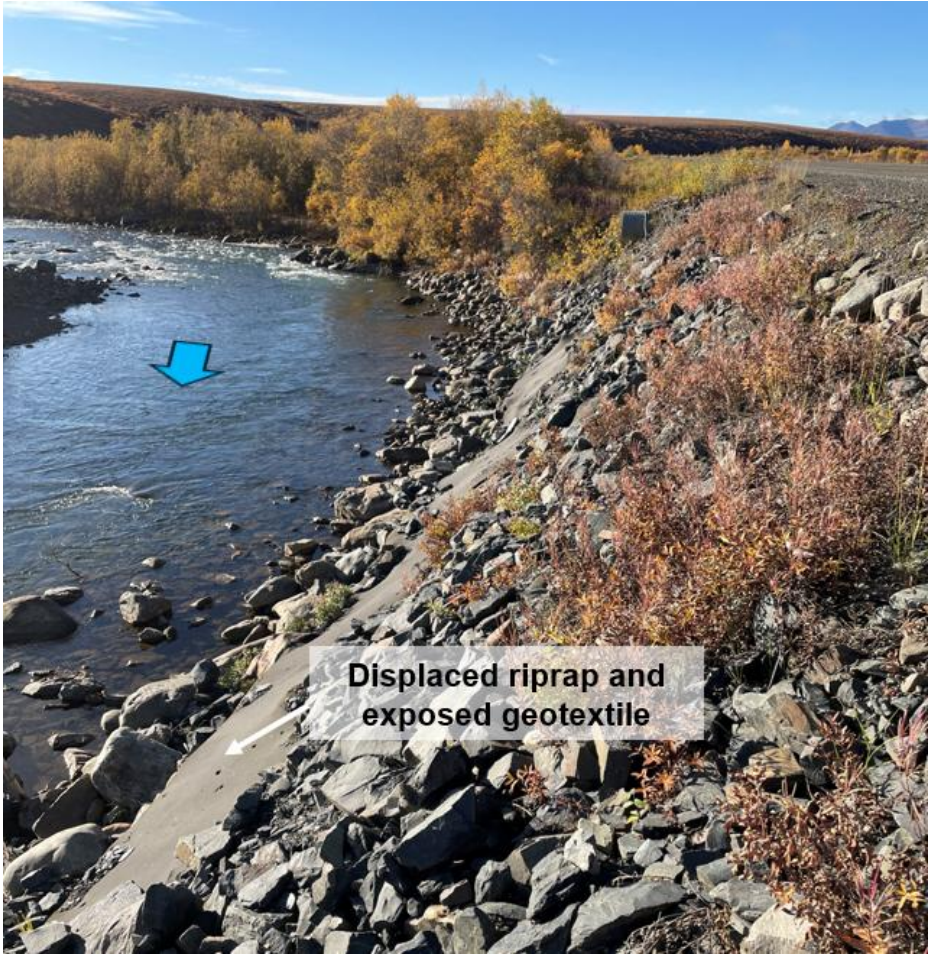
| <b>Representative Visual</b> | <p>Displaced riprap and exposed geotextile</p> |

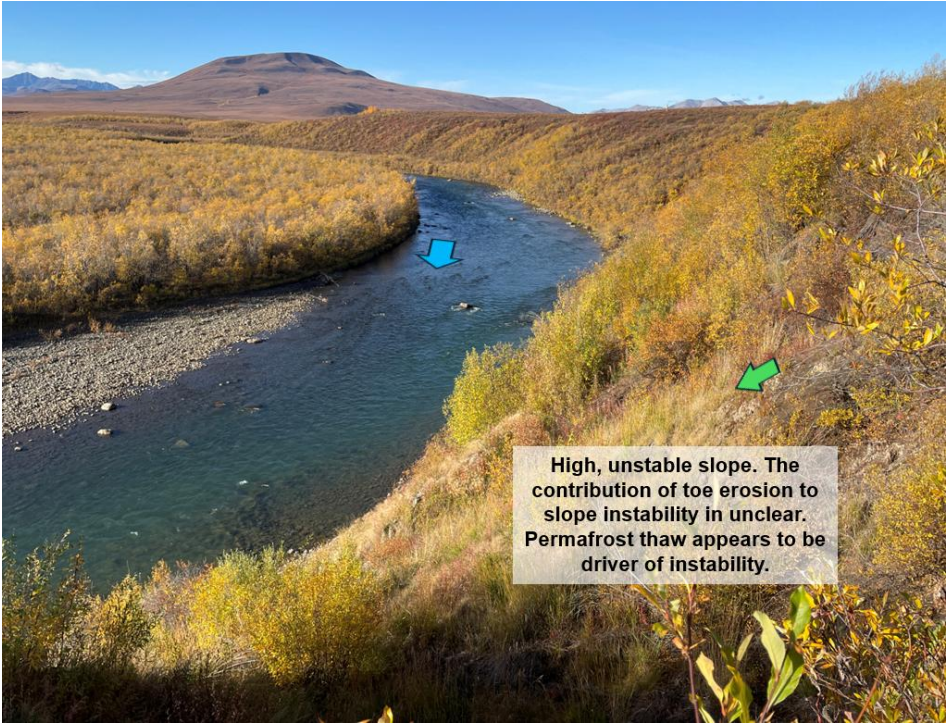
| <b>Representative Visual</b> | <p>High, unstable slope. The contribution of toe erosion to slope instability is unclear. Permafrost thaw appears to be driver of instability.</p> |

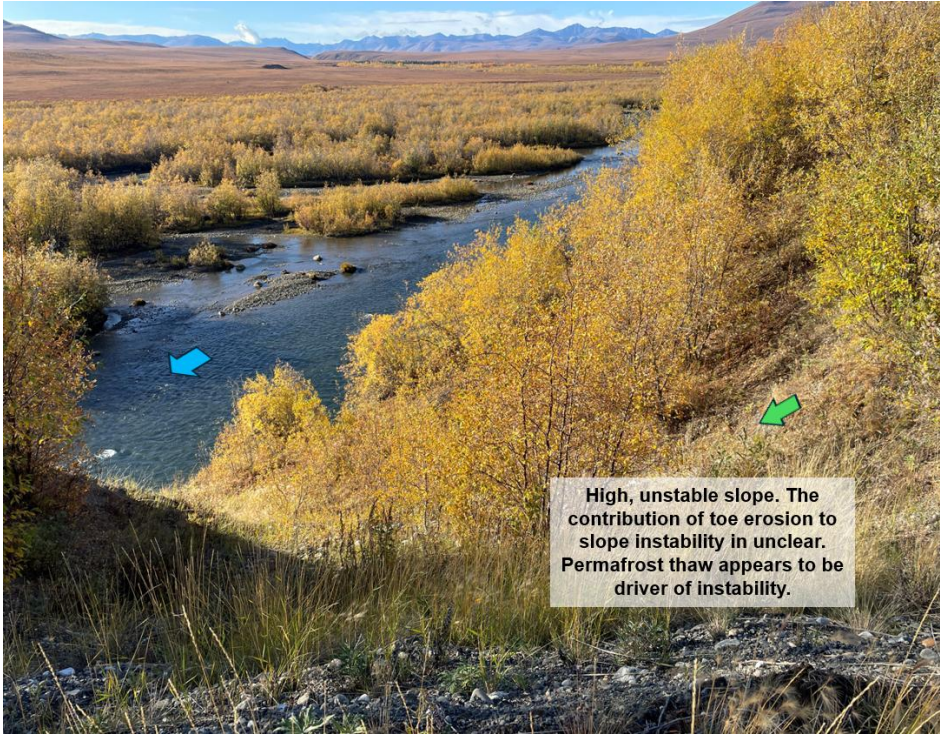
| <b>Representative Visual</b> | <p>High, unstable slope. The contribution of toe erosion to slope instability is unclear. Permafrost thaw appears to be driver of instability.</p> |

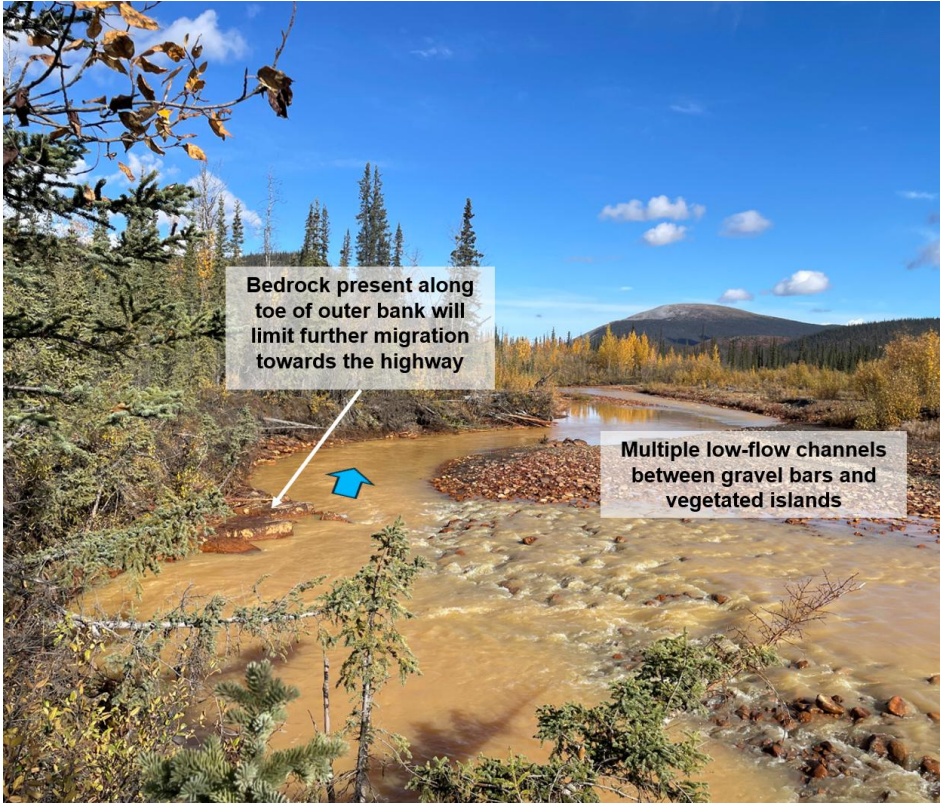
| <b>Representative Visual</b> | <p>Bedrock present along toe of outer bank will limit further migration towards the highway</p> <p>Multiple low-flow channels between gravel bars and vegetated islands</p> |

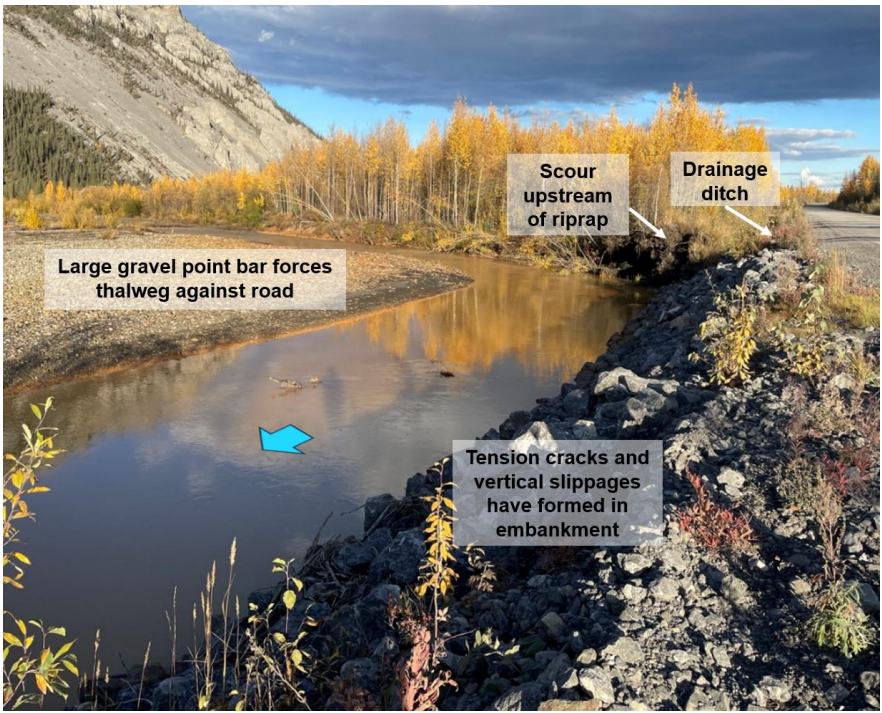
| <b>Representative Visual</b> | <p>The photograph shows a riverbank with a gravel point bar on the left, a drainage ditch on the right, and a riprap revetment. Labels indicate 'Scour upstream of riprap', 'Drainage ditch', 'Large gravel point bar forces thalweg against road', and 'Tension cracks and vertical slippages have formed in embankment'.</p> |

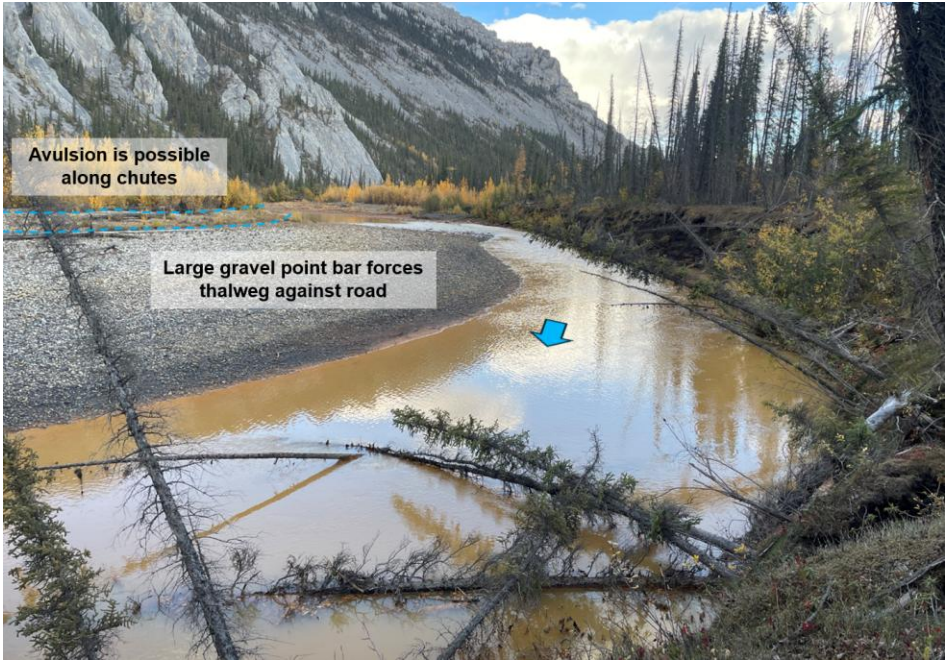
| Highway and KM | Dempster Highway KM 194.0 |
|---|---|
| Representative Visual | <p>Avulsion is possible along chutes</p> <p>Large gravel point bar forces thalweg against road</p> |

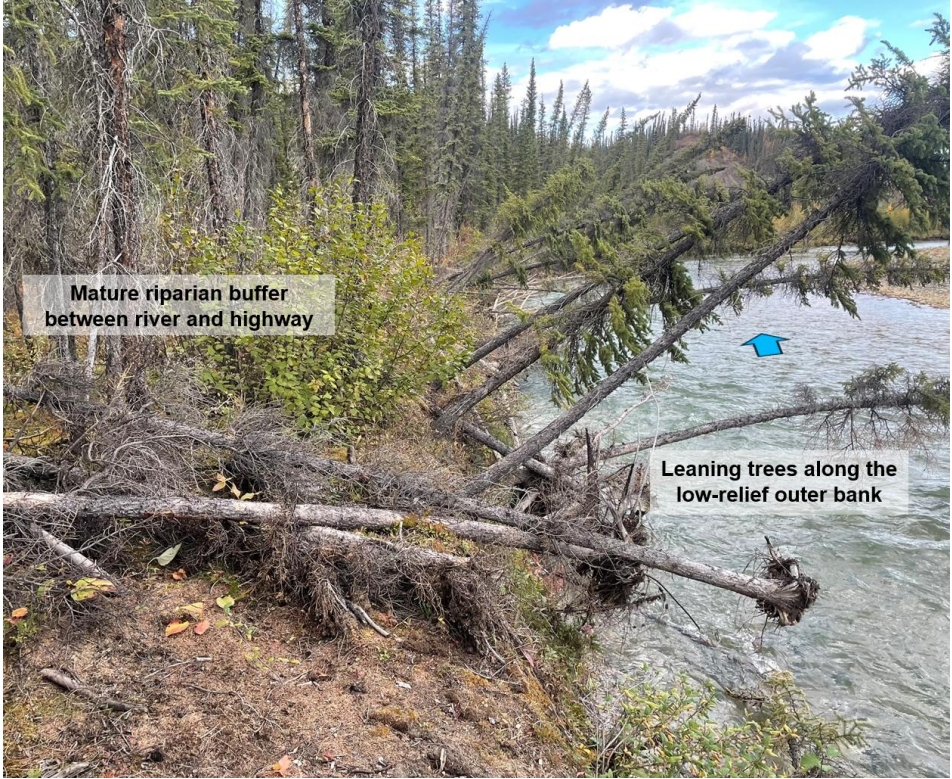
| Highway and KM | Dempster Highway KM 218.4 |
|---|---|
| Representative Visual | <p>Mature riparian buffer between river and highway</p> <p>Leaning trees along the low-relief outer bank</p> |

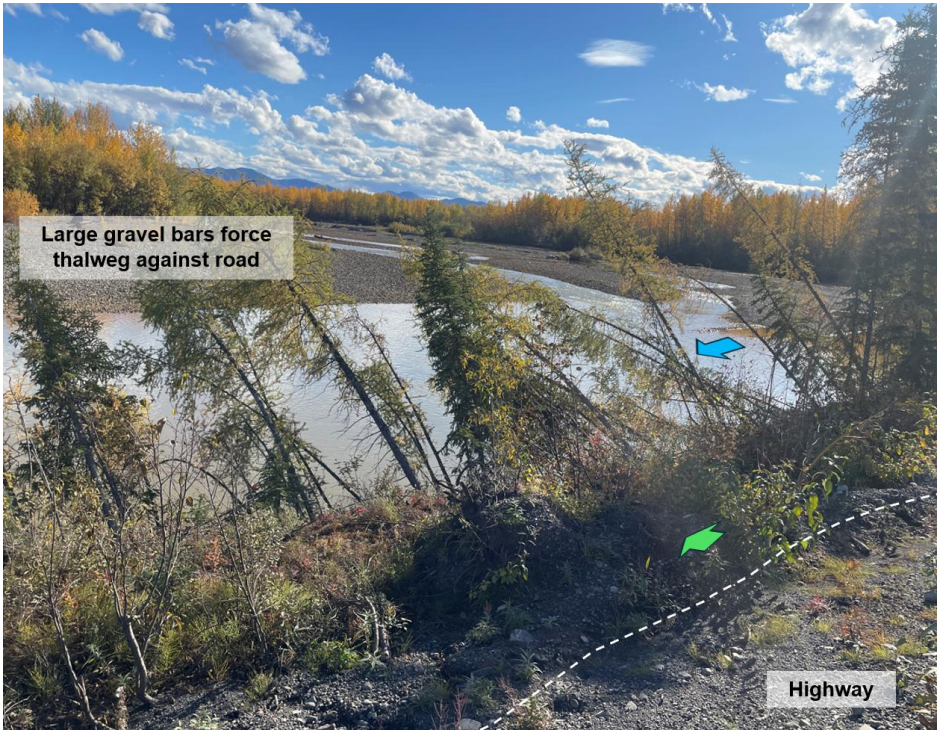
| Highway and KM | Dempster Highway KM 239.5 |
|---|---|
| Representative Visual | <p>Large gravel bars force thalweg against road</p> <p>Highway</p> |
