Assessment of Risk to Infrastructure from Permafrost Degradation and a Changing Climate, Ross River

Calmels, F., B. Horton, L.P. Roy, P. Lipovsky and B. Benkert. 2016. Assessment of Risk to Infrastructure from Permafrost Degradation and a Changing Climate, Ross River. Northern Climate ExChange, Yukon Research Centre, Yukon College.

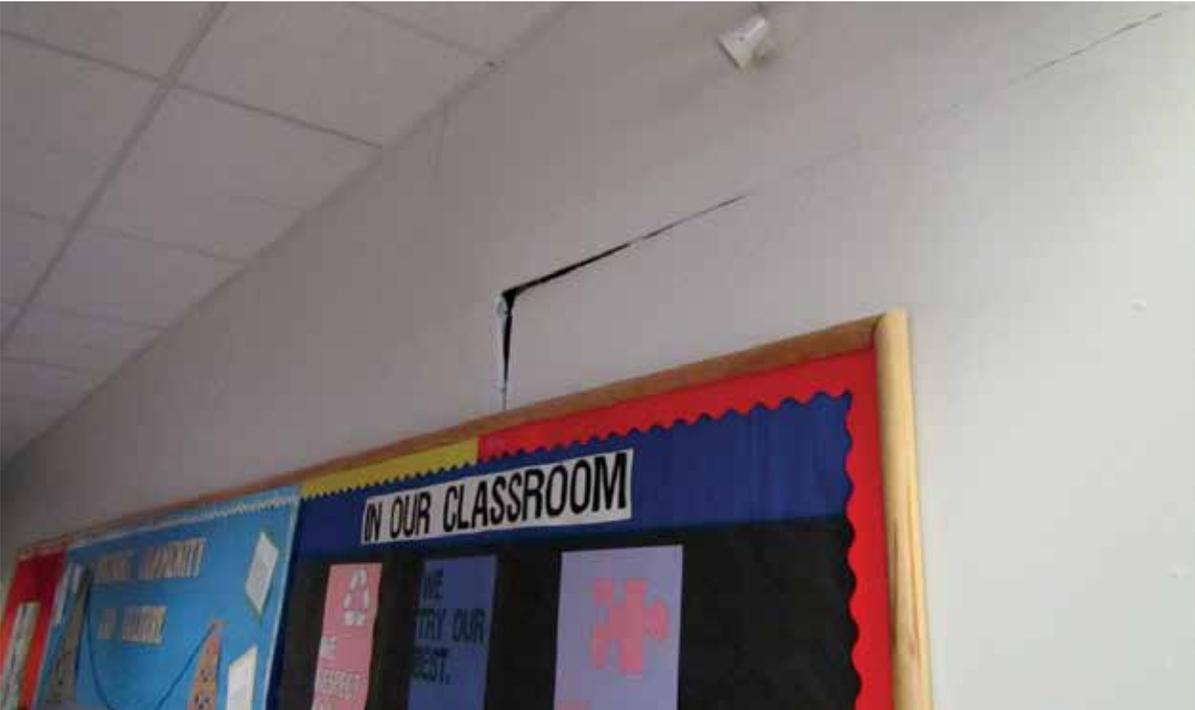
Figure 2.7.1.1 Damage to drywall in the northeast part of the school

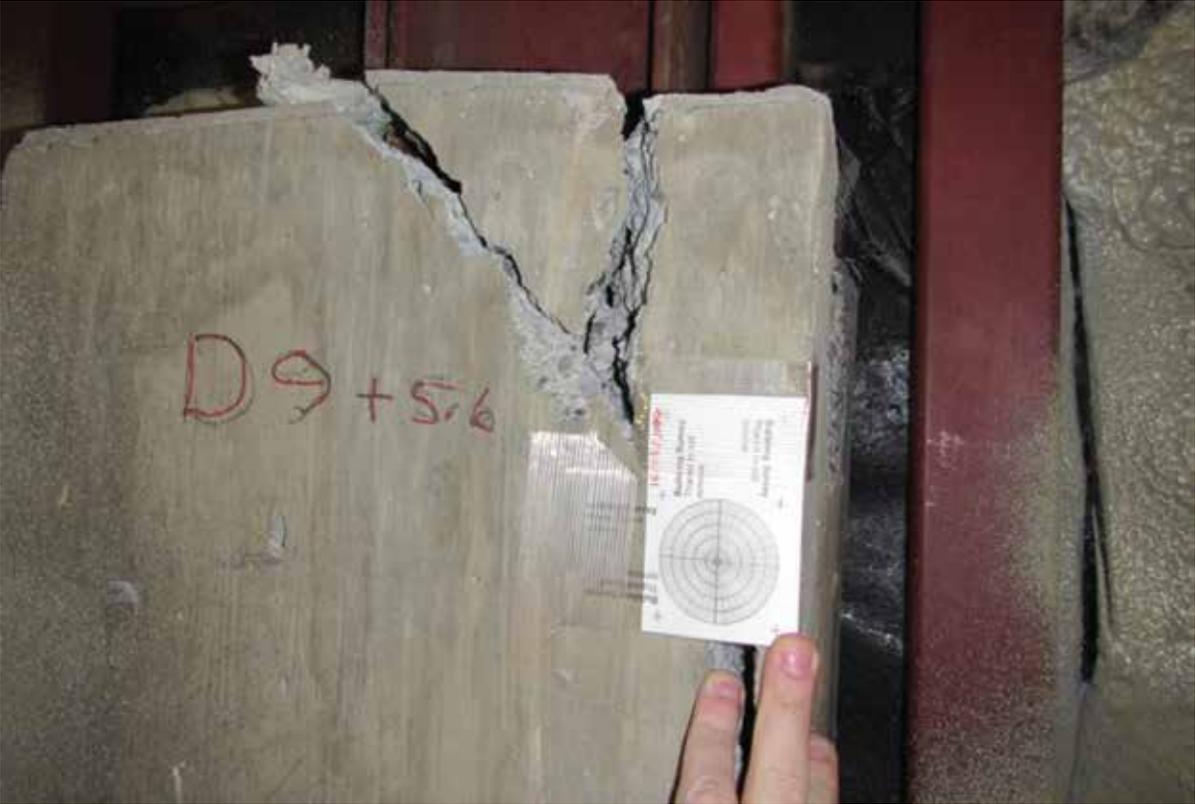
Figure 2.7.1.2 Damage to a concrete pier in the southwest part of the school

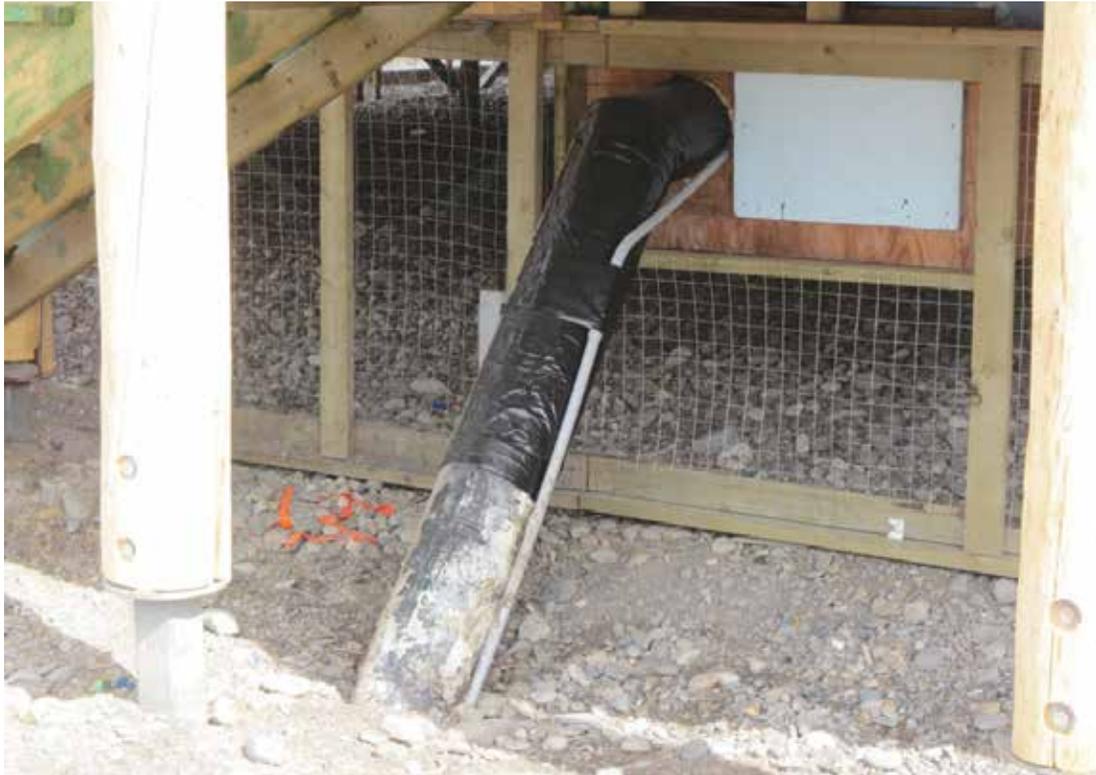
Figure 2.7.2.1 Repaired sewer line; sewer line had leaked for an unknown amount of time

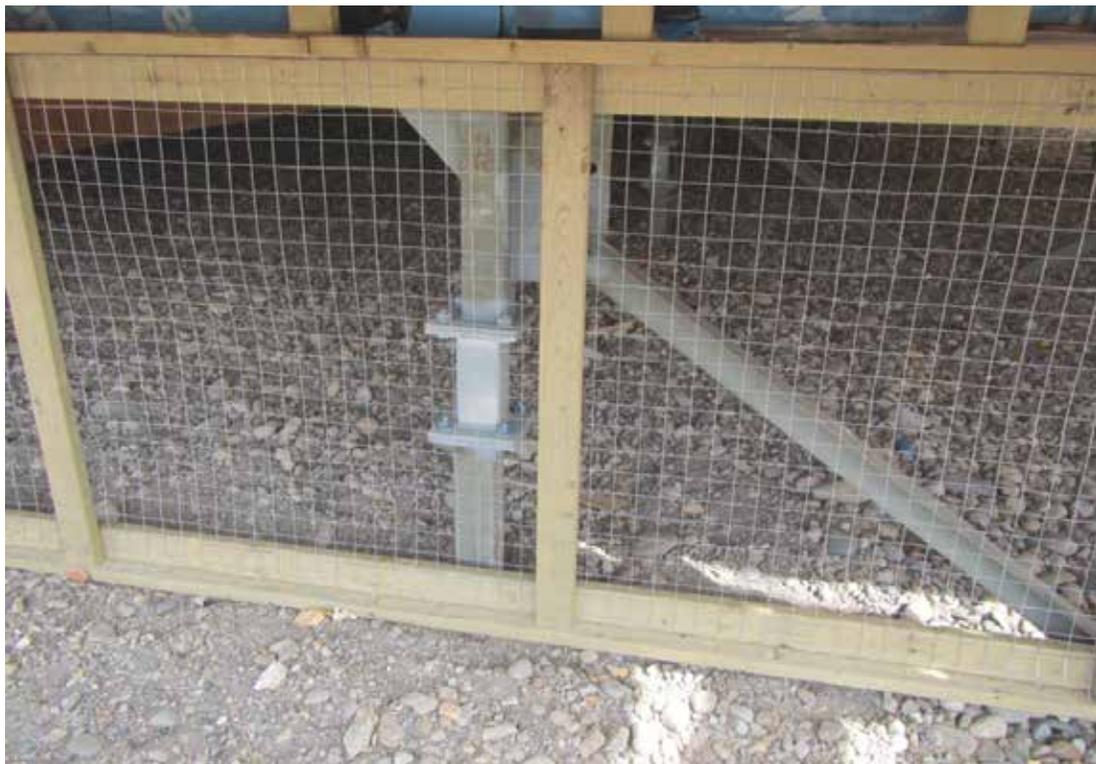
Figure 2.7.2.2 Extension added to piers on the community centre/daycare

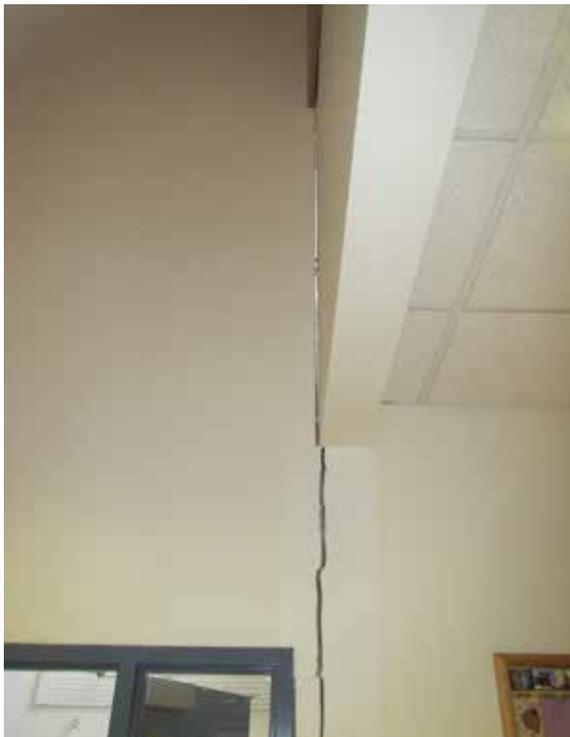
Figure 4.1.1 Cracked drywall, school

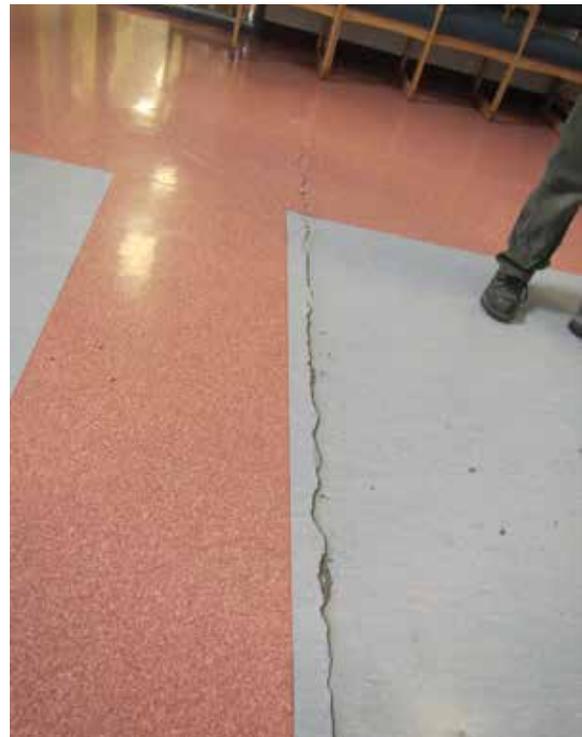
Figure 4.1.2 Cracks in the floor, school

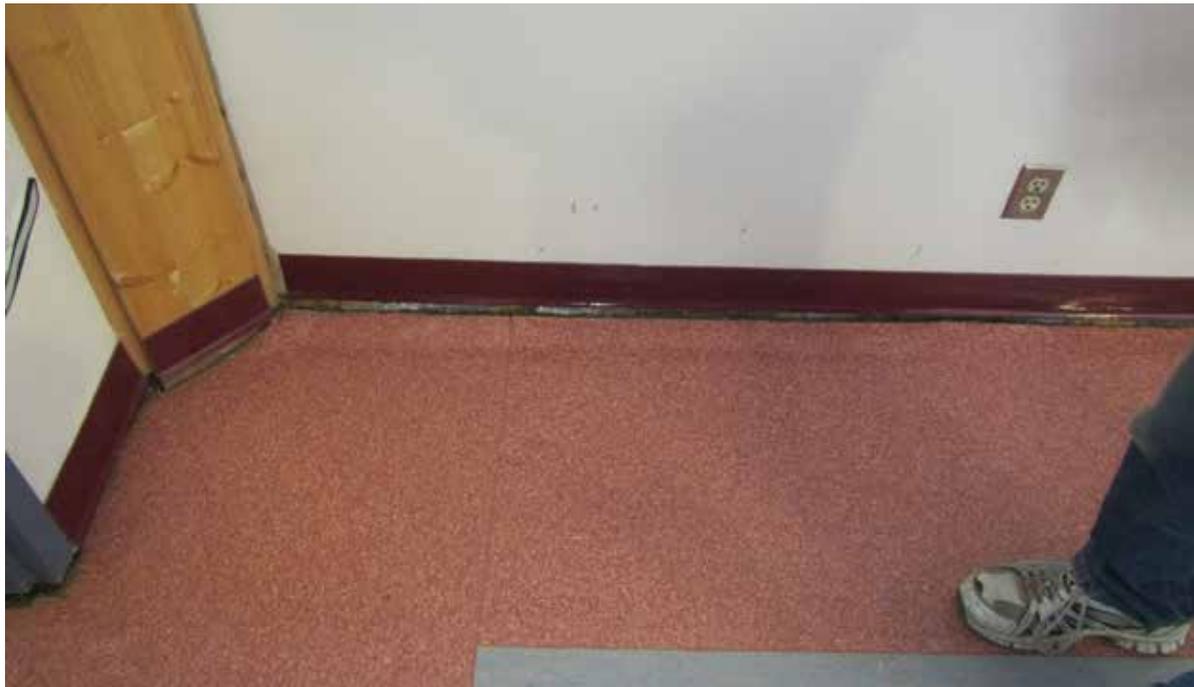
Figure 4.1.3 Gaps in joints between walls, and between walls and the floor, school

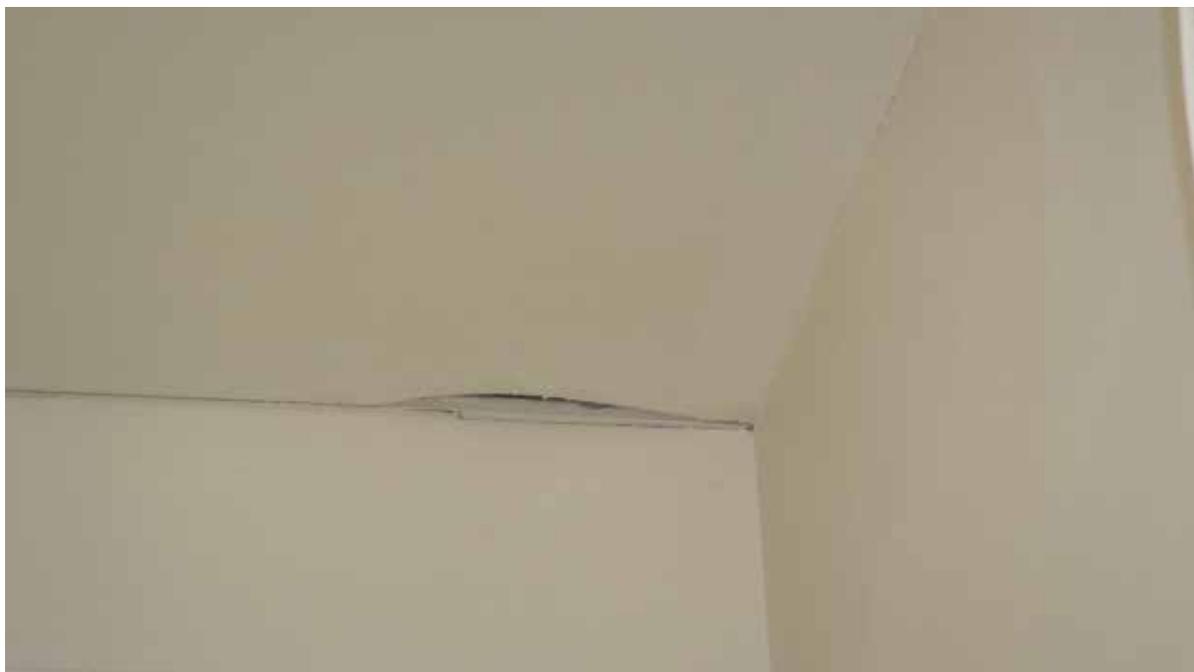
Figure 4.1.4 Small cracks between walls and ceiling, community centre

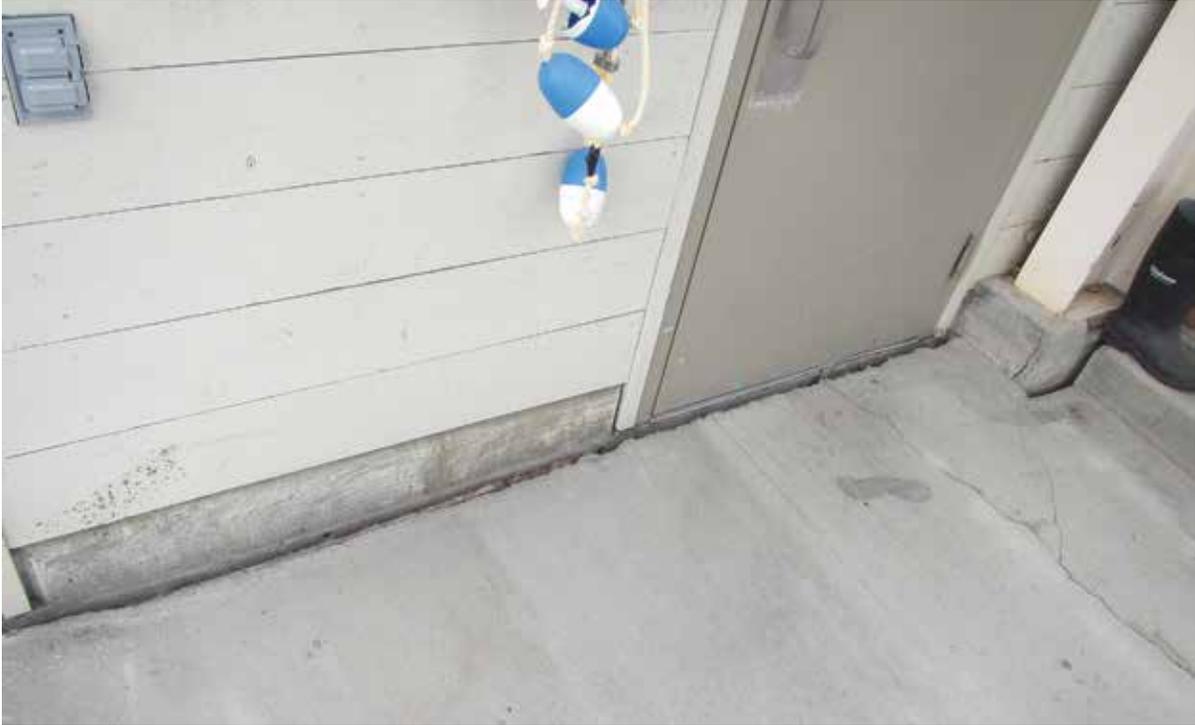
Figure 4.1.5 Gap between the wall and the floor, pool

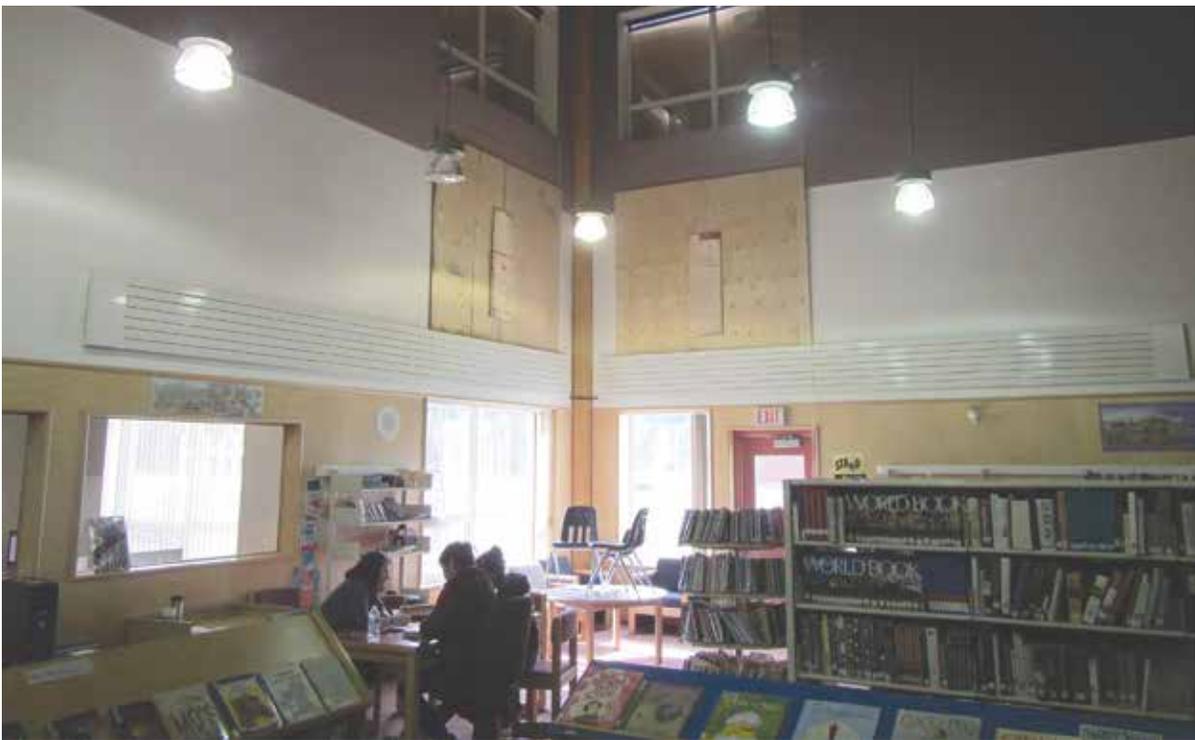
Figure 4.1.6 Window glass replaced by plywood, school

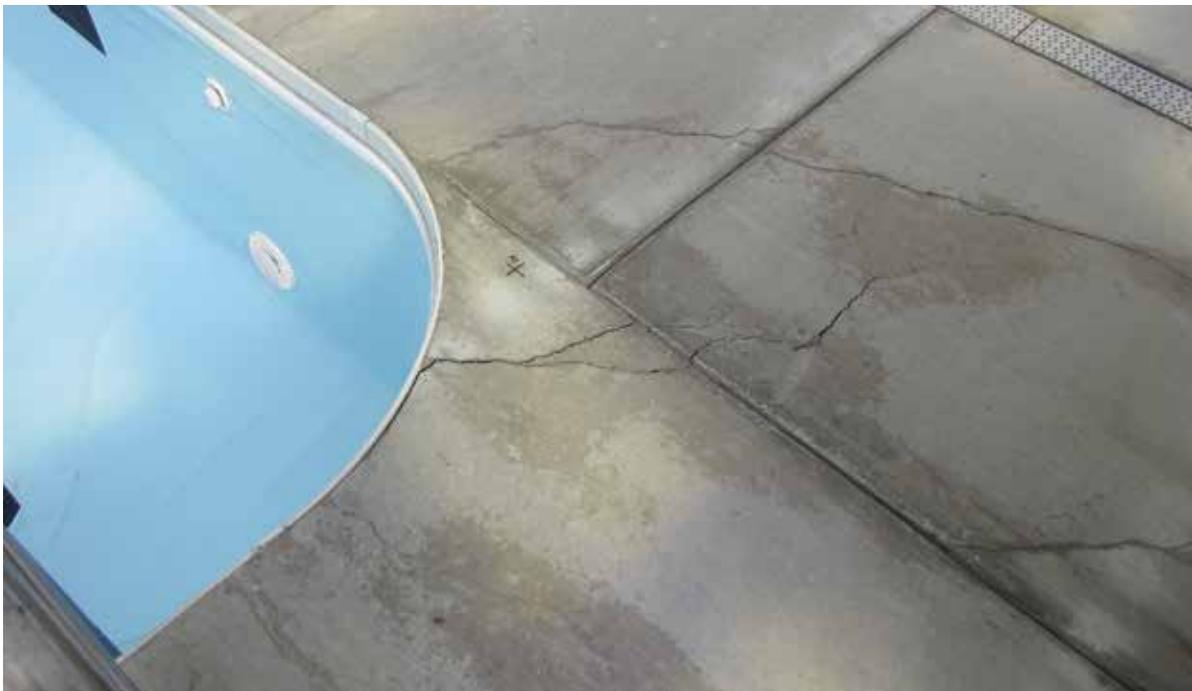
Figure 4.1.7 Cracks in concrete floor, pool

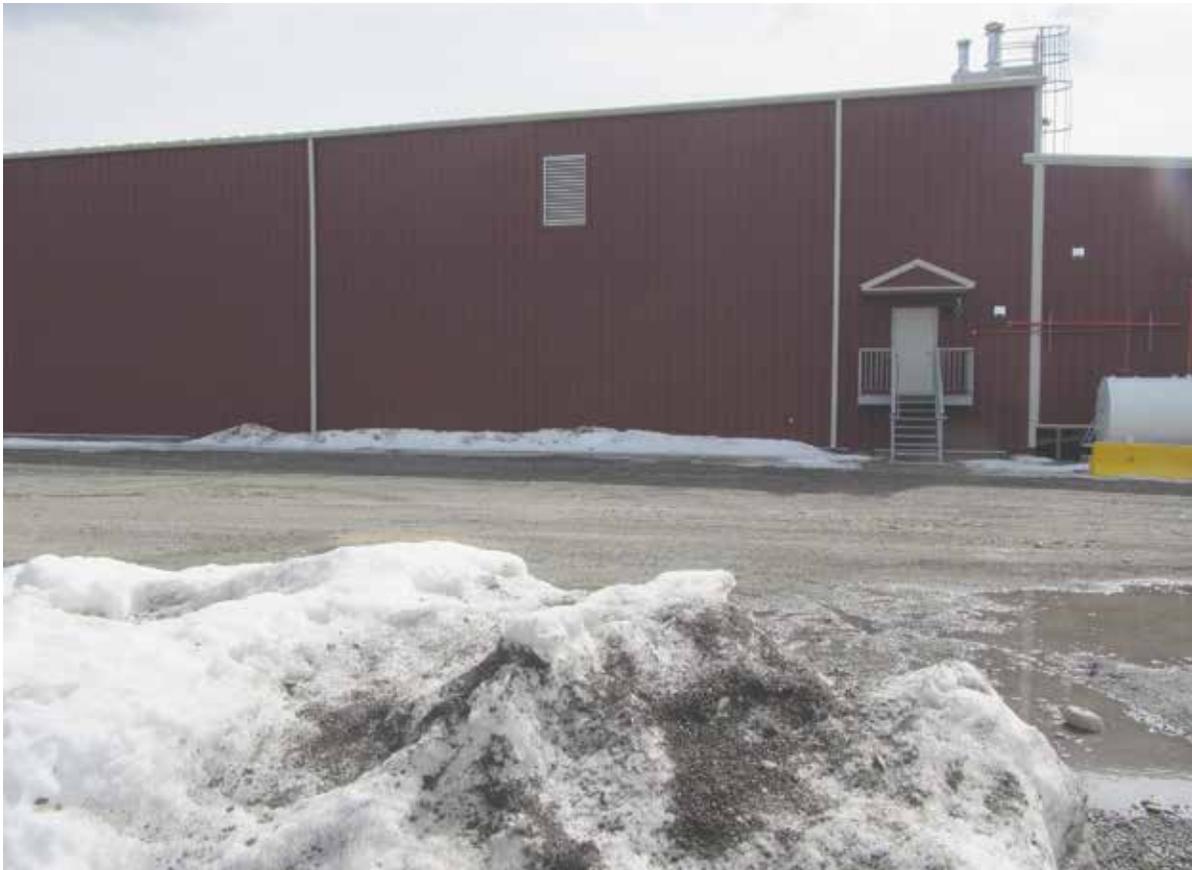
Figure 4.2.1.1 Remaining snow patches close to the north-facing side of the arena, April 2014

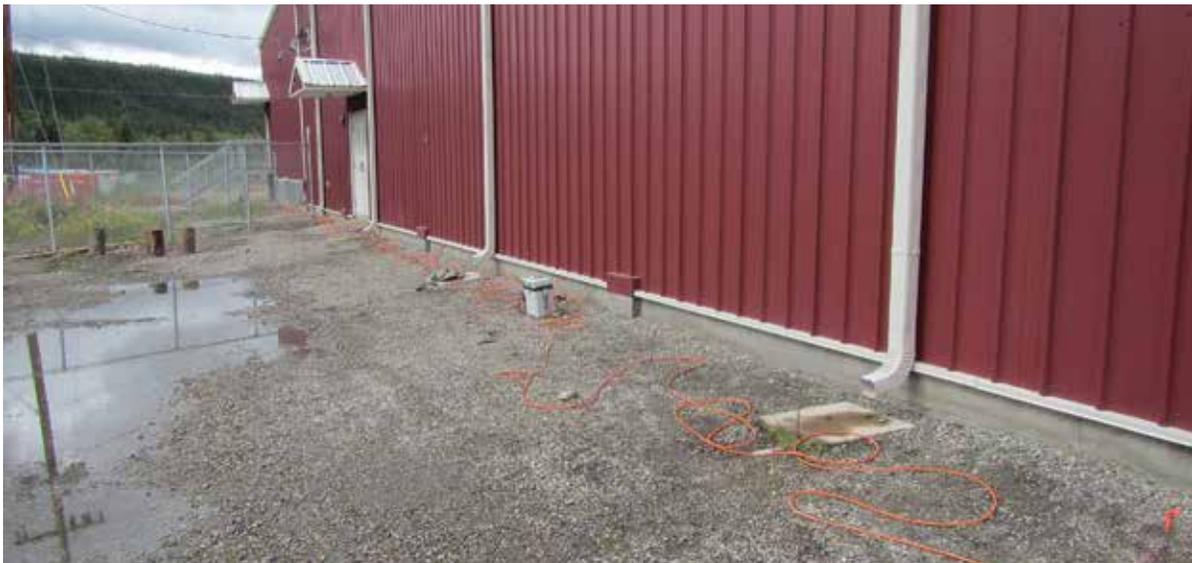
Figure 5.2 Water accumulation at the south side of the arena

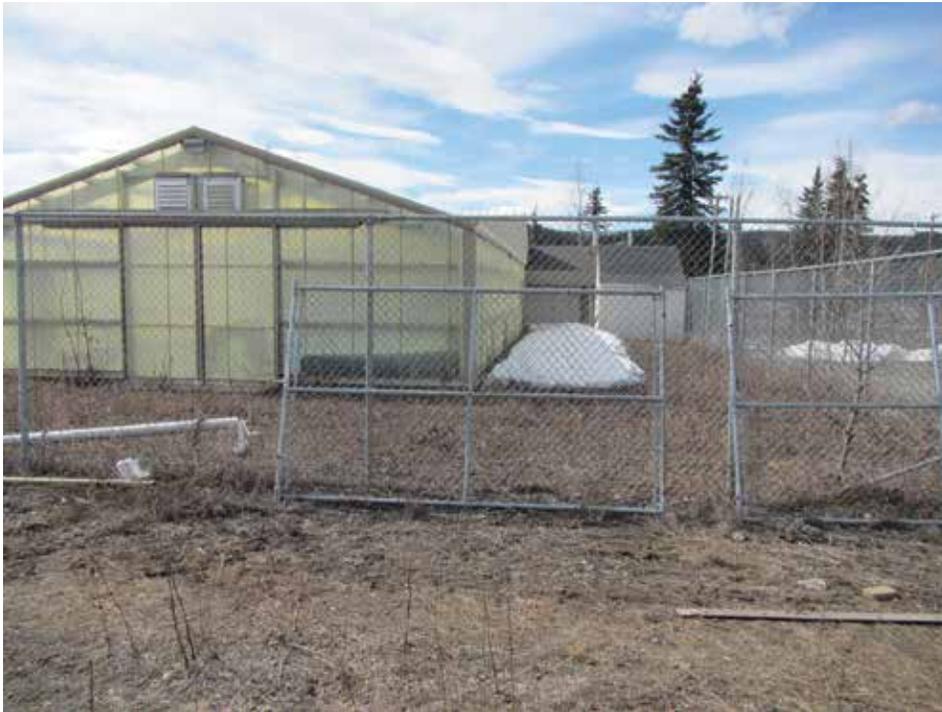
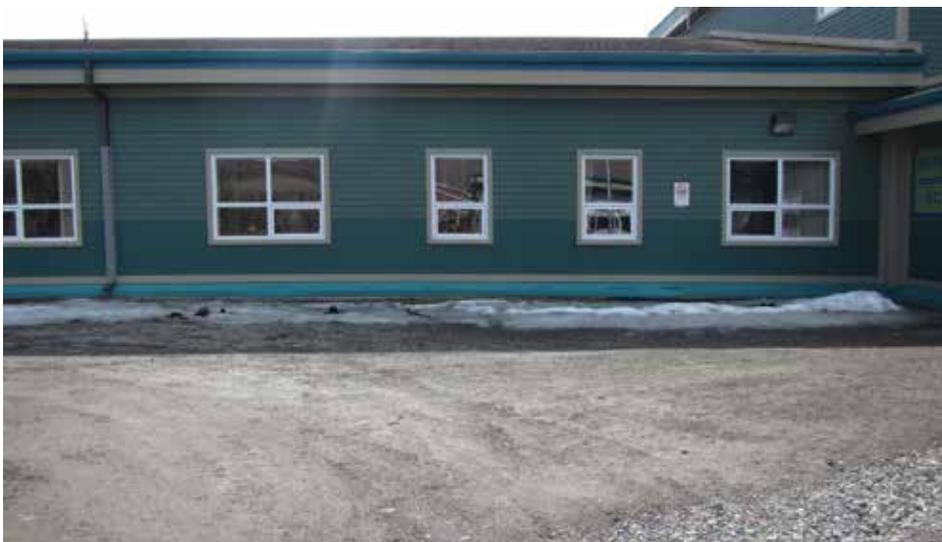
Figure 5.3 Snow accumulation on the north-facing side of the pool (above) and the school (below)
