Characterizing permafrost vulnerability to climate change induced thaw in the Traditional Territory of the Champagne and Aishihik First Nations

September 2025

YukonU Research Centre, Yukon University

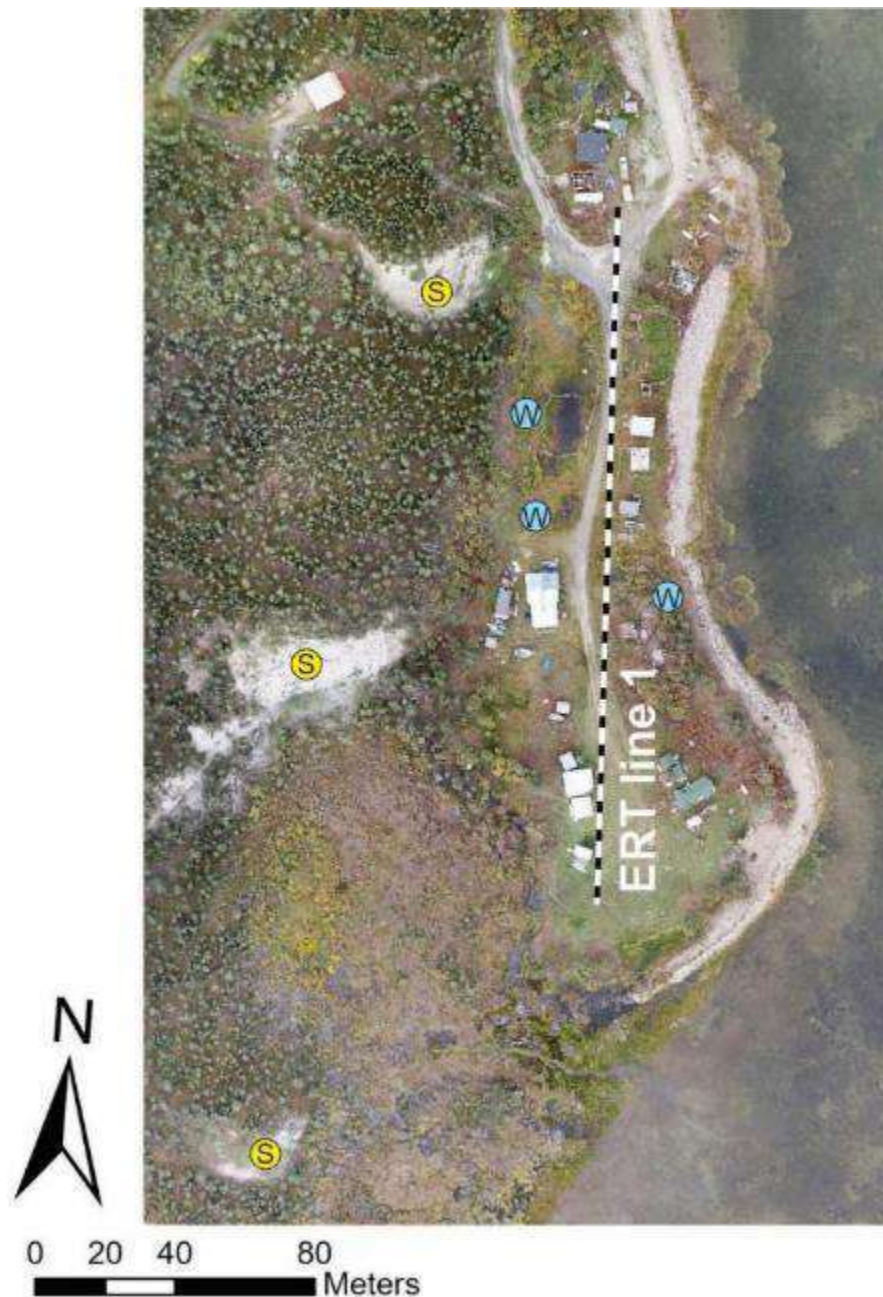
To determine whether there is permafrost underneath the study site, a 200m ERT survey was conducted parallel to the lake shore, following the access road (see ERT line 1, Figure 11) using two ERT configurations: the dipole-dipole and the Wenner arrays). The results of these surveys are presented in Figure 13. Both the dipole-dipole and the Wenner survey profiles suggest that permafrost is present, where highly resistive areas (blue areas in Figure 13) represent cold, frozen ground and less resistive areas (red areas in Figure 13), represent unfrozen ground. The Wenner profile shows a single bulk frozen area. However, the dipole-dipole profile shows a more detailed characterization of ground resistivity, with a main resistive layer, likely representing permafrost (marked with "P" in Figure 13), inset by even more resistive areas. These high resistivity pockets likely represent ice-rich permafrost (marked by "ice" in the same figure). Although these profiles do not constitute a geometrically exact representation of ground properties, they suggest that permafrost is present 3 to 5 meters below the ground surface and could extend as far as 10-15 m deep.

FIGURE 11 AERIAL IMAGE OF ÄSHÈYI ON THE LAKE SHORE, WHERE SLOPE INSTABILITY (YELLOW S SYMBOL) AND SUBSIDENCE (BLUE W SYMBOL) ARE SEEN.

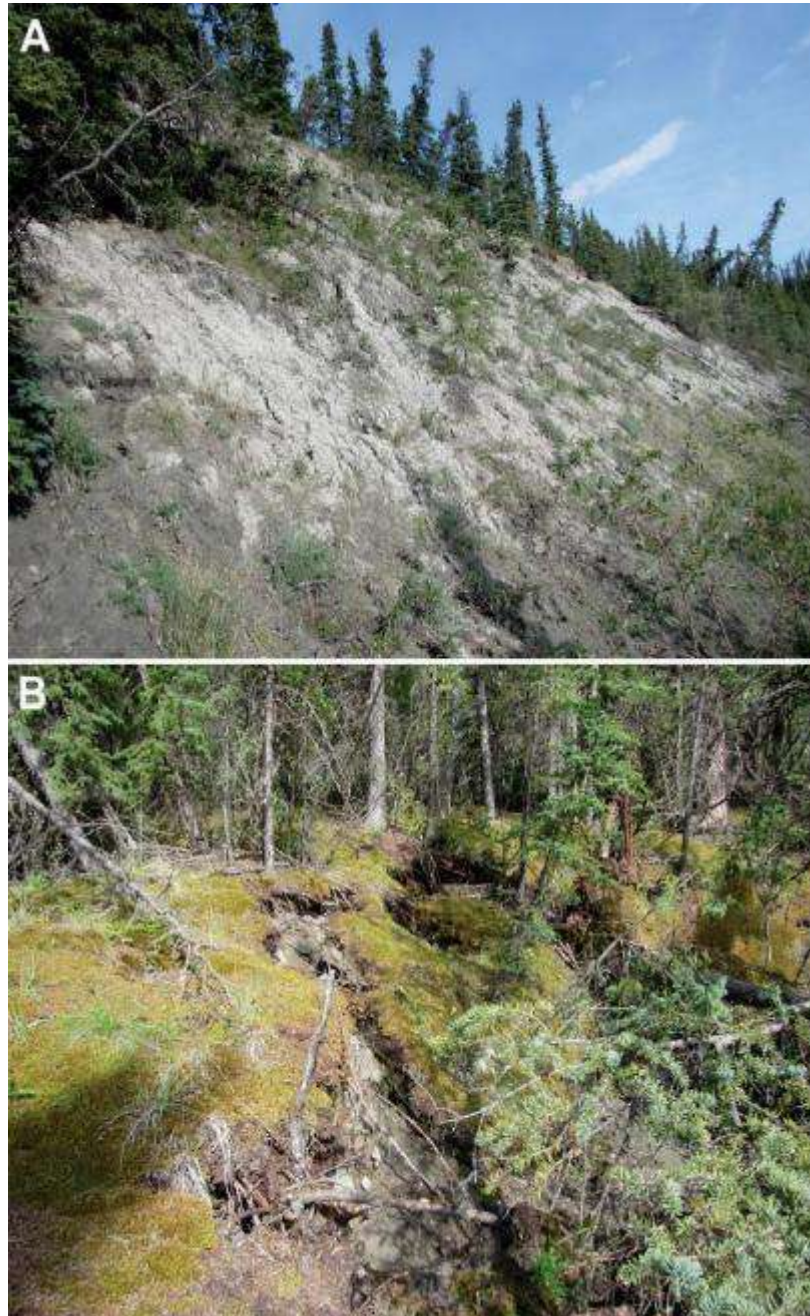
FIGURE 12 LANDSLIDE DEVELOPING ON THE WEST SIDE OF ÄSHËYI. A- BARE BLUFF WHERE VEGETATION HAS BEEN STRIPPED; B- TOP OF THE SLIDE WITH RAFT OF VEGETATION TOPPLING.

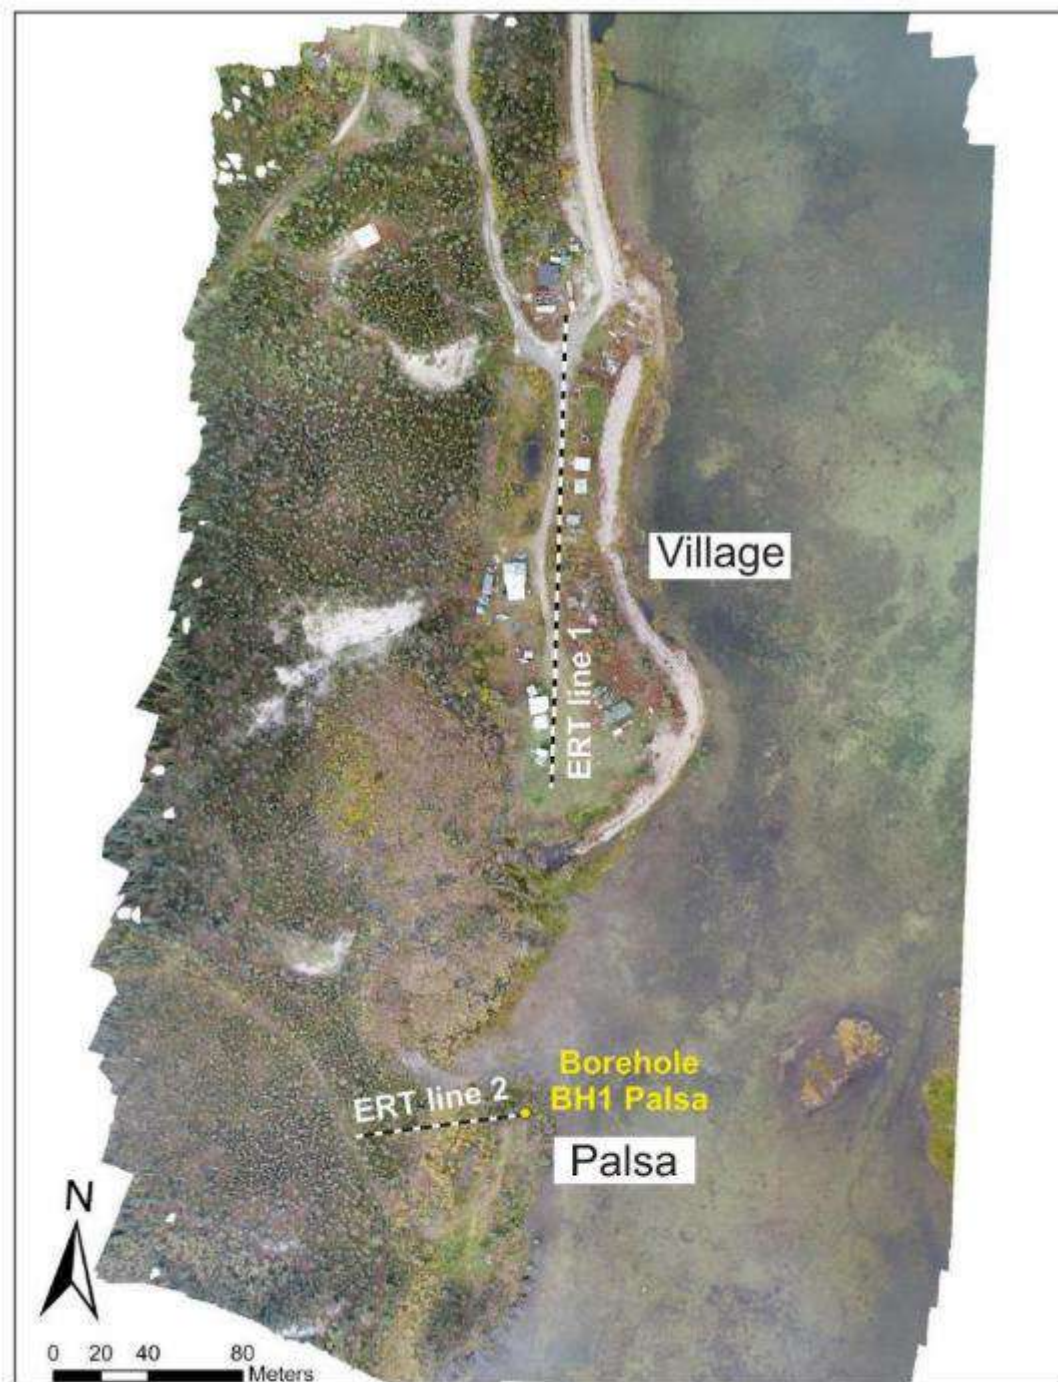
The *Palsa* site is a permafrost mound located between the foot of a hillslope and the shore of Äshèyi Mǎn about 150 m south of Äshèyi (Figure 15). A palsa is a permafrost mound with a frozen peat and sediment core. This site appears to be unaltered by human activities and likely represents permafrost conditions in the village before its settlement. In the summer of 2019, the location was drilled, permafrost cores were collected, and the resulting borehole was instrumented with ground temperature monitoring equipment (BH1 Palsa in Figure 15). An ERT survey also was conducted (ERT line 2 in Figure 15), and a drone survey was done in summer 2021.

FIGURE 15 AERIAL IMAGERY OF THE PALSA SITE WITH BOREHOLE AND ERT LINE LOCATIONS.

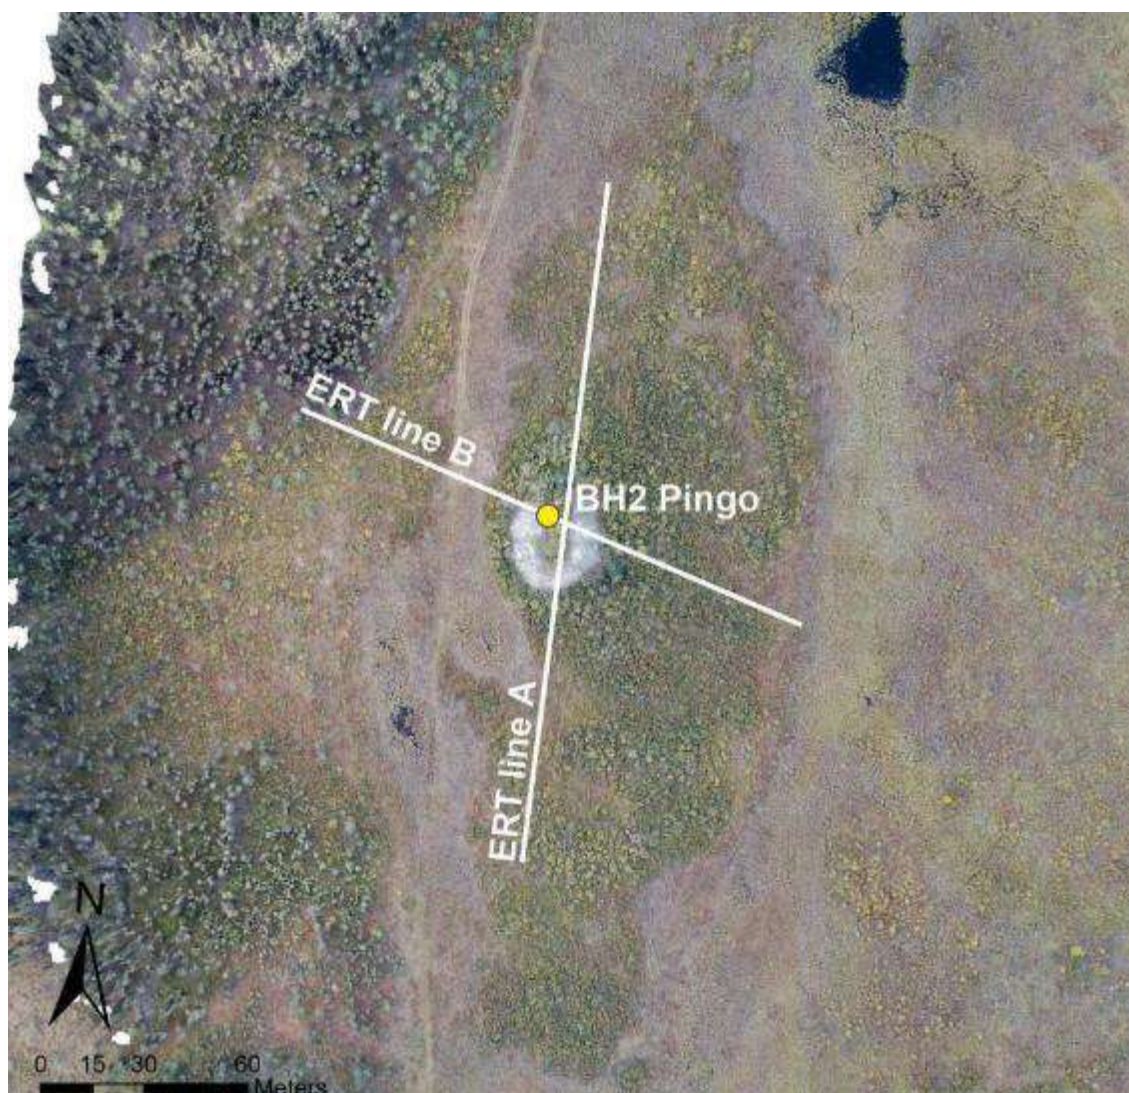
FIGURE 28 AERIAL IMAGERY OF THE PINGO NEAR ÄSHËYI AND ERT SURVEYS PRESENTED IN THIS WORK.

The pingo near Äshèyi is a landform located about 750 m northeast of the northern end of the Äshèyi airstrip (Figure 10).

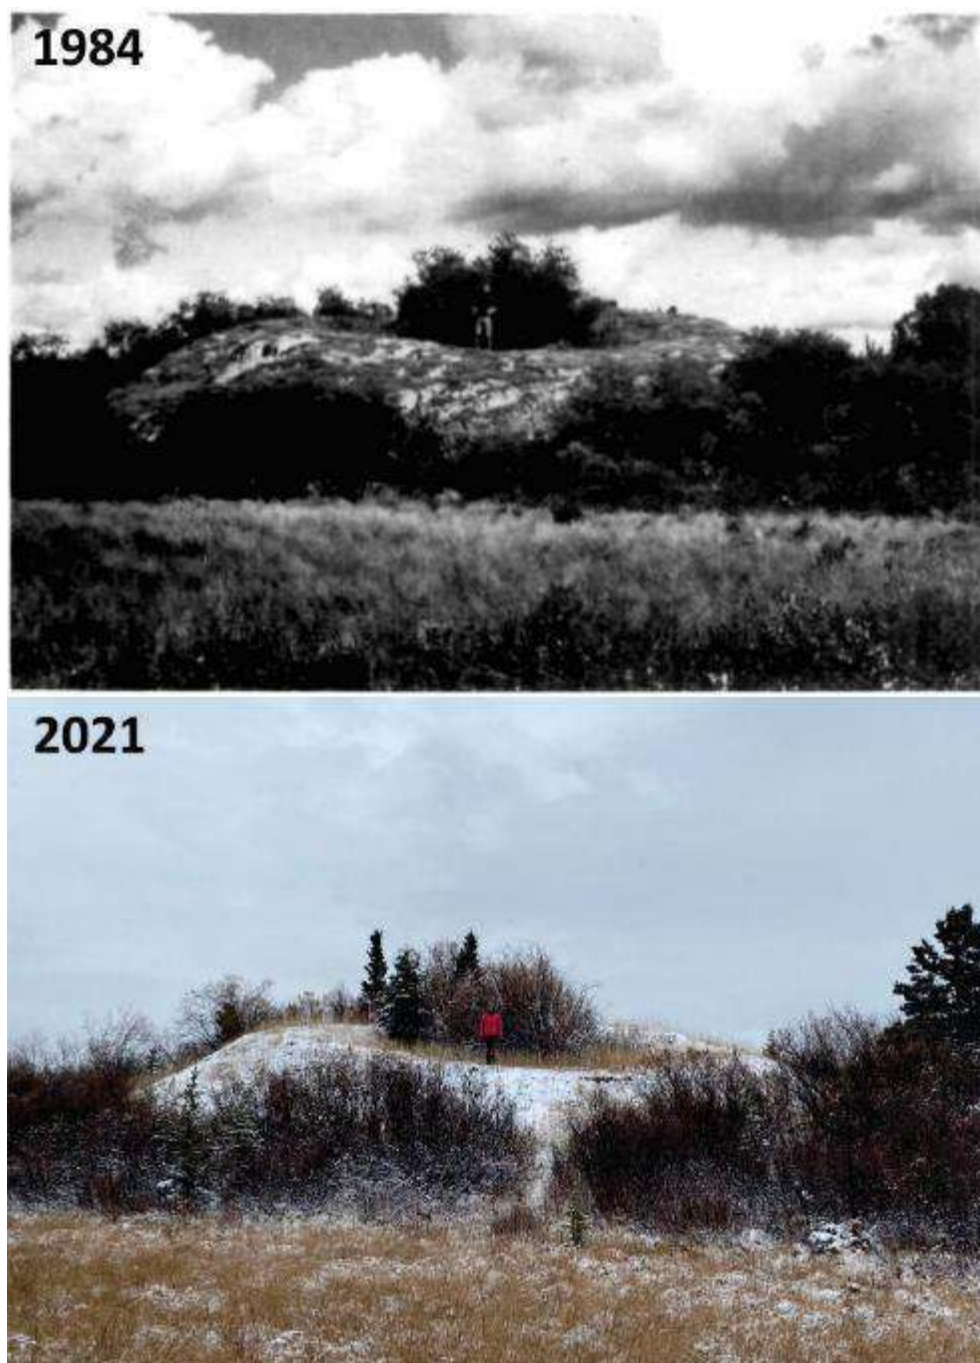
FIGURE 30 PICTURES OF THE ÄSHËYI PINGO TAKEN IN 1984 BY GEURTS AND DEWEZ (TOP) AND IN 2021 BY THE YUKON UNIVERSITY TEAM.

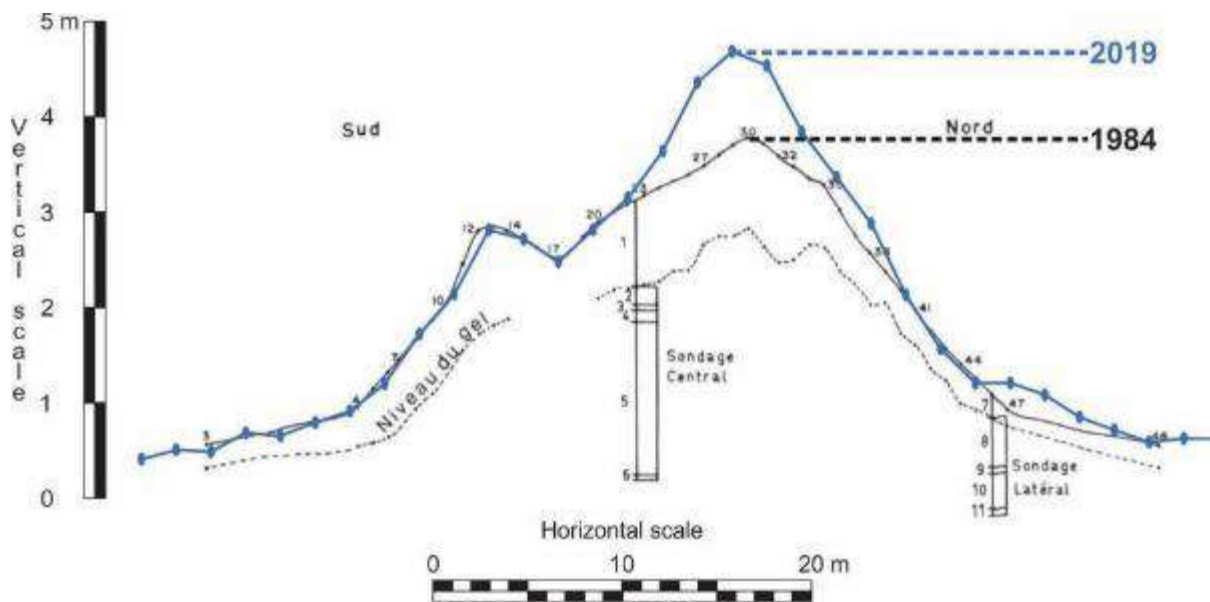
FIGURE 31 COMPARISON BETWEEN 1984 AND 2019 TOPOGRAPHICAL SURVEYS OF THE ÄSHÈYI PINGO.

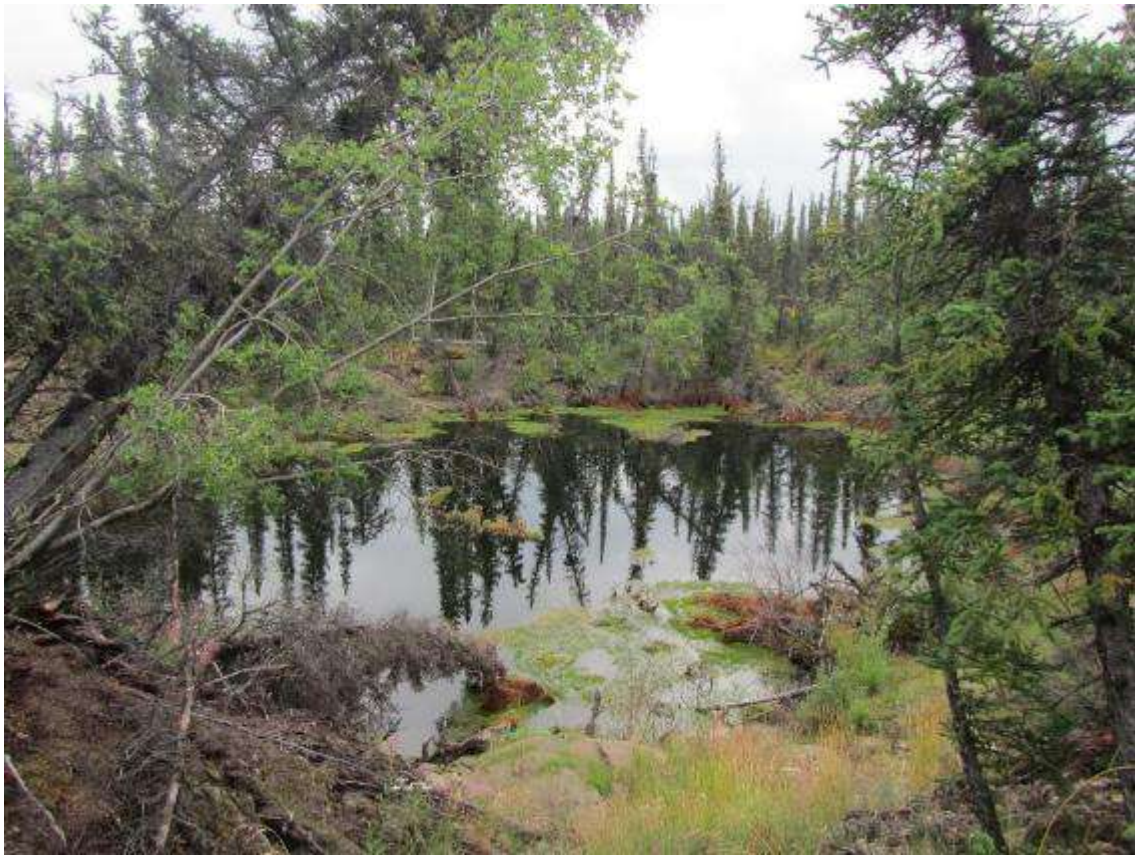
FIGURE 36 THE KETTLE POND SITE, WITH TILTED TREES AND SOIL CRACKING IN FOREGROUND.

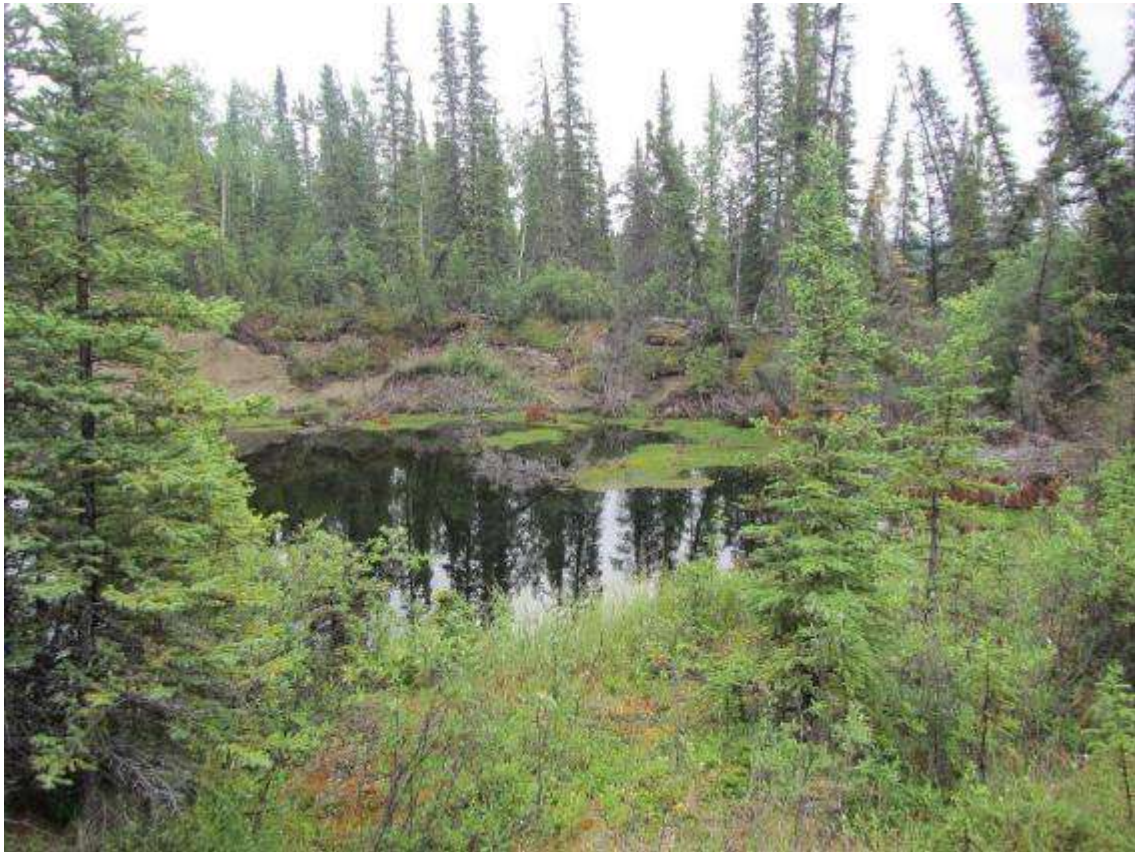
FIGURE 37 THE KETTLE POND SITE, WITH TILTED TREES AND SOIL CRACKING IN BACKGROUND

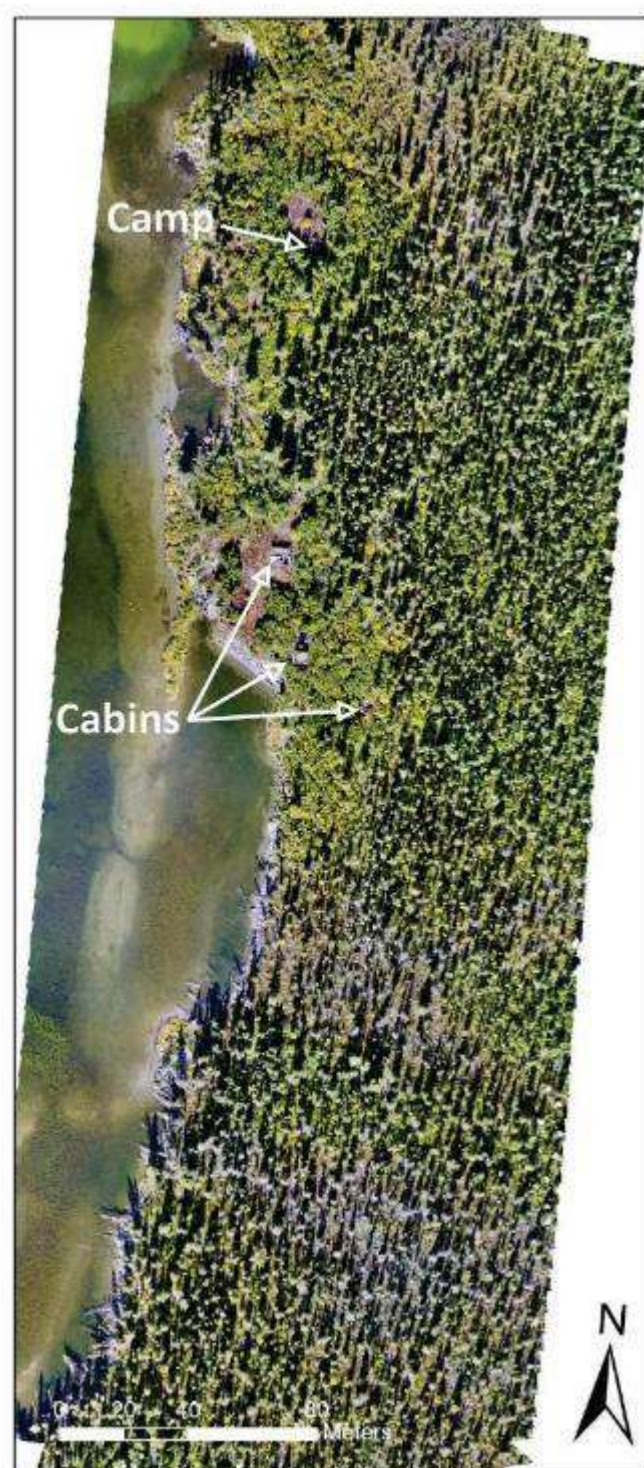
FIGURE 42 AERIAL VIEW OF CHÄMÌ OLD SETTLEMENT.

The aerial imagery resulting from the drone survey allowed us to accurately locate the cultural artifacts (Figure 42), which are occasionally difficult to observe on the imagery because of the abundant vegetation present on site. Better observation can be obtained using a 3-D model produced from the aerial imagery (Figure 43).

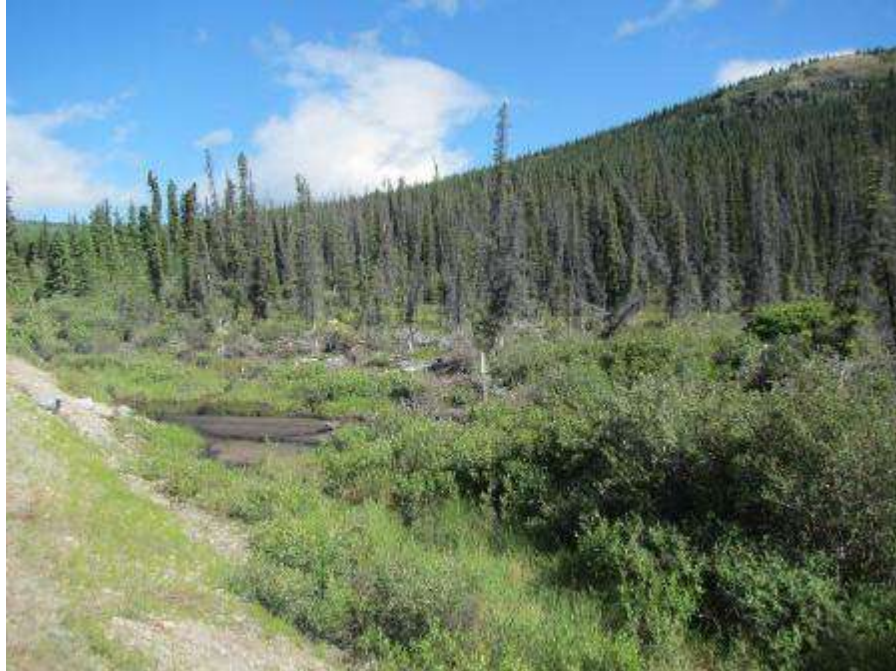
FIGURE 44 ÄSHÈYI ROAD, CULVERT SITE.

The site *Culvert* on Äshèyi Road is an area where a creek is flowing from an eastern hillslope under the road through a culvert. The site was selected because indicators of permafrost degradation such as subsidence, tilting trees, ground surface cracking, and organic sediment accumulating at the entrance of the culvert were present (Figure 44).

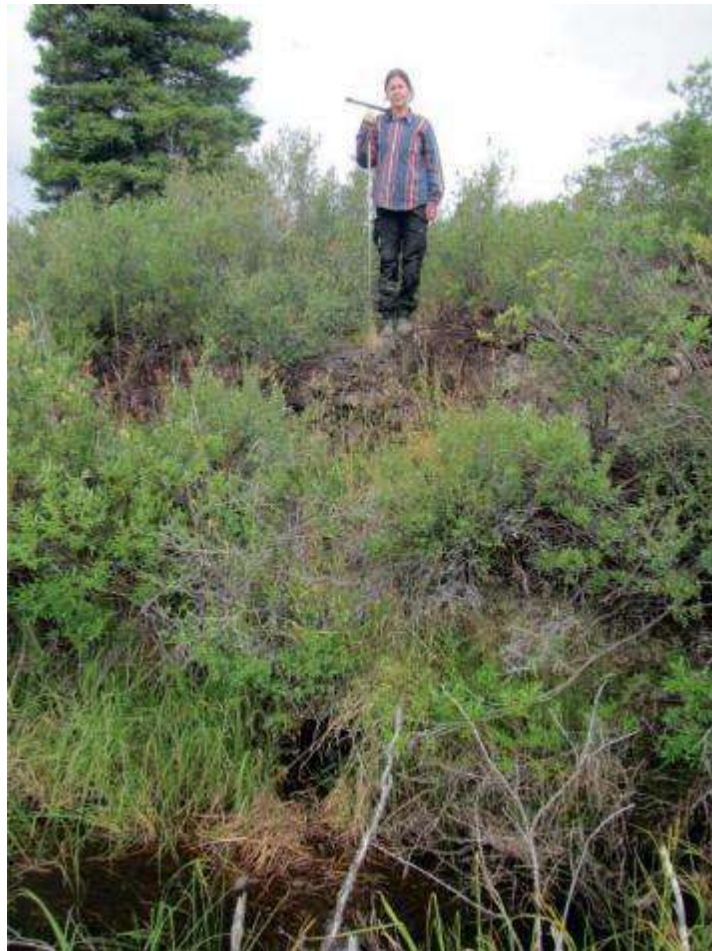
FIGURE 49 A PERMAFROST MOUND IN THE VALLEY OF PERMAFROST VALLEY WITH A POND AT ITS FOOT.

The permafrost mounds are large, exceeding 100 m in width, and are more than 2 meters in height. Often, water is accumulating at the foot of the mounds such as in Figure 49. The wetlands surrounding the mounds consist of grasslands with ponds (Figure 50), and the hillslope is a dry, wooded area with lichen on the ground (Figure 51). A general aerial view of the site is presented in Figure 52.

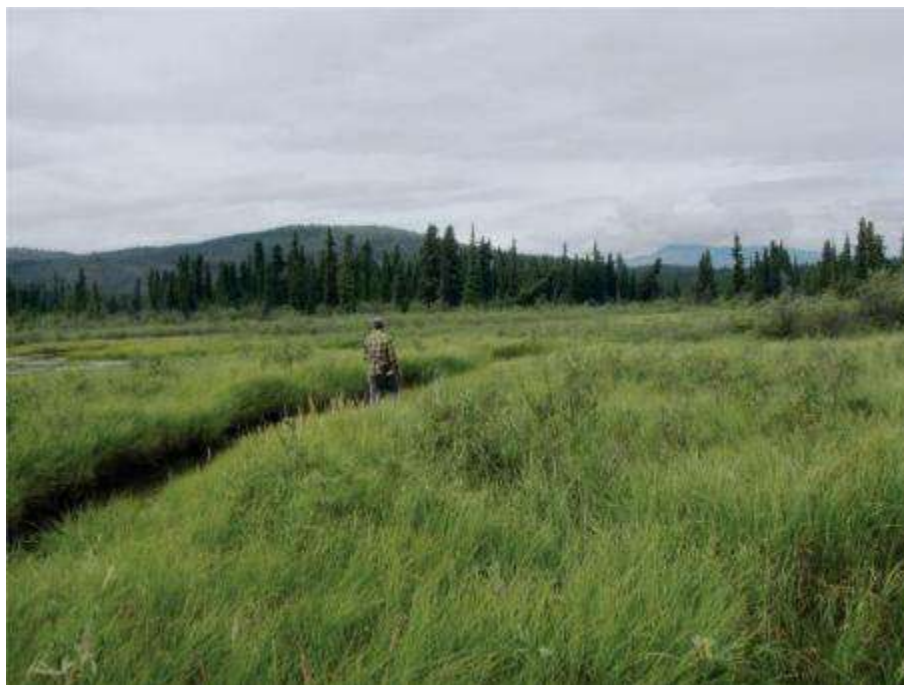
FIGURE 50 WETLANDS AT *PERMAFROST VALLEY*. DEGRADING PERMAFROST MOUNDS WITH TOPPLING TREES ARE VISIBLE IN THE BACKGROUND.

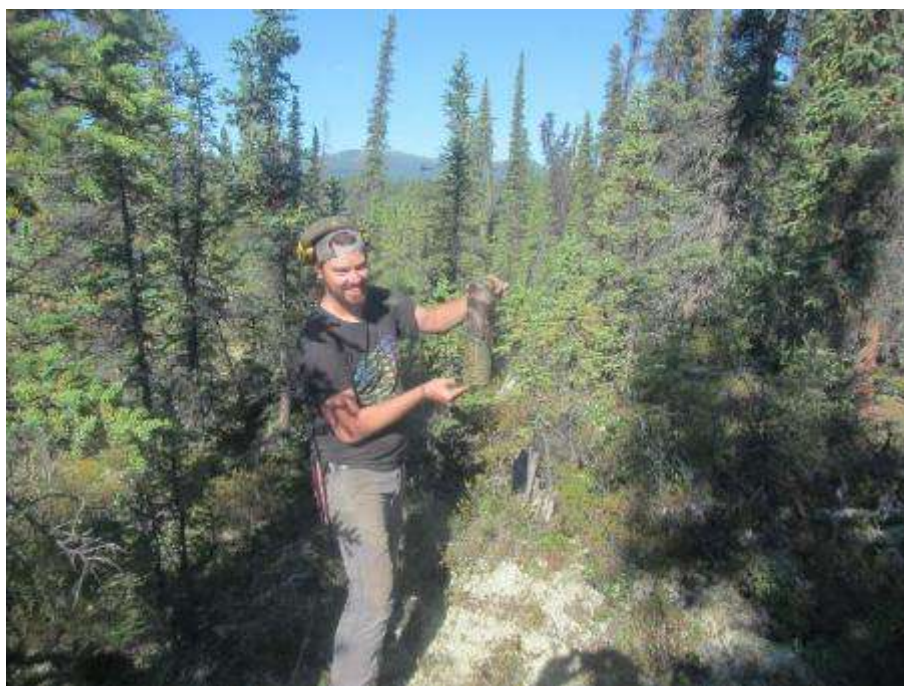
FIGURE 51 HILLSLOPE AT *PERMAFROST VALLEY*.

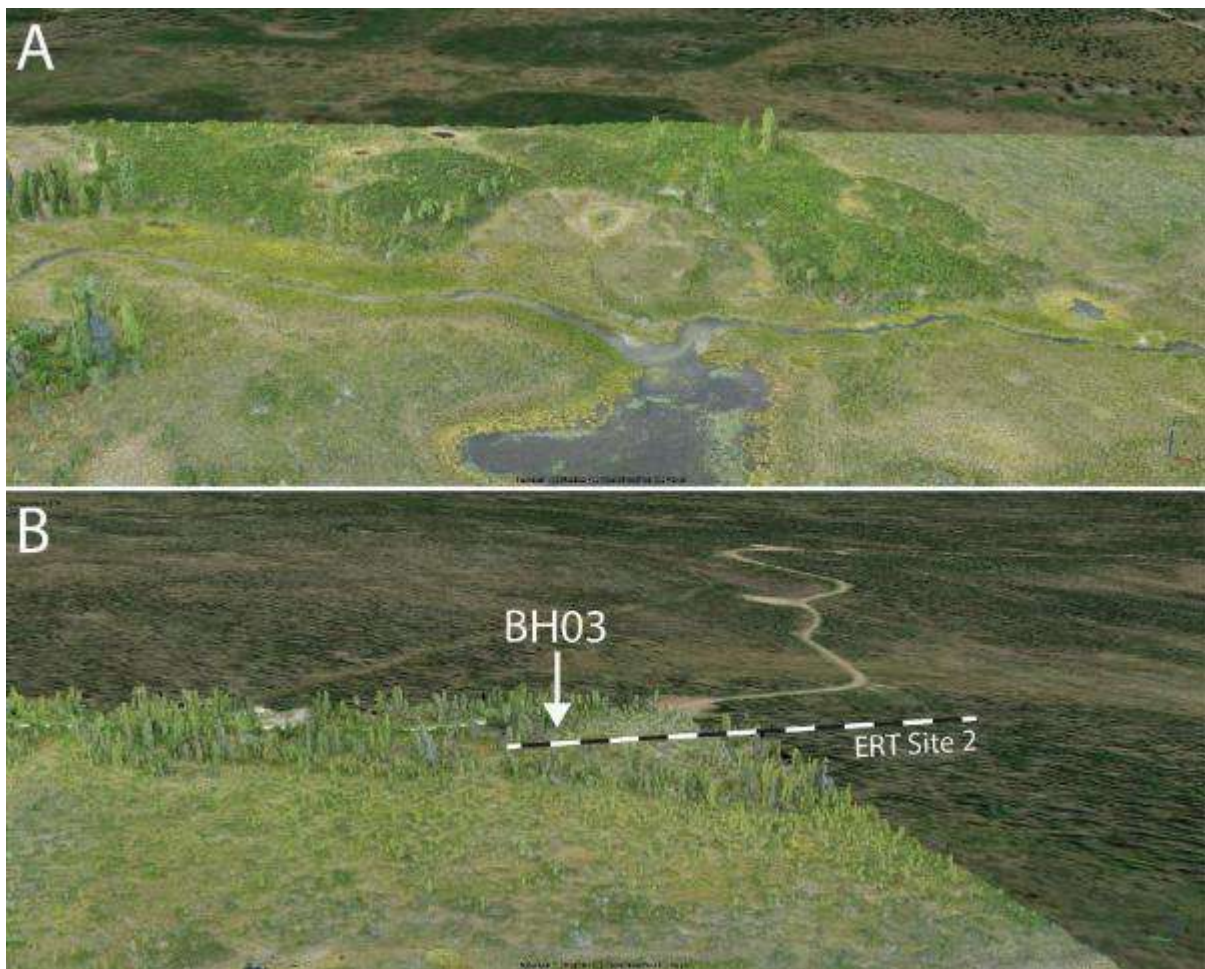
FIGURE 53 THREE-DIMENSIONAL VIEWS OF *PERMAFROST VALLEY*. A- WETLAND WITH PERMAFROST MOUNDS AND THERMOKARST LAKES; B- HILLSLOPE NEAR THE ROAD AND BOREHOLE AIS_BH03 AND A 160 M ERT PROFILE.

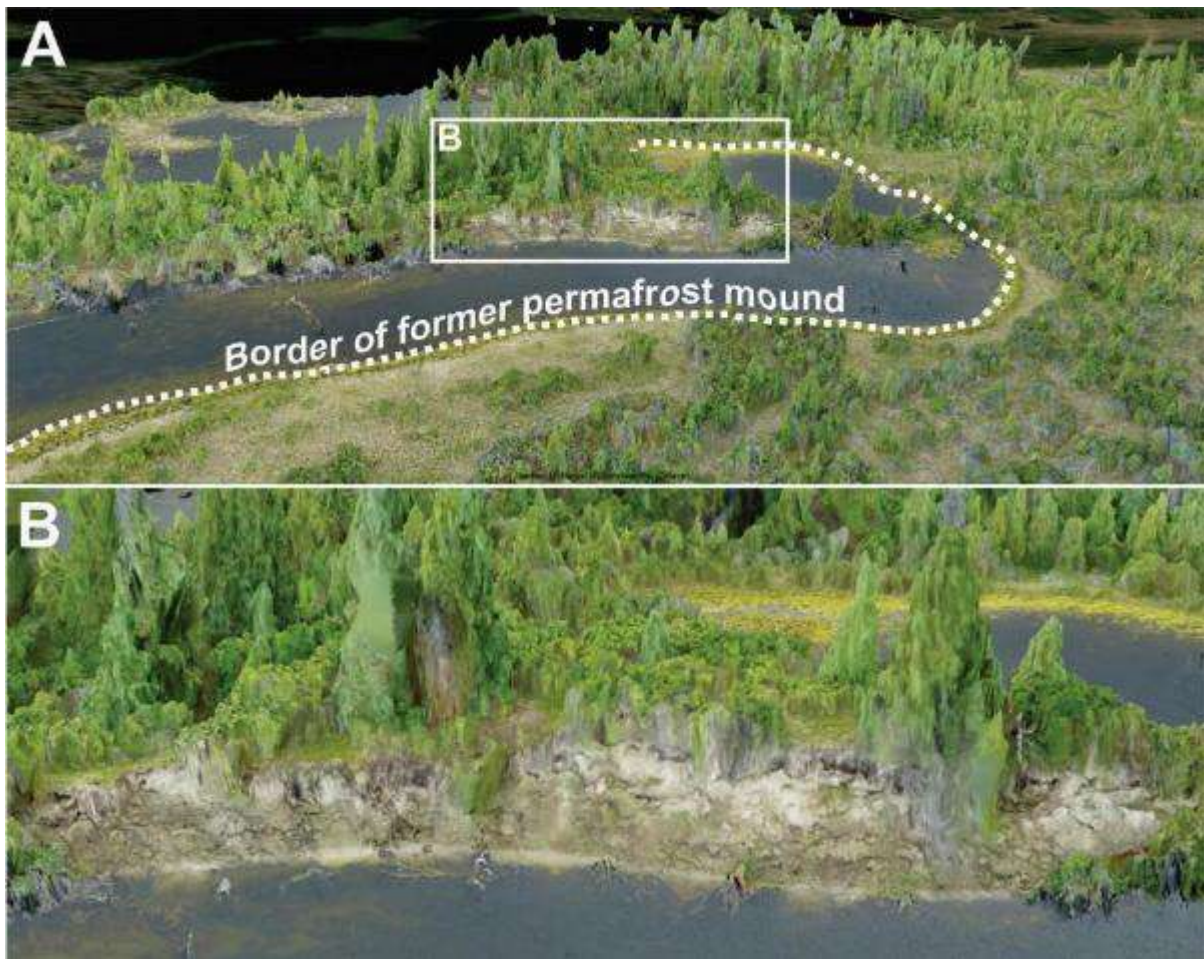
FIGURE 54 THREE-DIMENSIONAL VIEWS OF A DEGRADING PERMAFROST MOUND IN THE WETLAND OF PERMAFROST VALLEY. A- PERMAFROST MOUND SURROUNDED BY A THERMOKARST LAKE RESULTING FROM THE THAW OF THE MOUND; B- COLLAPSING EDGE OF THE DEGRADING PERMAFROST MOUND.

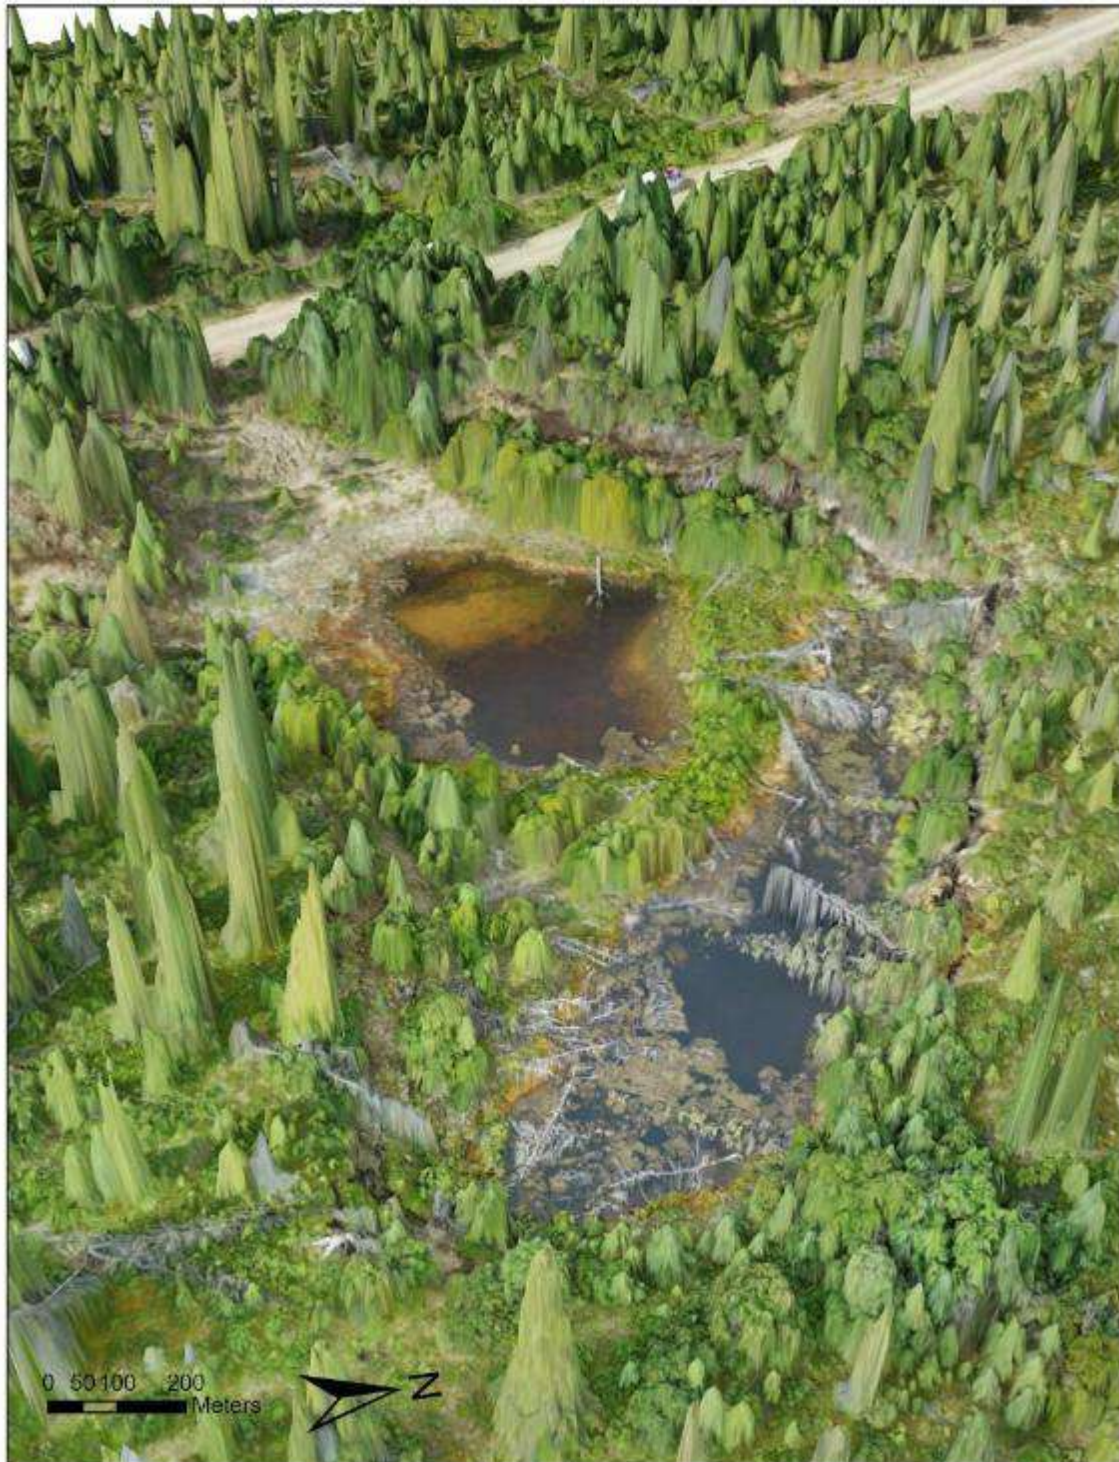
FIGURE 61 THREE-DIMENSIONAL REPRESENTATION OF *THERMOKARST POND*, FROM DRONE AERIAL IMAGERY. STEEP EDGES (RIDGES) ARE FORMING, AND TREES ARE COLLAPSING WHILE THE POND IS GROWING.

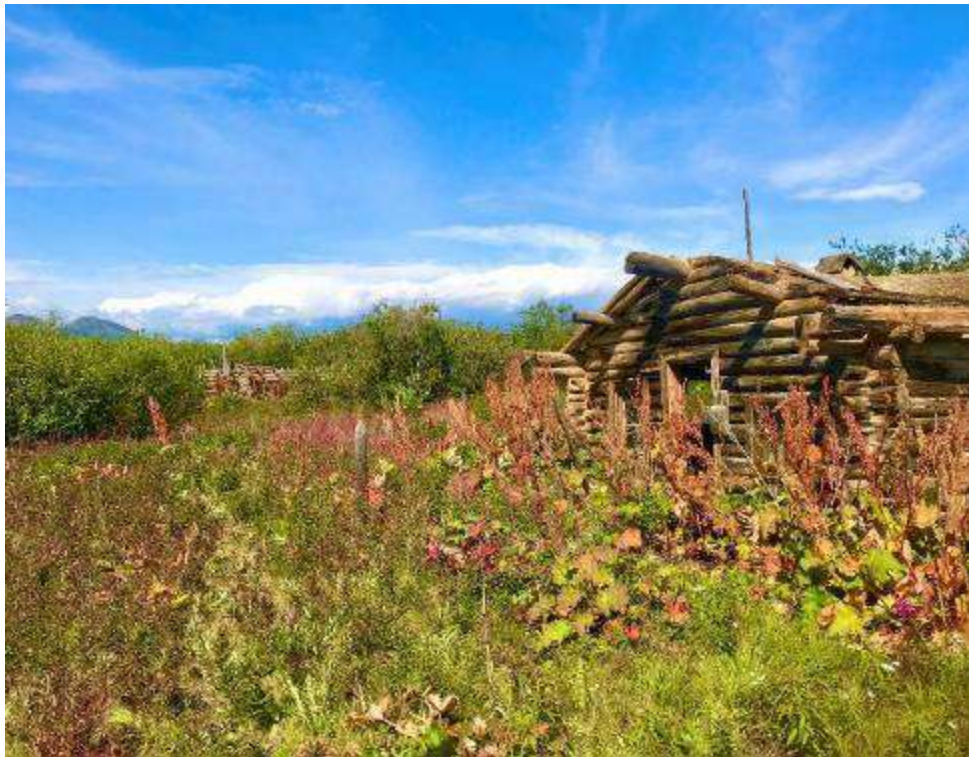
FIGURE 72 CABINS AT K'ÙÀ OLD SETTLEMENT SITE, SURROUNDED BY VEGETATION.

At the time of the visit, several heritage cabins were identified, and their locations were used as boundaries for the survey area. Several areas were highly vegetated (Figure 72). A drone flight was done over the area to better observe the permafrost conditions. An orthomosaic of this area is shown in Figure 73. The observations carried out with the imagery had two main objectives: first, to identify and locate heritage buildings on site; and second, to observe and locate signs of permafrost and/or degradation.

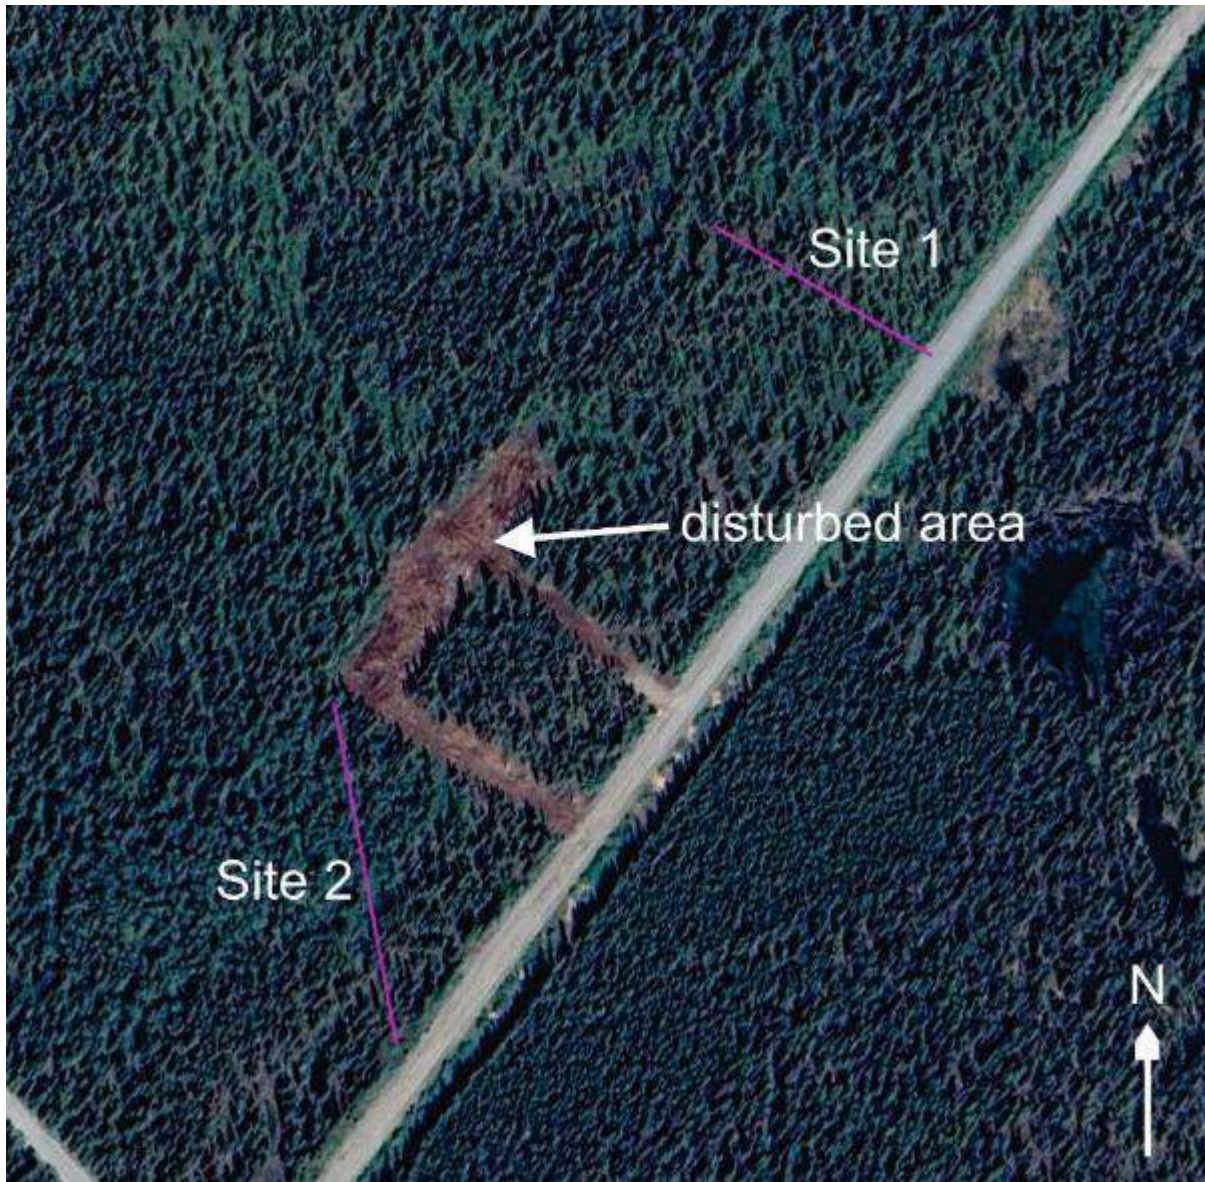
FIGURE 84 AREA OF FOREST CLEARED IN SUMMER OF 2023. SITE 1 AND 2 ERT PROFILE EXTENTS ARE IN SHOWN IN PURPLE.

On August 8th, 2023, recent vegetation removal and churned up soil from heavy machinery was found between Sites 1 and 2 (Figure 84). Loss of vegetation, disturbance of surface organic horizon, and creation of divots where water can pool means thermal degradation of ground ice is expected to occur here if patches of ice-rich ground are present.

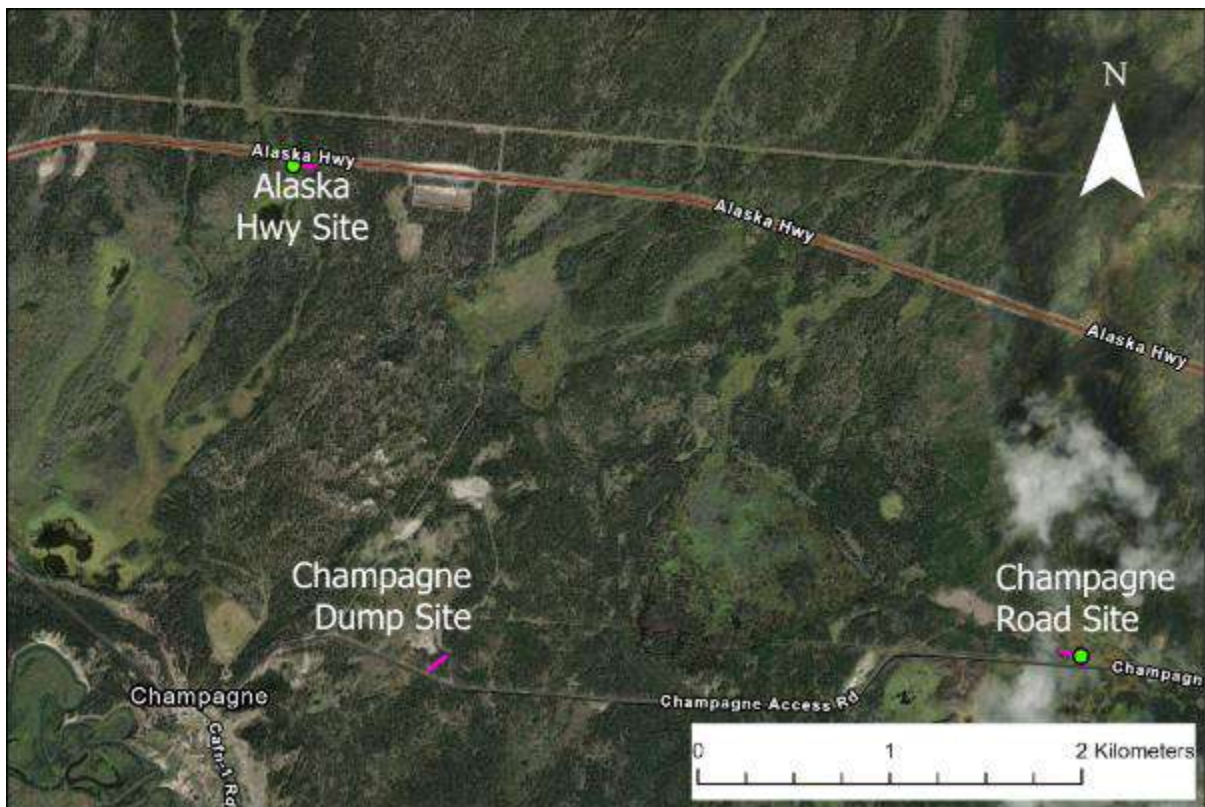
FIGURE 87 INVESTIGATION SITE MAP FOR THE SHADHÄLA AREA. GREEN DOT: BOREHOLE. PINK LINE: ERT SURVEY.

There are three sites in the Shadhäla area: *Alaska Highway* site, *Dump* site, and *Champagne Road* site (Figure 87). The *Alaska Highway* and *Champagne Road* sites were chosen because they were representative of the terrain in this area – generally flat or sloping at a very low angle, heavily forested with interspersed wetlands. Permafrost cores were extracted and ground temperature stations installed at the *Champagne Road* and *Alaska Highway* sites on August 11th, 2023, and ERT dipole-dipole surveys conducted on August 10th and 11th, 2023, respectively. An ERT survey was also conducted at the *Dump Site* on August 9th, 2023, after the community expressed concern over the state of the ground in the vicinity of the dump. Ground temperature data were collected from the *Alaska Highway* and *Champagne Road* sites during subsequent visits.
