Design and implementation of early detection and warning systems for transportation infrastructure impacted by permafrost-related geohazards

January 31 2022

This report presents the results of a project aiming to develop an automated alarm system to warn transportation infrastructure operators of permafrost-related geohazards. While linear infrastructure like roads or airstrips can themselves cause disturbances to surrounding permafrost, so can climate change. As temperatures warm and precipitation patterns change, permafrost thaw-related geohazards such as ground subsidence and landslides are increasingly likely, which could lead to dangerous conditions and the possibility of isolating communities. To address these hazards, the research team has developed an automated system to collect data in real-time to continuously assess conditions of the ground and infrastructure using site-specific algorithms to define risk levels. Elevated risk levels are automatically communicated to infrastructure operators for action to be taken. This report outlines the three primary components of the project including: 1) conception of the system; 2) site characterizations and analyses; and 3) imple

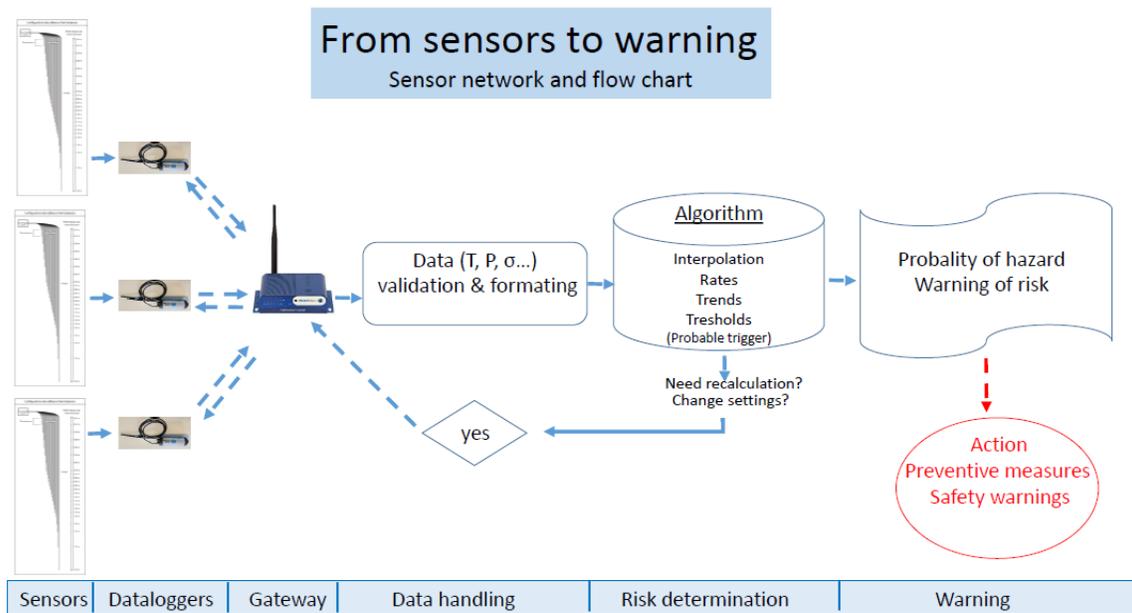
Figure 1 Flow diagram from sensors to warning launch. The sensors in the field are linked to transmitting/receiving dataloggers. The transmitted data are received in a base station called a gateway, which re-transmits the data to a computer (server). The data are validated, and quality checked by software before being introduced into the algorithm. From the output of the algorithm, a warning signal is sent if deemed necessary. The program settings of the dataloggers can be modified as required.

The frequency of data acquisition must be high enough to make these automated calculations timely to assess the level of risk. This implies that data from the monitoring site be retrieved in real-time (daily, hourly, or even more frequently). Therefore, data transmission to a base station is necessary via a means of telecommunication (radio, satellite, phone or internet). If the alert system fails or transmits an advance pre-warning, it may be necessary to have access to the data acquisition system in the field to change data acquisition frequency or obtain instantaneous validation; therefore, the base station must also be able to communicate with the datalogger in the field. Communication capabilities must be bi-directional as shown in Figure 1.

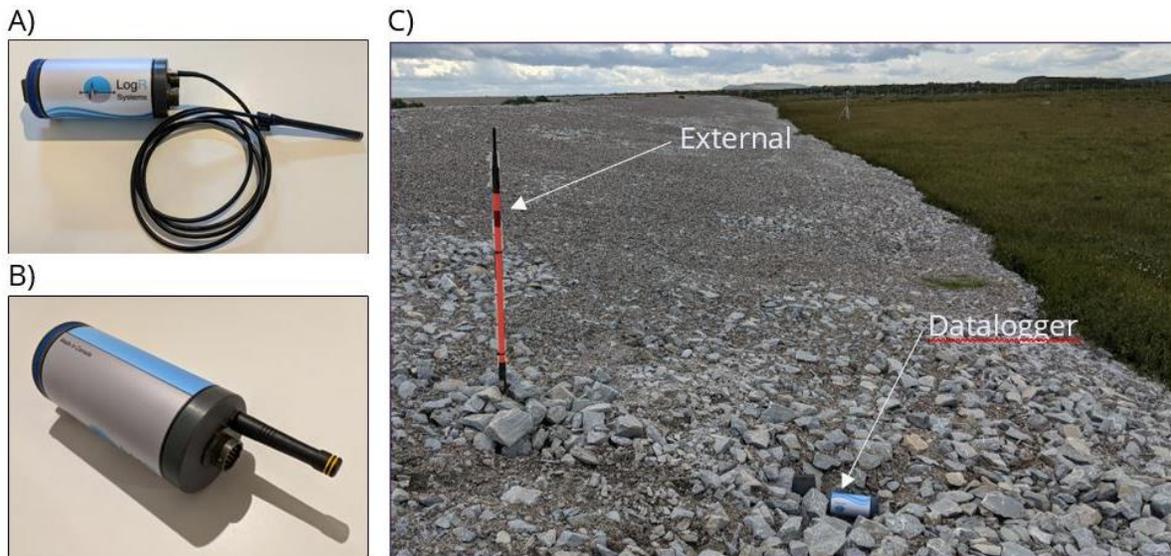
Figure 4 The ULog datalogger (end-node) with A) external antenna with 2 m lead cable or B) directly attached to the enclosure. C) End-node installation at the Tasiujaq runway test site using an external antenna configuration.

To maximize RF transmission performance, an external antenna connected to the datalogger is recommended, as seen in Figure 4. However, it is possible to install an internal antenna inside the dataloggers in cases where enhanced protection is needed. The external antenna can be extended up to several meters away from the datalogger in order to enhance signal reception and transmission when deployed in environments with physical constraints or obstacles.

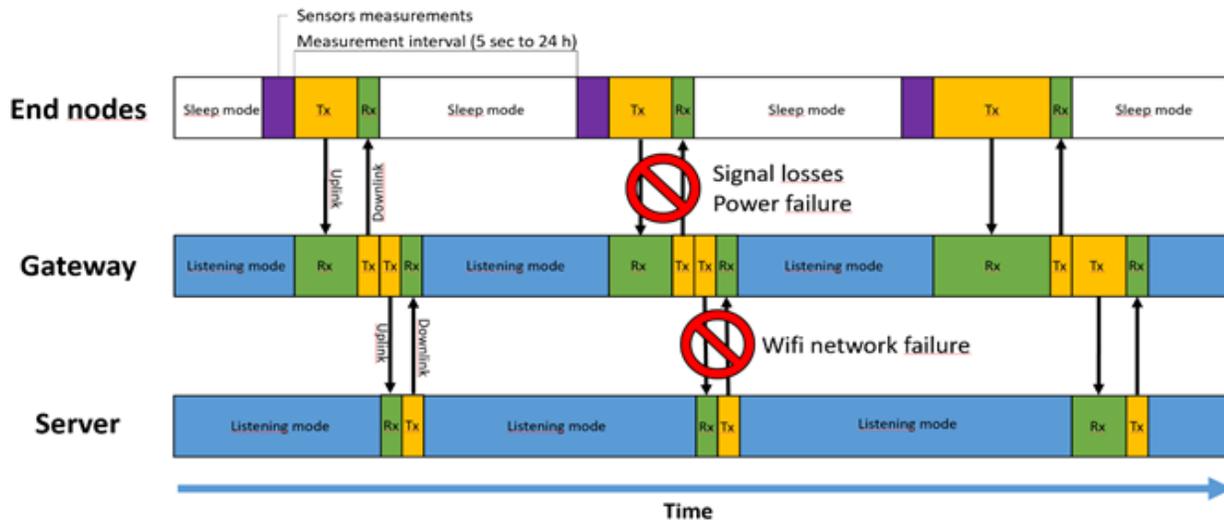
Figure 6 Most common hazard likely to affect the links between the network components during uplink or downlink transmission.

Each network component can be exposed to specific threats that might cause communication failures. The most common threat affecting the links between the end-nodes and the gateway are signal losses (caused by an electromagnetic interference or simply a specific meteorological condition) or a power outage of the gateway. Both threats could cause non-acknowledgement of data integrity during uplink or downlink transmissions, thus postponing data transmission until the links are fully recovered. The most common threat that is likely to affect the link between the gateway and the server is an internet outage either caused by a power outage (internet router down) or a network outage (internet service disruption). In order to avoid any data loss or gaps when such hazards occur, several safety transmission mechanisms were implemented to increase the resilience of the network and will be specifically described in the following section.

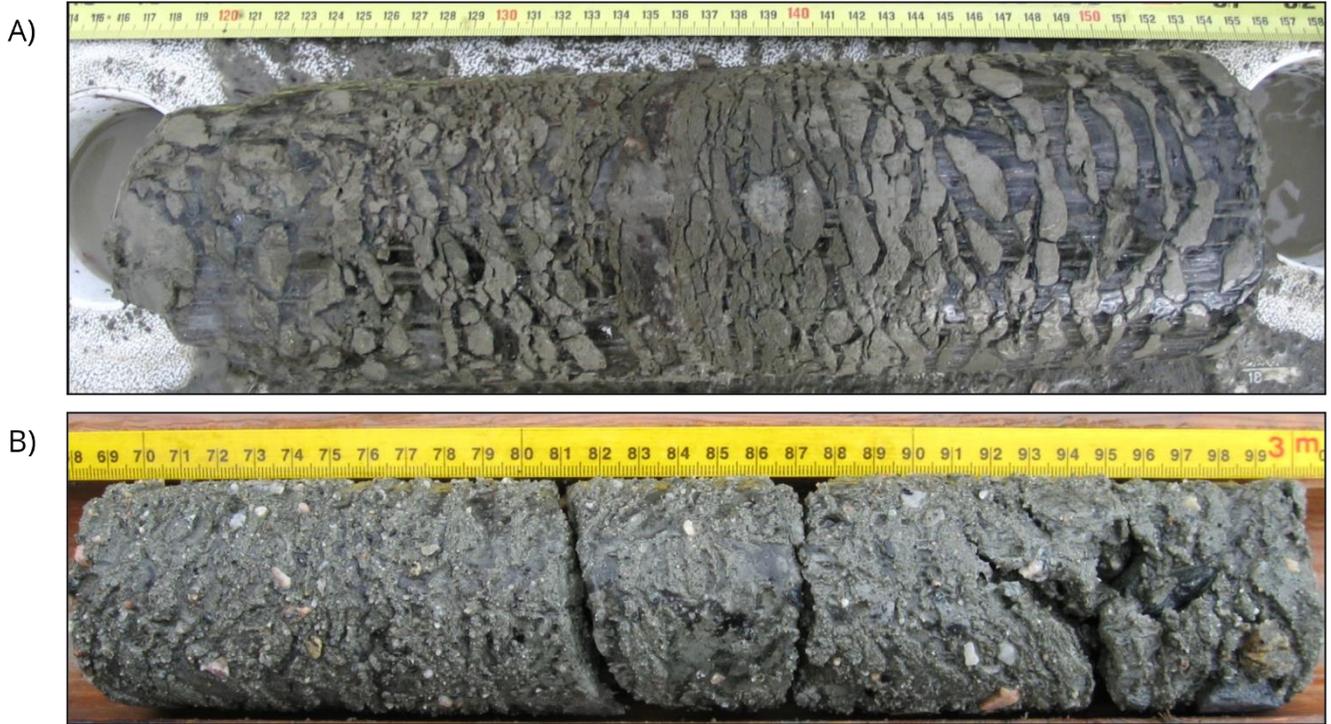
Figure 8 Ice-rich permafrost cores extracted from A) the post-glacial marine silty clay at the valley bottom and B) the silty till deposits covering the slopes and plateaus.

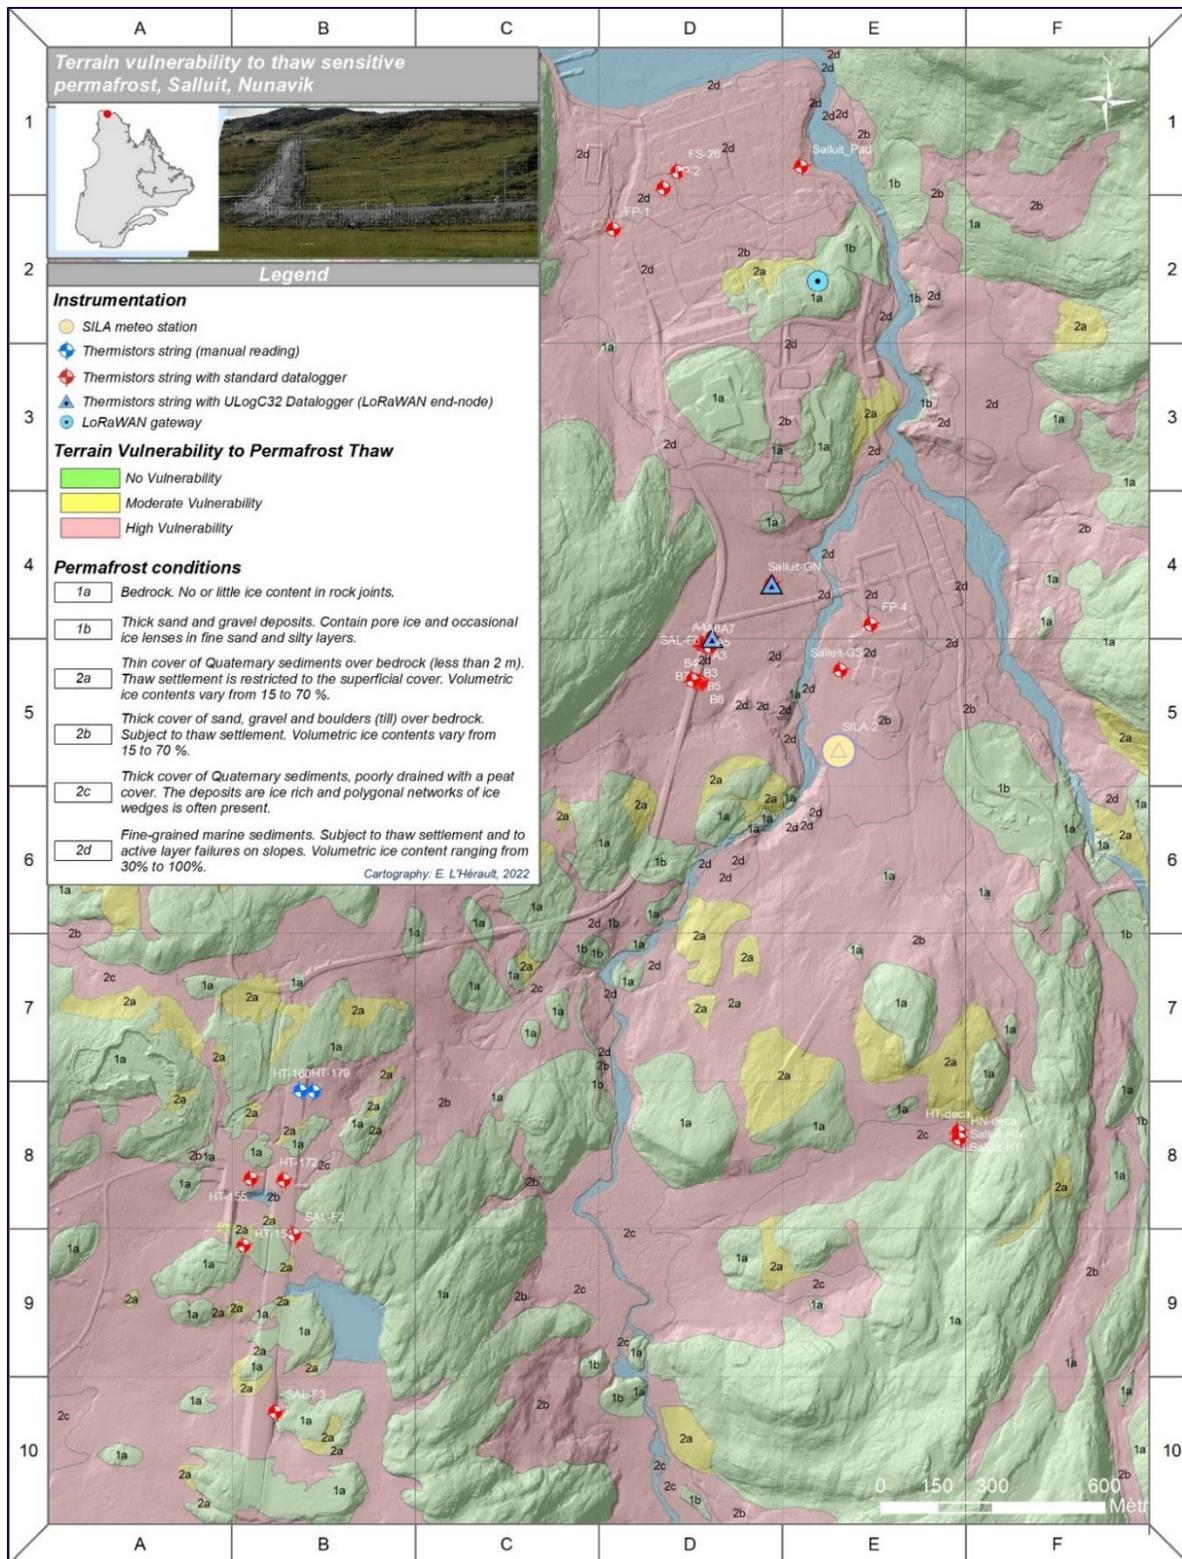
Figure 9 Map of the terrain vulnerability to permafrost thaw and the available instrumentation, Salluit, Nunavik.

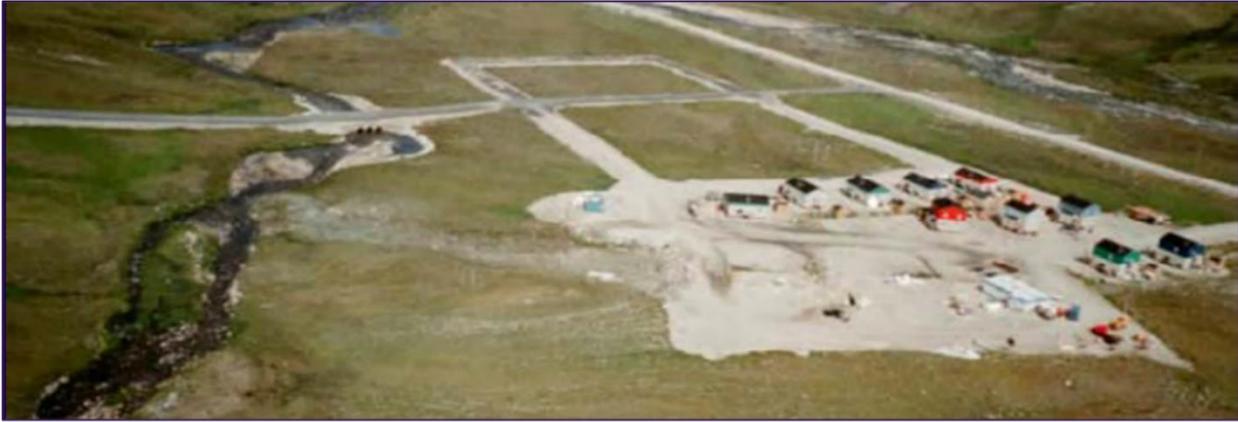
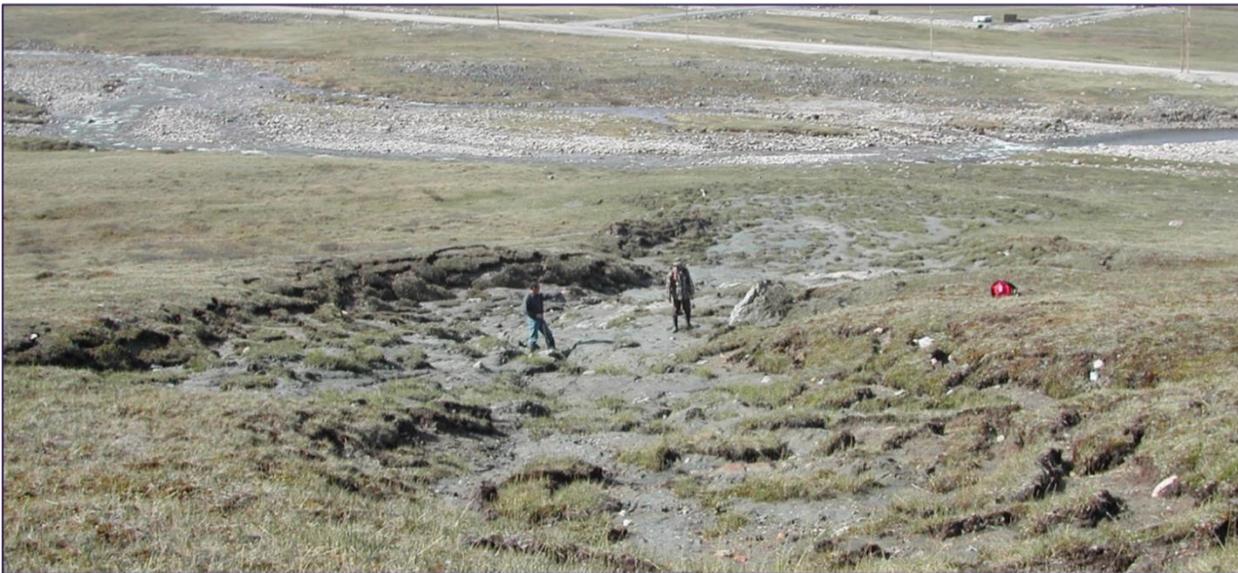
Figure 10 Active layer detachment slides in Salluit. Top: 5 September 1998 event; the planned housing development was halted, existing houses were moved. Reconstruction restarted after 2010 in the area on adapted foundations. Middle: summer 1998 event located on a riverside slope near the Kuuguluk river. Bottom left: Summer 2005 event (initial event), note the road embankment near the head scarp. Bottom right: subsequent event further north in the same area, August 2010.

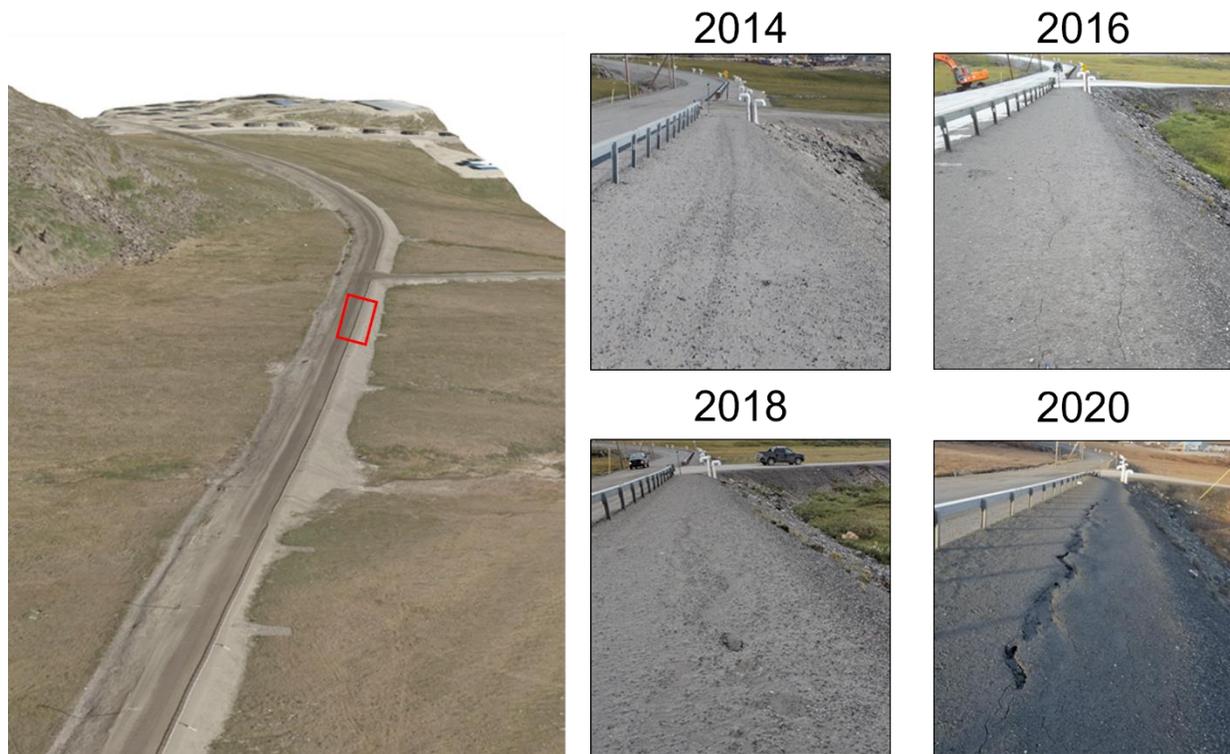
Figure 11 Active embankment shoulder creep processes affecting a section of the Salluit airport access road from 2014 to 2020.

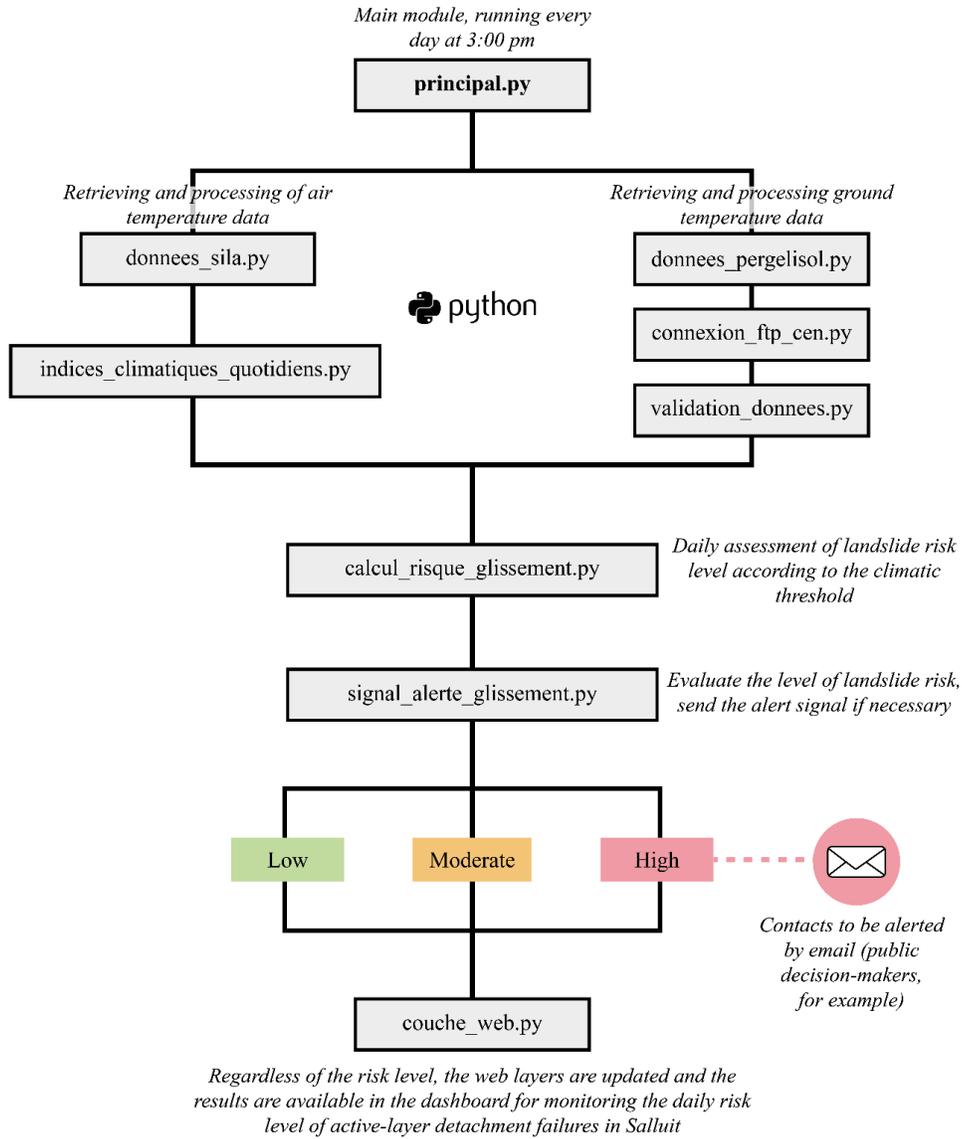
Figure 14 Logical diagram of the sequence of modules, showing the structure and functioning of the main program and its modules (sub-routines).

The program automatically starts at 15:00 daily and is executed through the launch of the main program *principal.py* with a command file (*batch file*; extension .bat) by the task planner. The task is planned on a standing operating computer at the Centre d'Etudes Nordiques at Université Laval (UL). Once launched, the main program calls the different modules to read the data from the LoRA server and accomplishes the tasks of averaging hourly data, calculating degree-days, summation of degree-days, interpolate thaw depth (0 °C isotherm) between thermistors, and assess the level of risk by comparison with the set threshold. The call sequence of the modules is shown in the logical diagram (Figure 14).

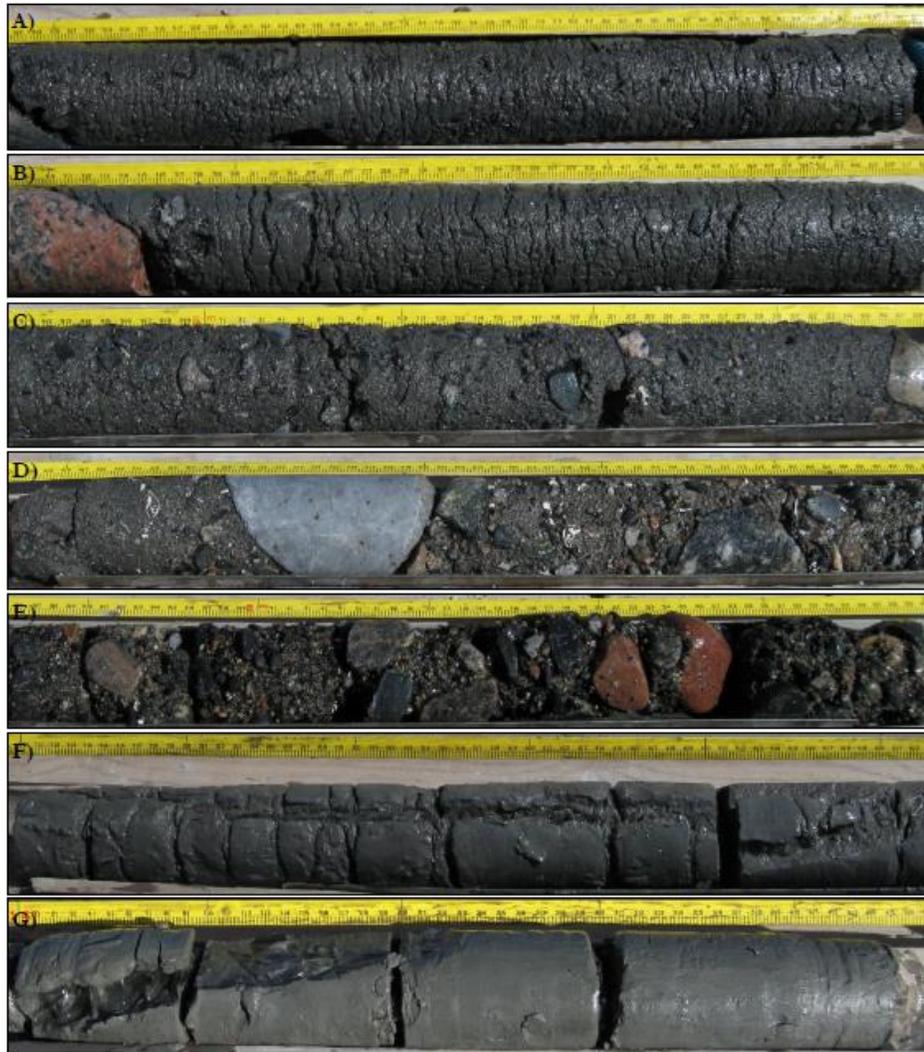
Figure 16 Cores of the stratigraphic units beneath the Tasiujaq runway: A and B) Poorly sorted and brackish intertidal silts of from unit 2, between 2.5 and 3.6 m deep; C) Increase in coarseness with depth and transitional, base of unit 2 at ~ 5 m depth; D and E) Sand and gravel with shell fragments of unit 3, depth of 7.8 to 8.4 m; F and G) Marine clay with interspersed ice lenses and vertical ice veins, depth from 10.1 to 14.5 m

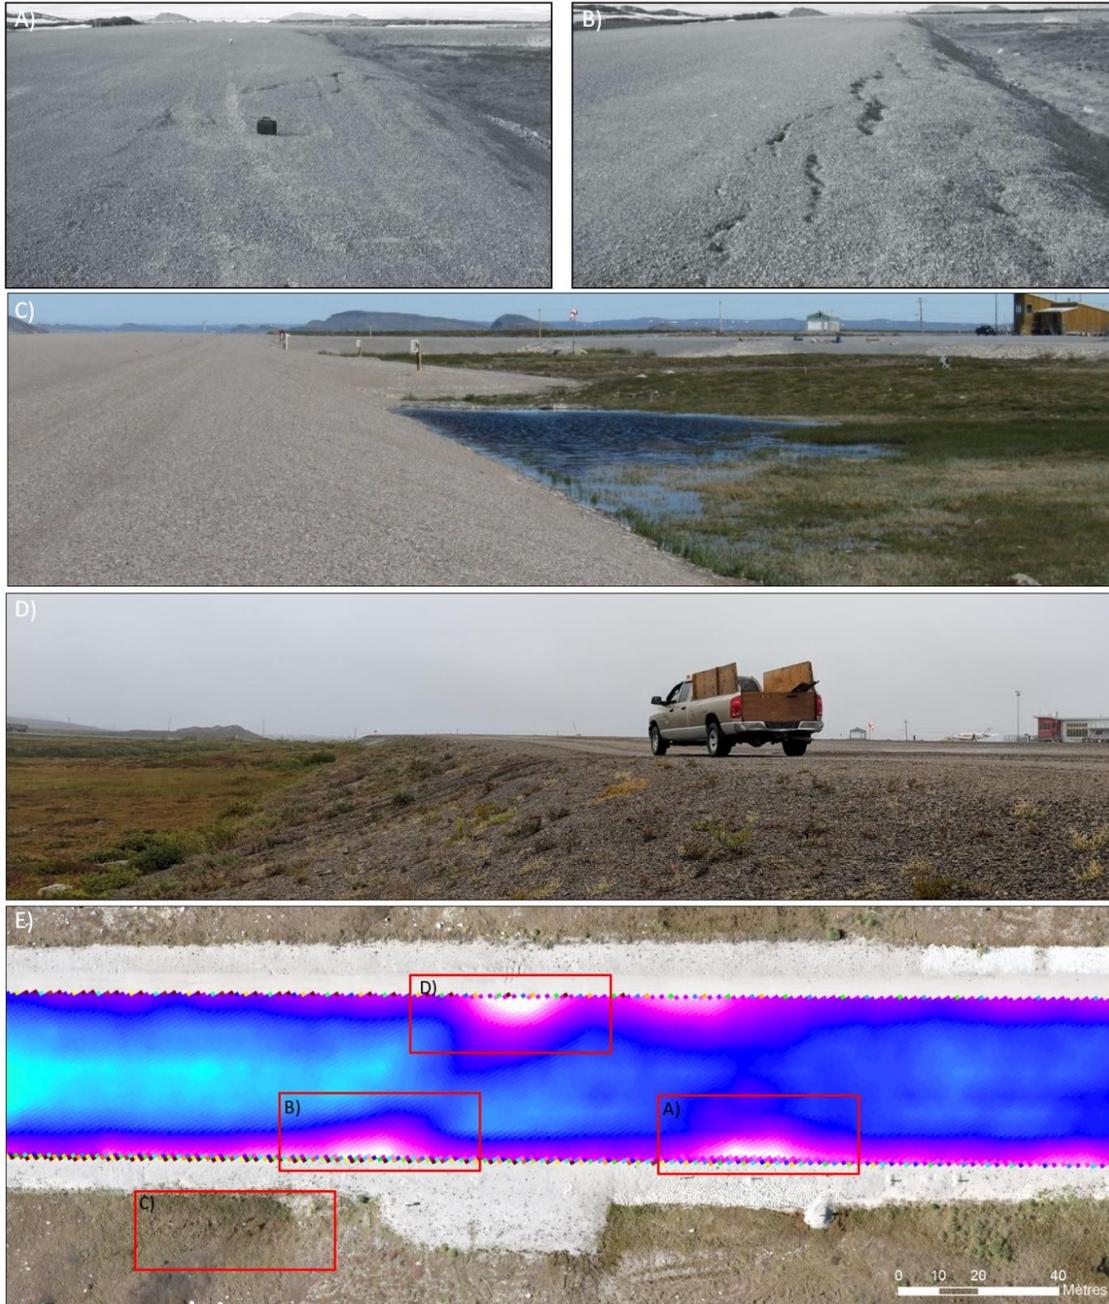
Figure 17 A) and B) Significant depressions with longitudinal cracks as observed in 2004 on the east side of the Tasiujaq runway. C) Accumulation of water at the foot of the embankment on the east side in July 2009. D) Major depression on the west side observed in the fall of 2018 during the adaptation work. E) Topographic survey carried out during the summer of 2018 highlighting major depressions still affecting the runway. (From L'Hérault et al, 2021)

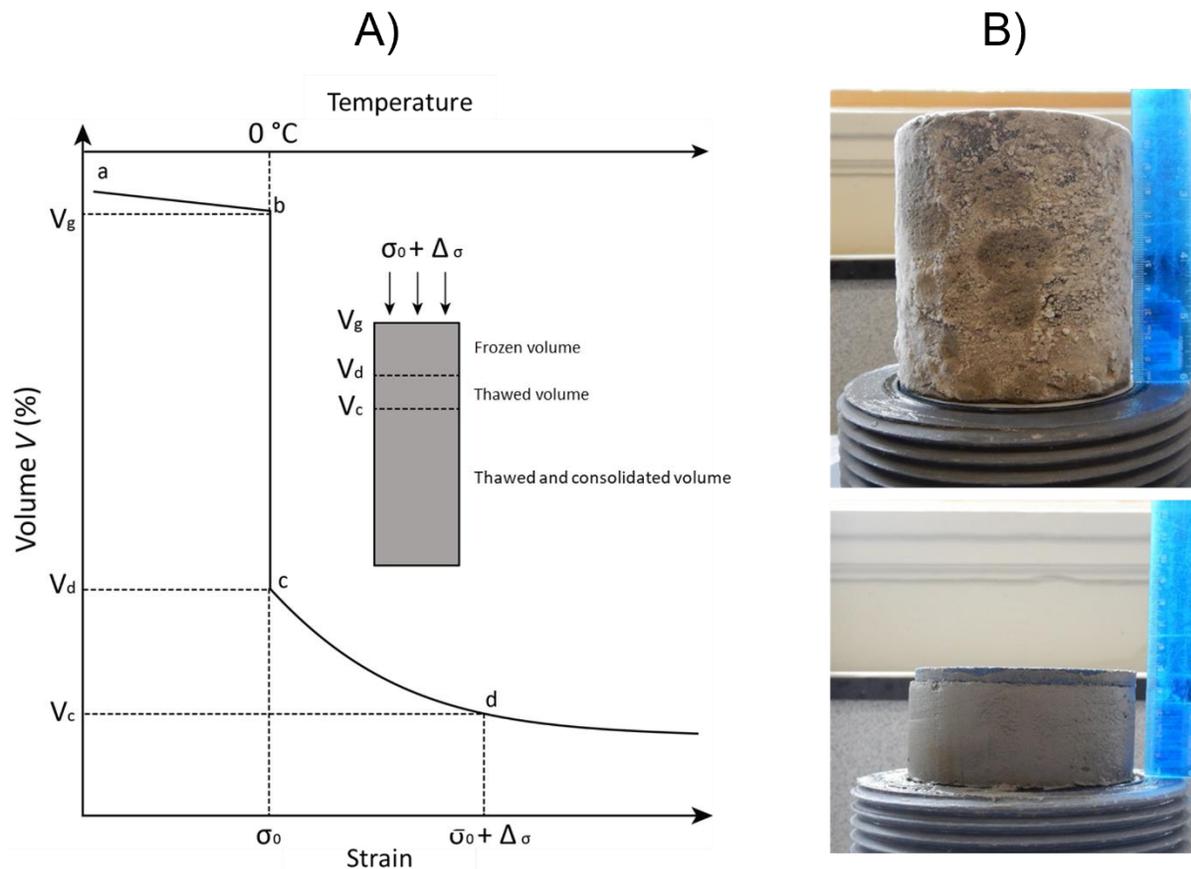
Figure 22 A) Typical volume change versus strain for ice-rich frozen soil subjected to thawing (modified from Andersland and Ladanyi, 2003). B) Ice-rich permafrost sample before and after thaw settlement laboratory test.

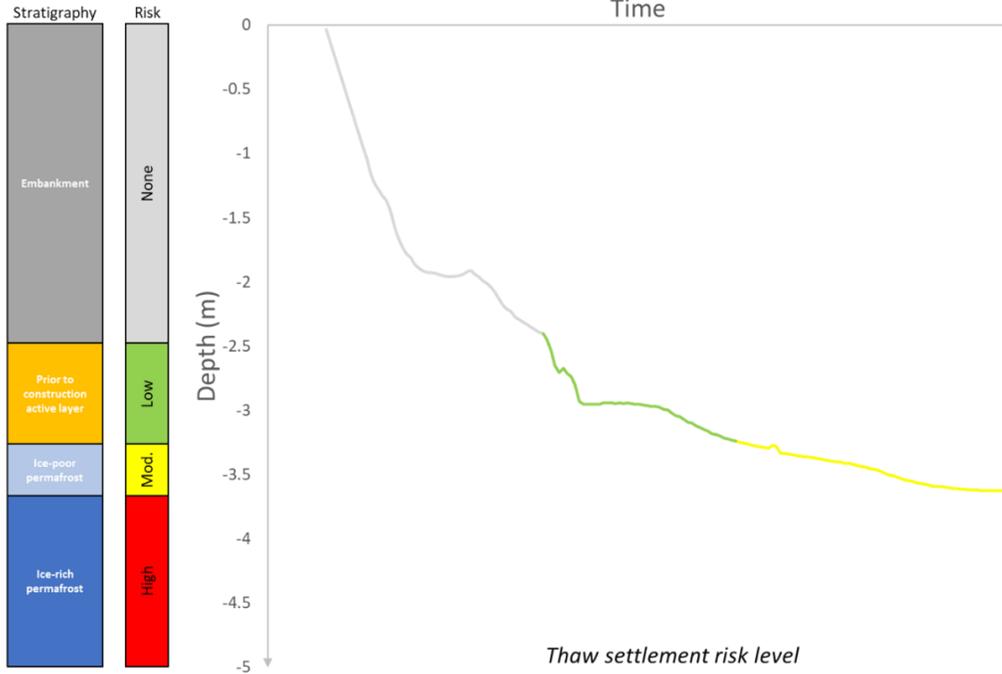
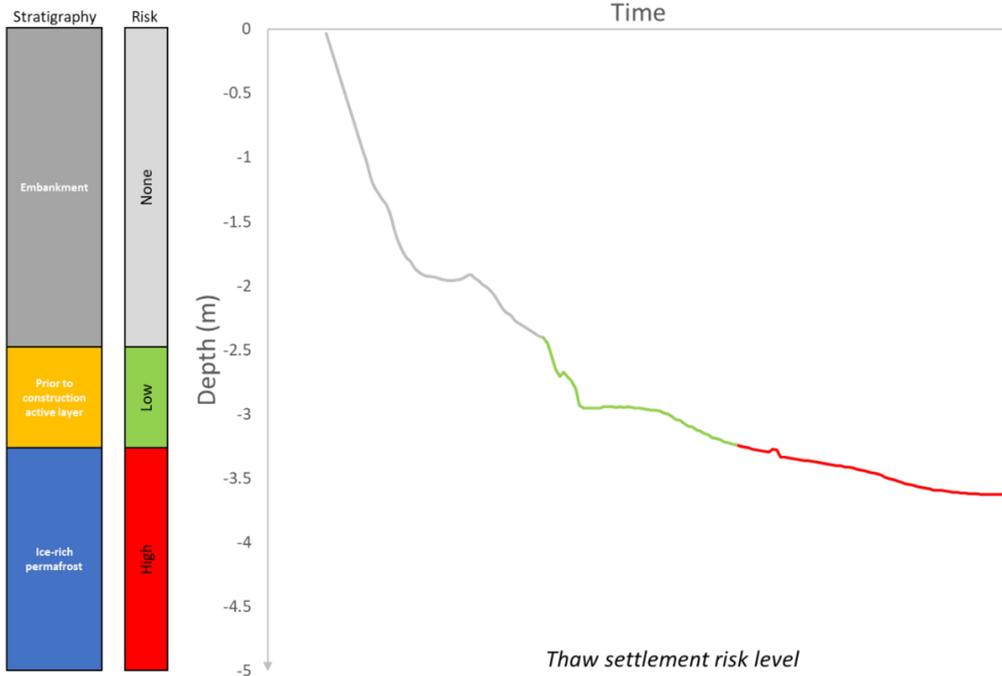
Figure 23 Daily evolution of the thaw settlement risk warning during the thawing season based on the site stratigraphy, the cryostratigraphy and the daily thaw depths estimated from the ground temperatures reading. Without (Case A) or with (Case B) an intermediate layer of ice-poor permafrost located below the prior to construction maximum thaw depth.

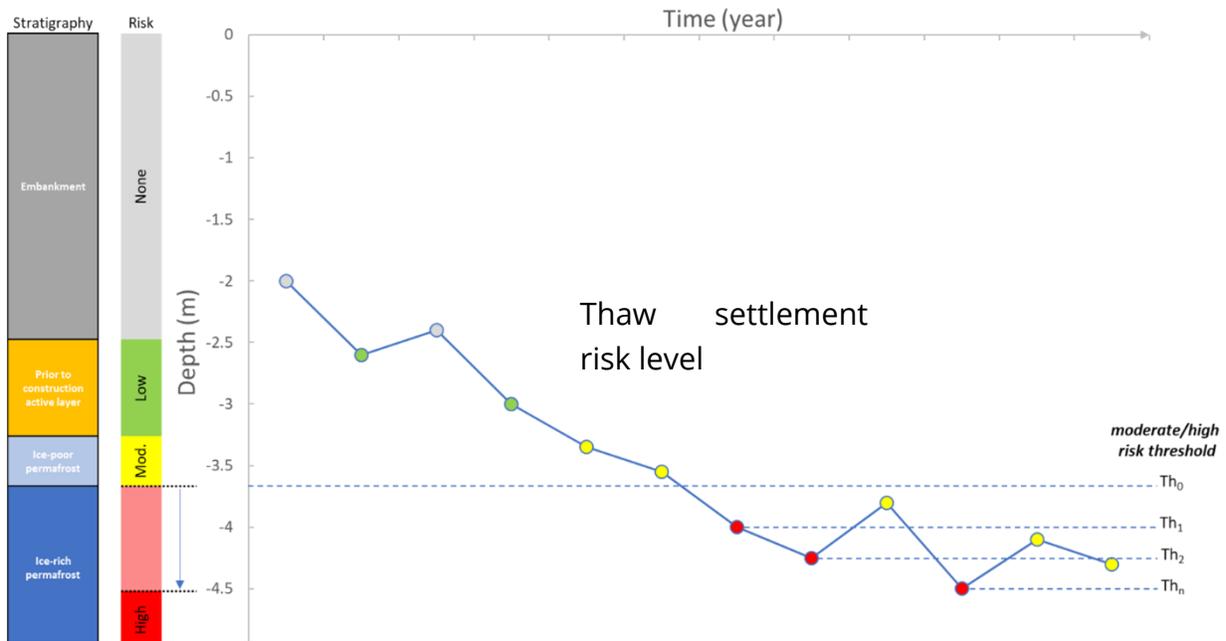
Figure 24 Thaw depth variations and the associated thaw settlement risk based on the site stratigraphy. Maximum thaw depth position from previous years defines the new moderate/high risk threshold.

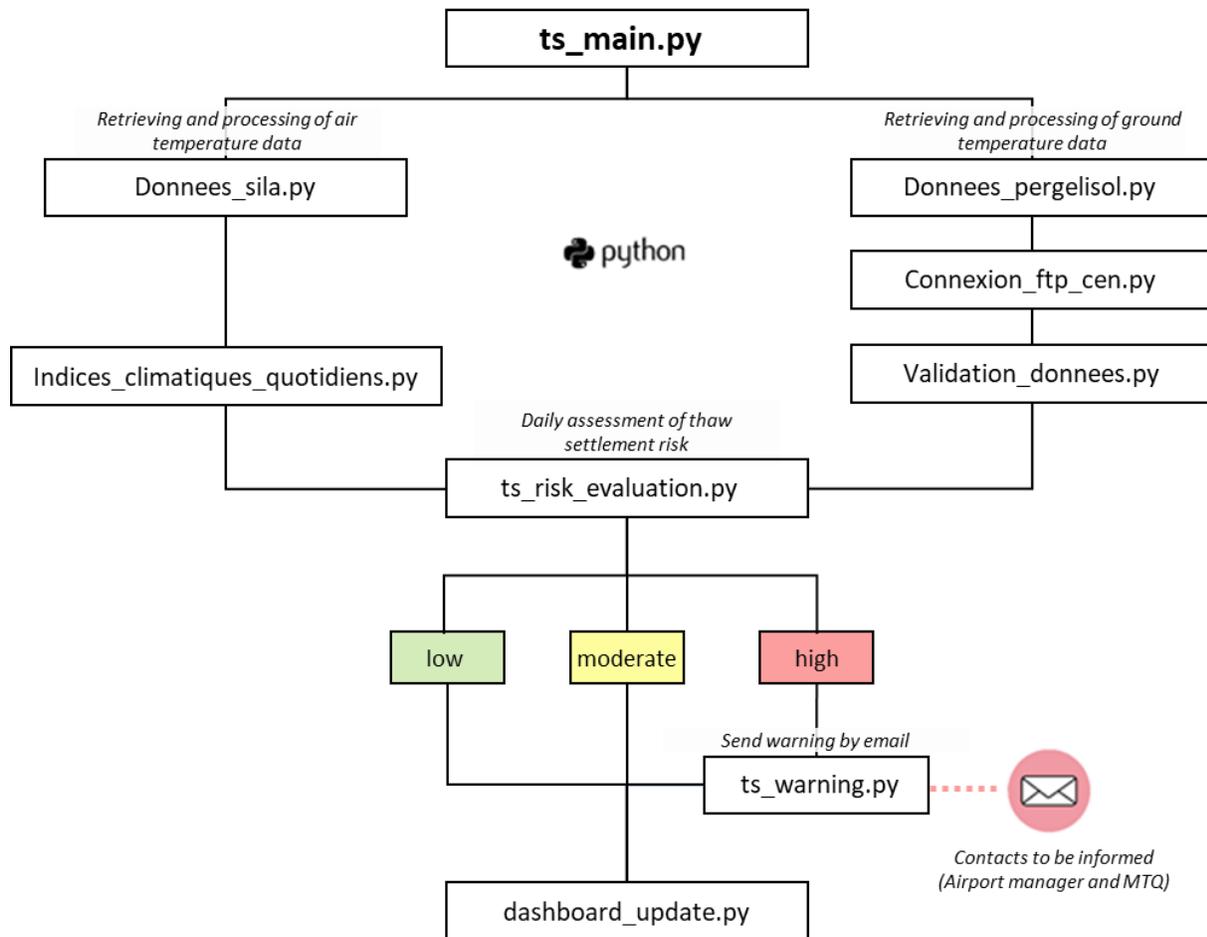
Figure 25 Logical diagram of the thaw settlement hazard warning program (ts_main.py) and its sub-modules and functions.

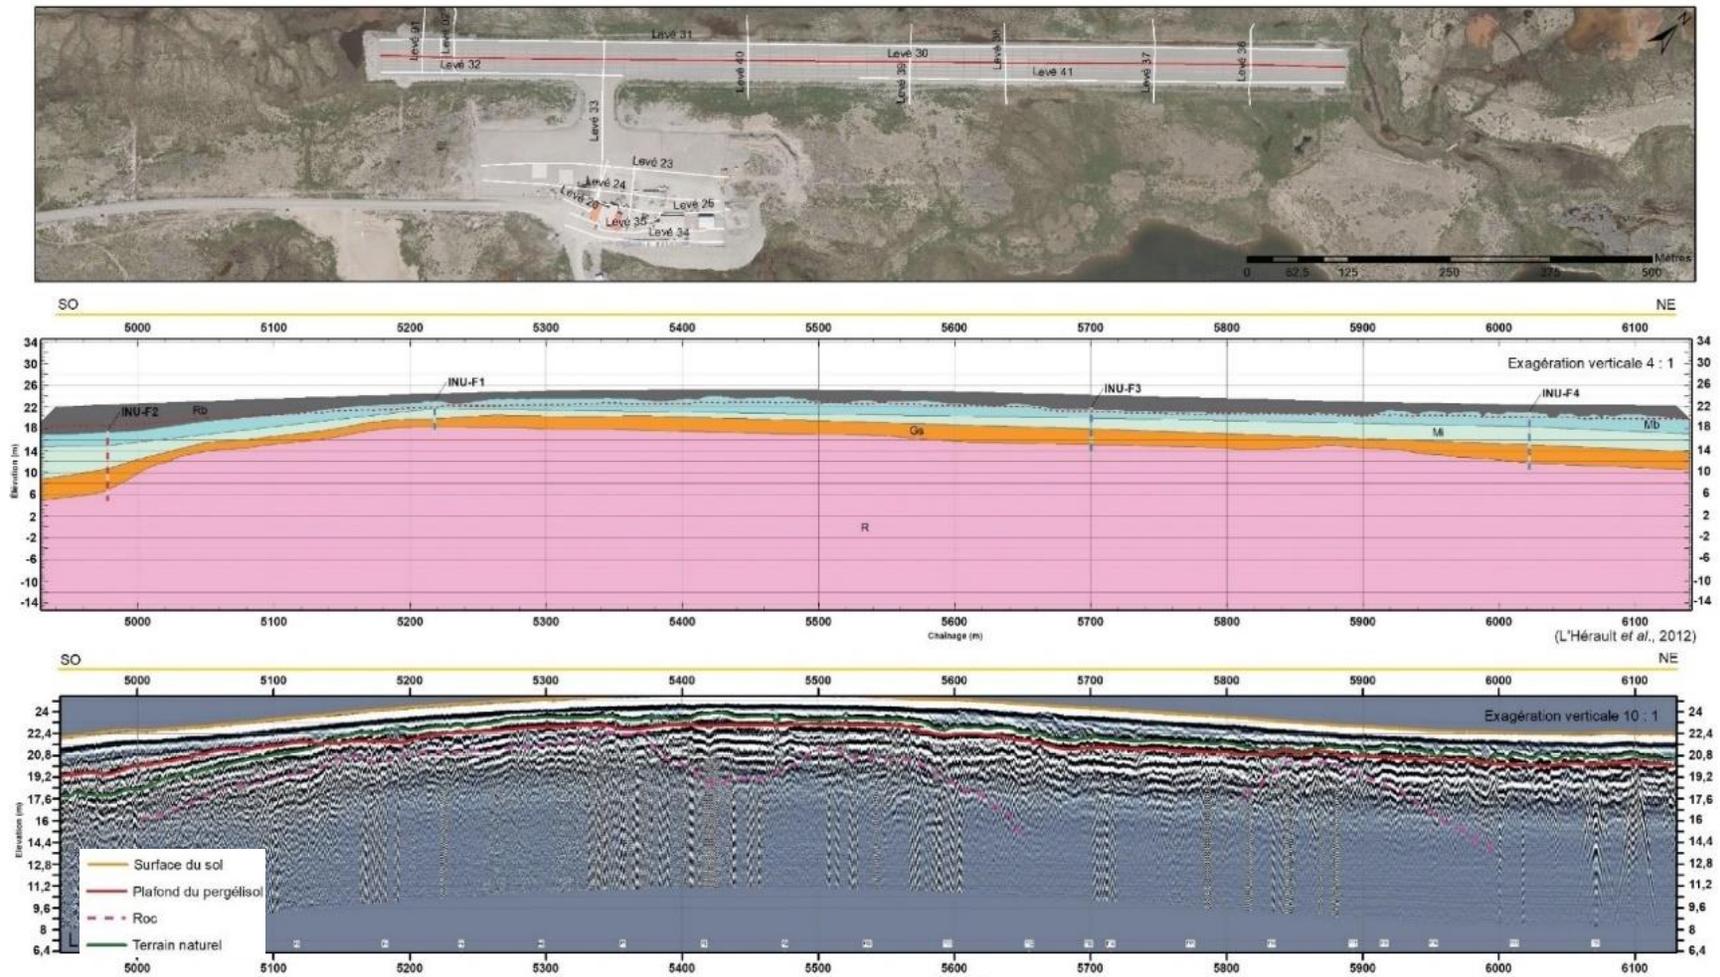
Figure 29 Top) Aerial view with plan of GPR survey lines; Middle) The general stratigraphy under the runway; Rb, embankment; Mb, sandy coastal sediments; Mi, silty ice rich intertidal sediments; Gs submarine fluvio-glacial outwash sediments made of sands with interstratified silt layers; R, bedrock; Bottom) GPR profile along the center-line of the runway showing the permafrost table, the natural ground surface beneath the embankment and a reinterpretation of the bedrock topography (dashed pink line).

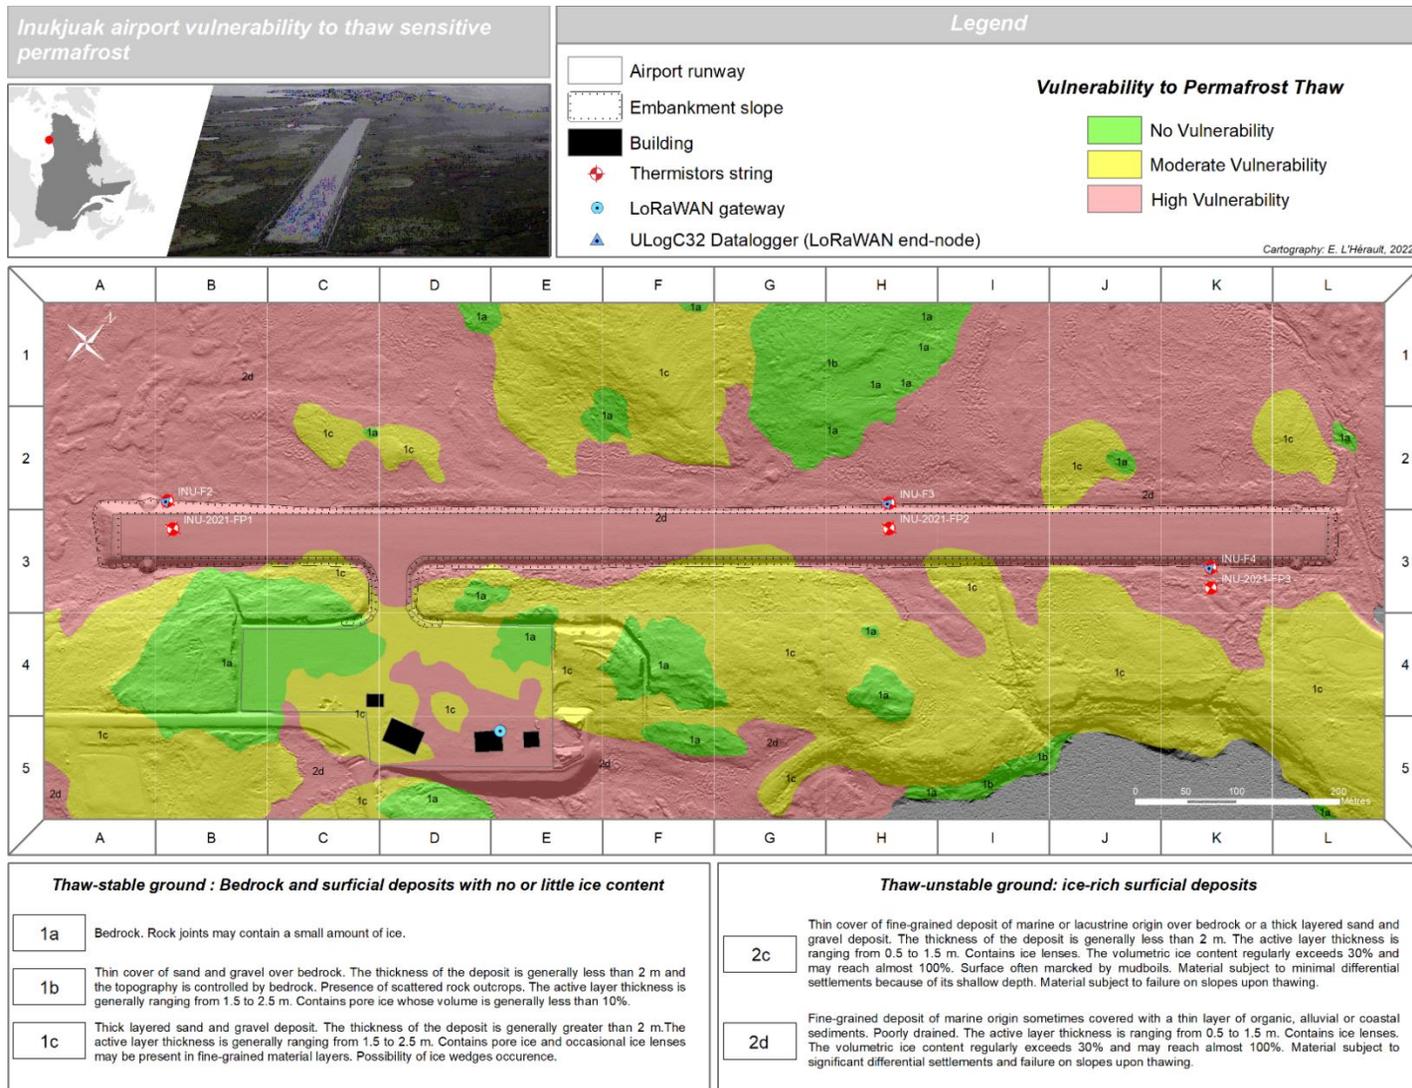
Figure 30 Map of the terrain vulnerability to permafrost thaw and the available instrumentation, Inukjuak runway, Nunavik.

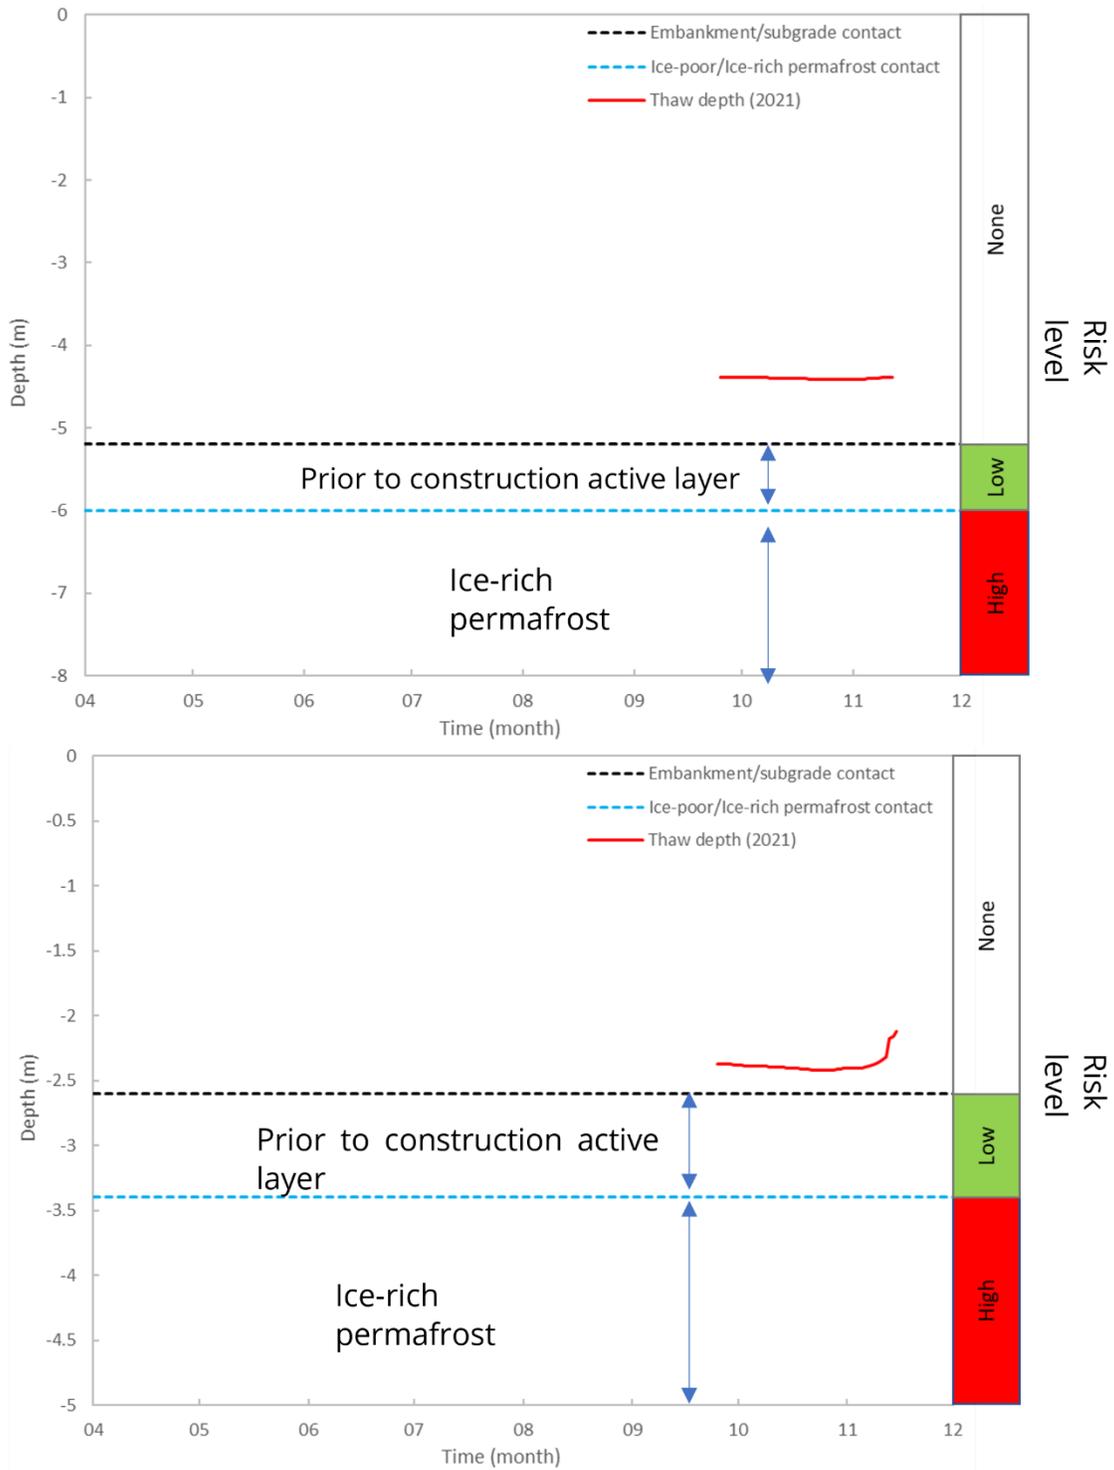
Figure 33 Thaw depth progression for the end of summer 2021 estimated from ground temperature data provided by the centerline thermistors strings A) INU-2021-FP1 (thick embankment section) and B) INU-2021-FP2 (thin embankment section).

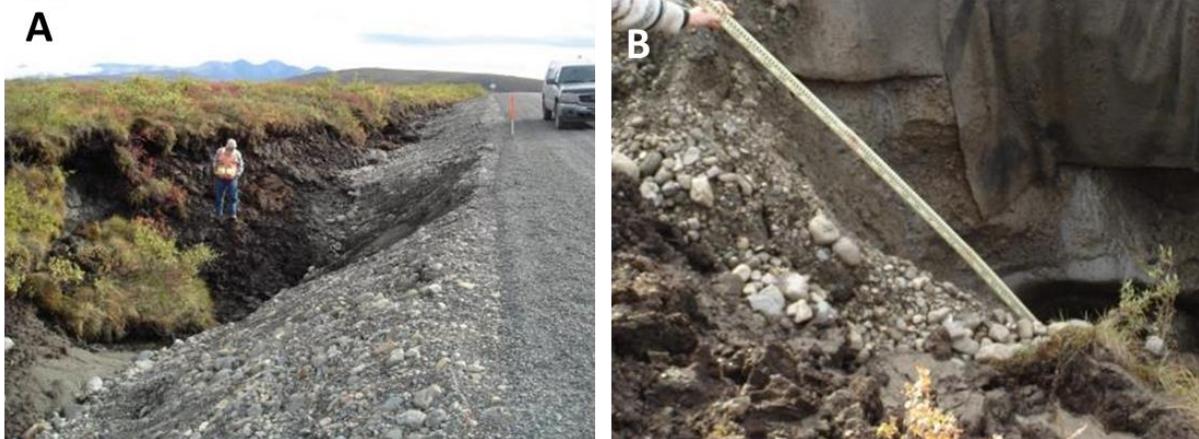
Figure 35 Degradation observed in summer 2006 along the newly built embankment at km 116. A- thermal erosion along the left-hand side shoulder; B- water tunneling under the embankment along an ice-wedge.
