Design and implementation of early detection and warning systems for transportation infrastructure impacted by permafrost-related geohazards

January 31 2022

This report presents the results of a project aiming to develop an automated alarm system to warn transportation infrastructure operators of permafrost-related geohazards. While linear infrastructure like roads or airstrips can themselves cause disturbances to surrounding permafrost, so can climate change. As temperatures warm and precipitation patterns change, permafrost thaw-related geohazards such as ground subsidence and landslides are increasingly likely, which could lead to dangerous conditions and the possibility of isolating communities. To address these hazards, the research team has developed an automated system to collect data in real-time to continuously assess conditions of the ground and infrastructure using site-specific algorithms to define risk levels. Elevated risk levels are automatically communicated to infrastructure operators for action to be taken. This report outlines the three primary components of the project including: 1) conception of the system; 2) site characterizations and analyses; and 3) imple

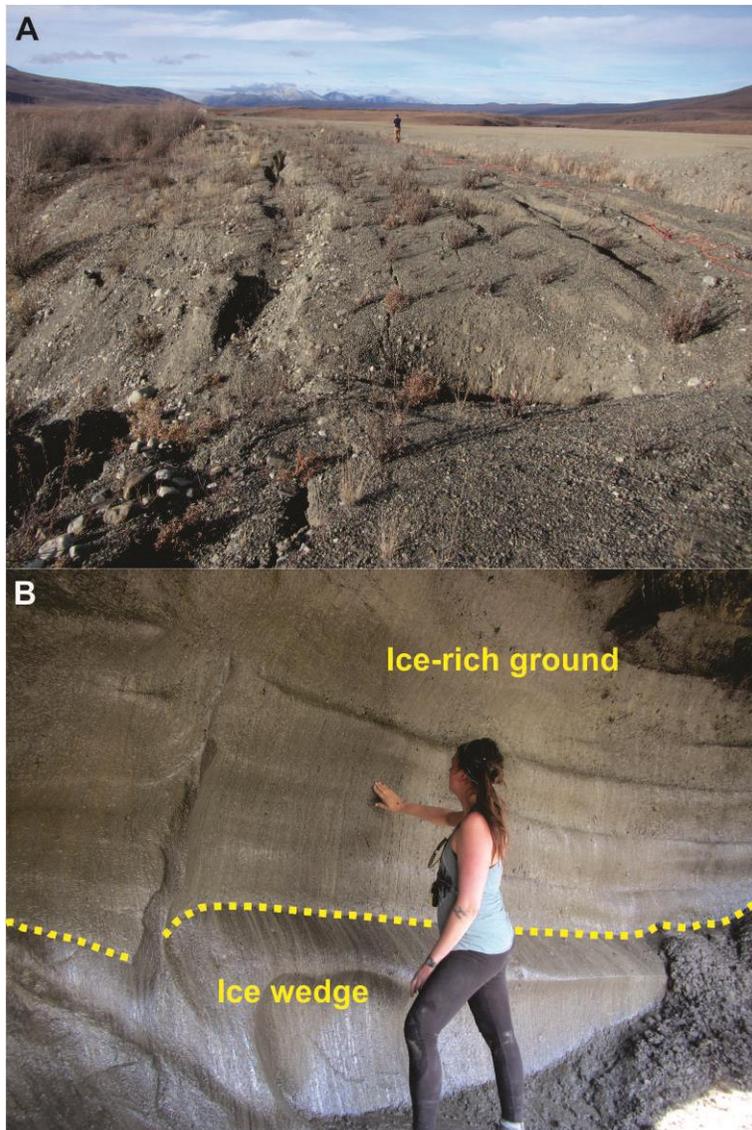
Figure 36 Degradations observed at DH116. A- Former embankment at the right-hand side affected by permafrost degradation; B- ice-rich ground and ice-wedge observed at landslides along the cliff.

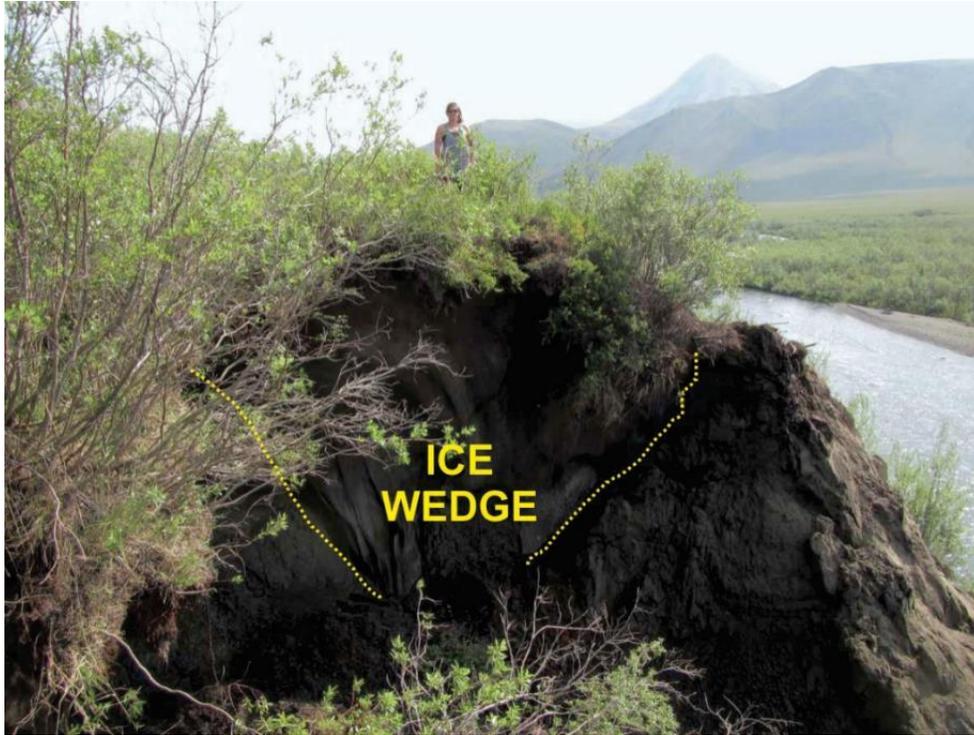
Figure 37 Headwall of the 2017 thaw slump with visible ice-wedge in June 2017.

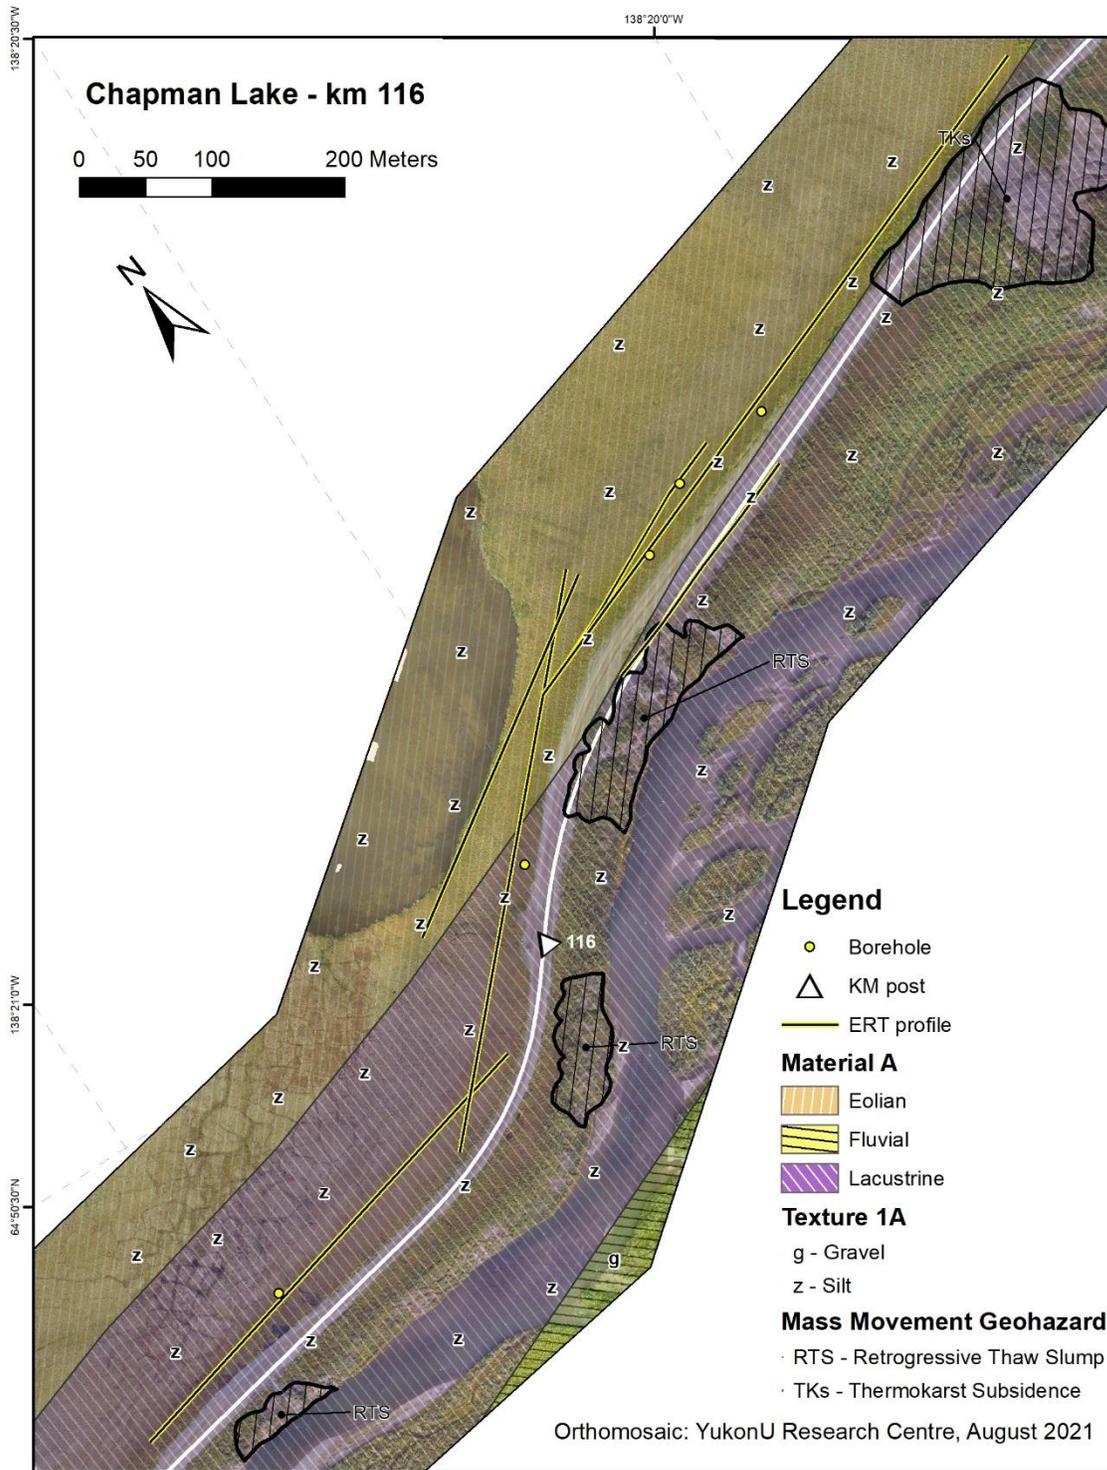
Figure 41 Map of the surficial deposits and mass movement geohazards along Chapman Lake study site (km 116)

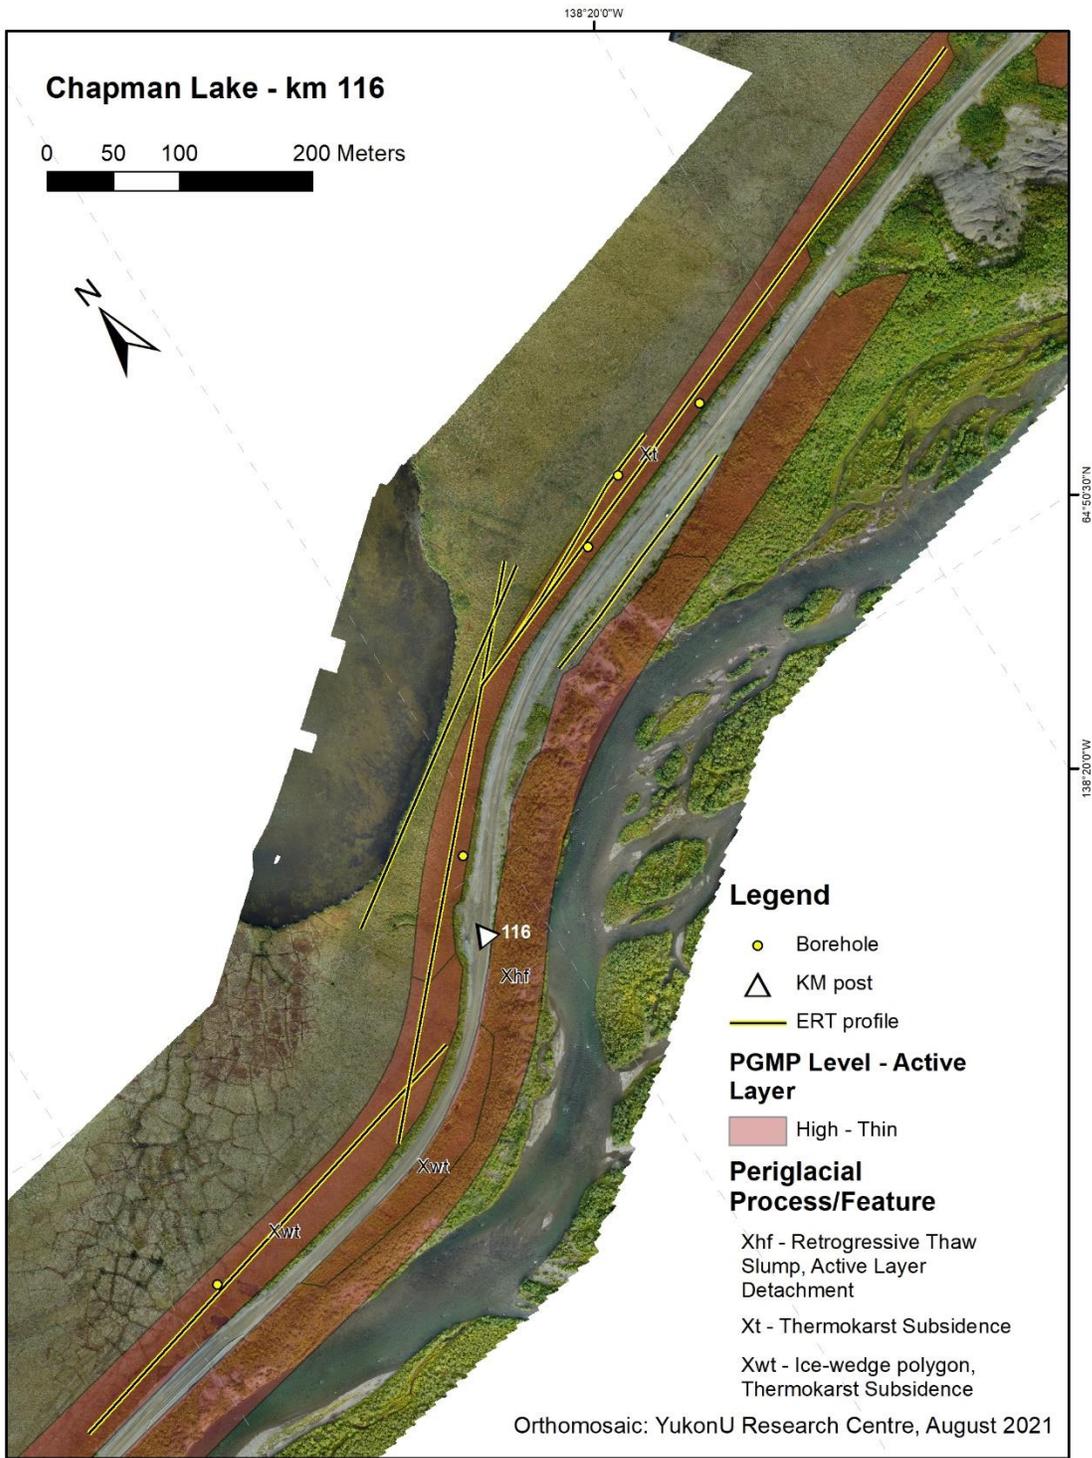
Figure 42 Map of Permafrost-related ground movement potential and periglacial process/features along Chapman Lake study site (km 116)

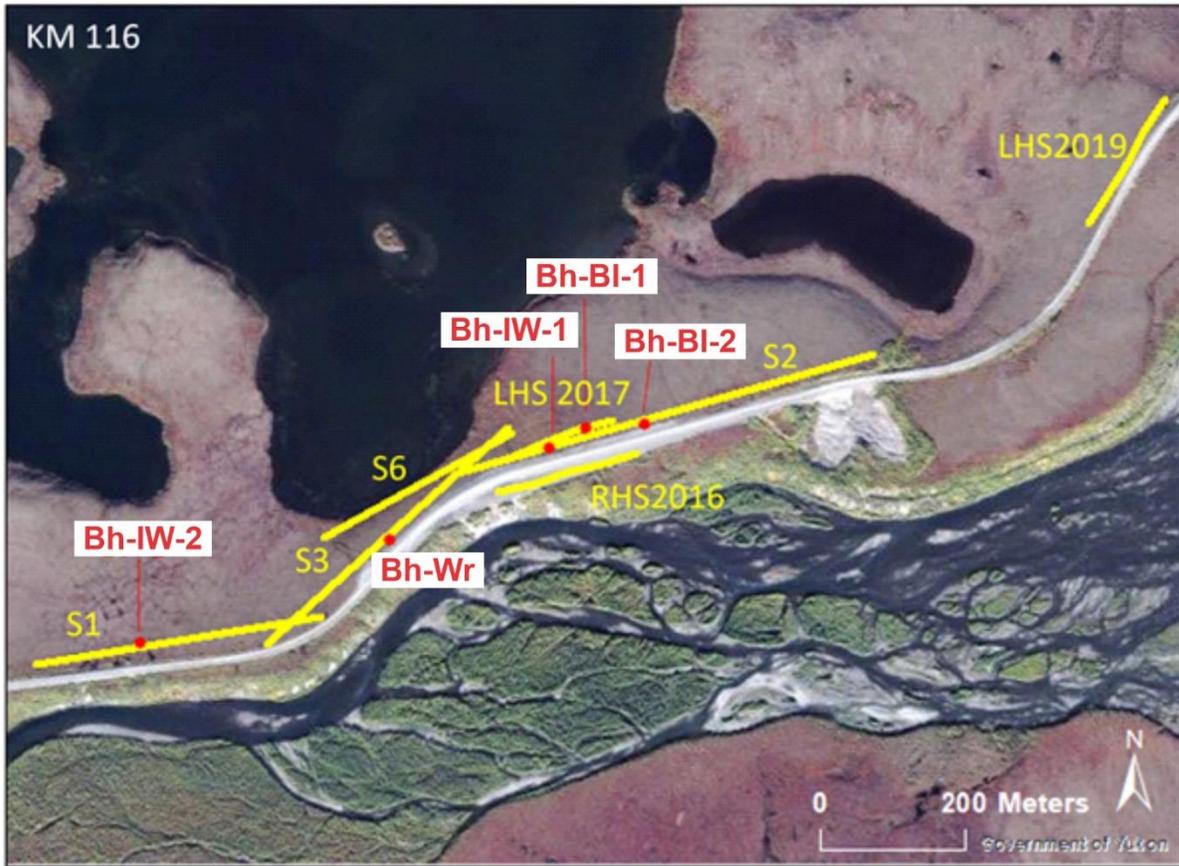
Figure 43 Locations of the boreholes and ERT surveys at Chapman Lake section (km 116).

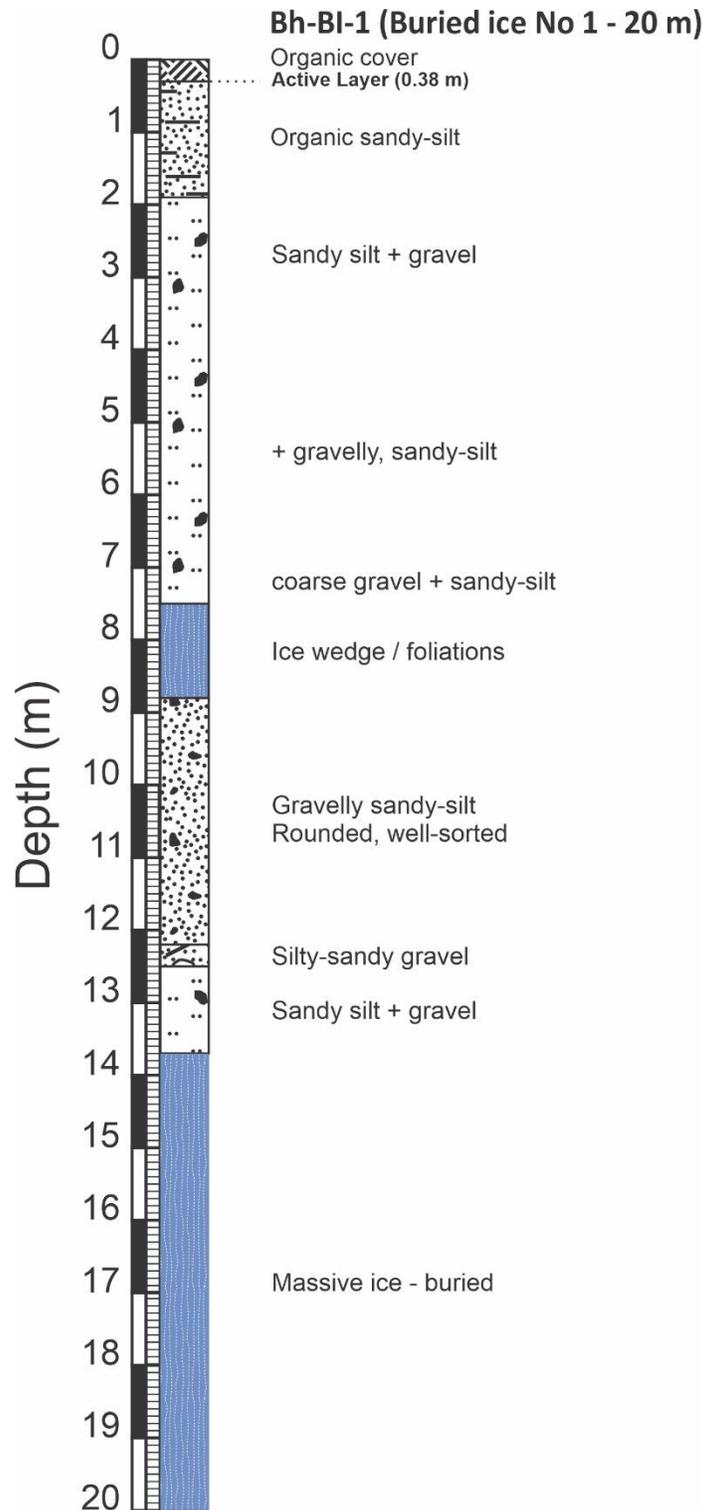
Figure 47 Log of borehole Bh-BI-1.

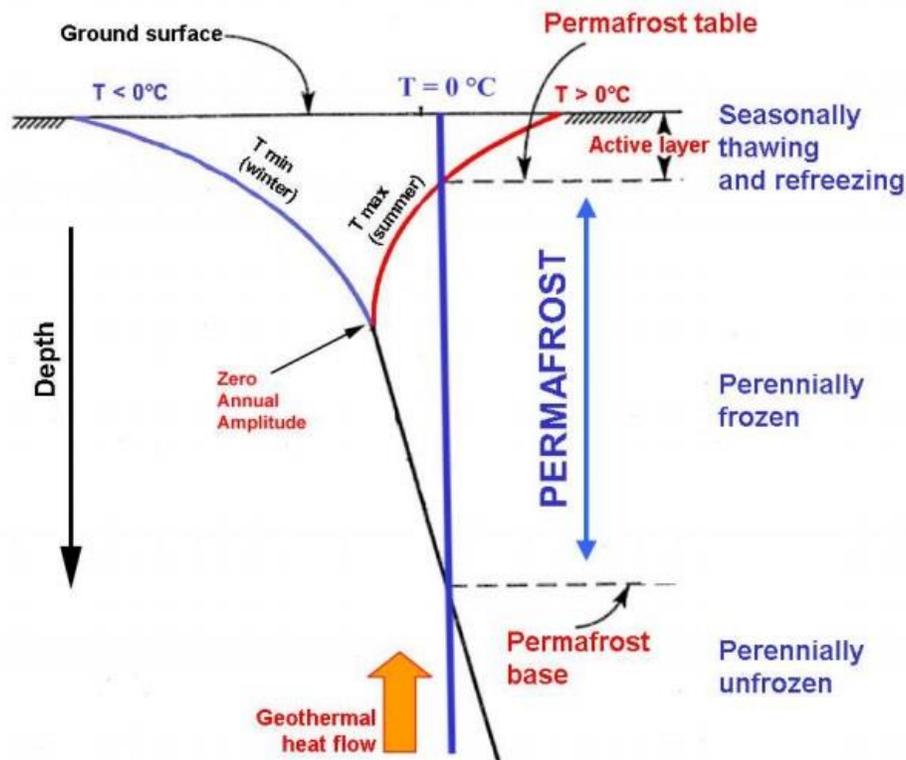
Figure 51 Typical temperature trumpet curve with the depth of zero annual amplitude (PermaNet Alpine Space).

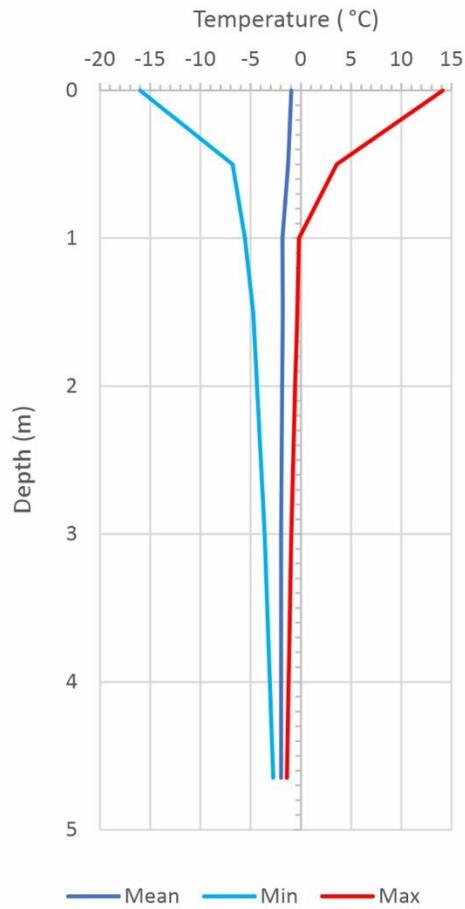
2019								
Depth	0.00 m	1.50 m	5.00 m	9.00 m	10.50 m	12.00 m	15.00 m	20.00 m
Mean	-0.2 °C	-2.3 °C	-2.5 °C	-2.5 °C	-2.5 °C	-2.4 °C	-2.3 °C	-2.2 °C
Min	-10.9 °C	-5.9 °C	-3.6 °C	-2.7 °C	-2.7 °C	-2.5 °C	-2.4 °C	-2.3 °C
Max	13.8 °C	-0.4 °C	-1.6 °C	-2.2 °C	-2.4 °C	-2.3 °C	-2.3 °C	-2.2 °C

Figure 52 Ground temperature trumpet curves at borehole Bh-IW-1 in 2019.

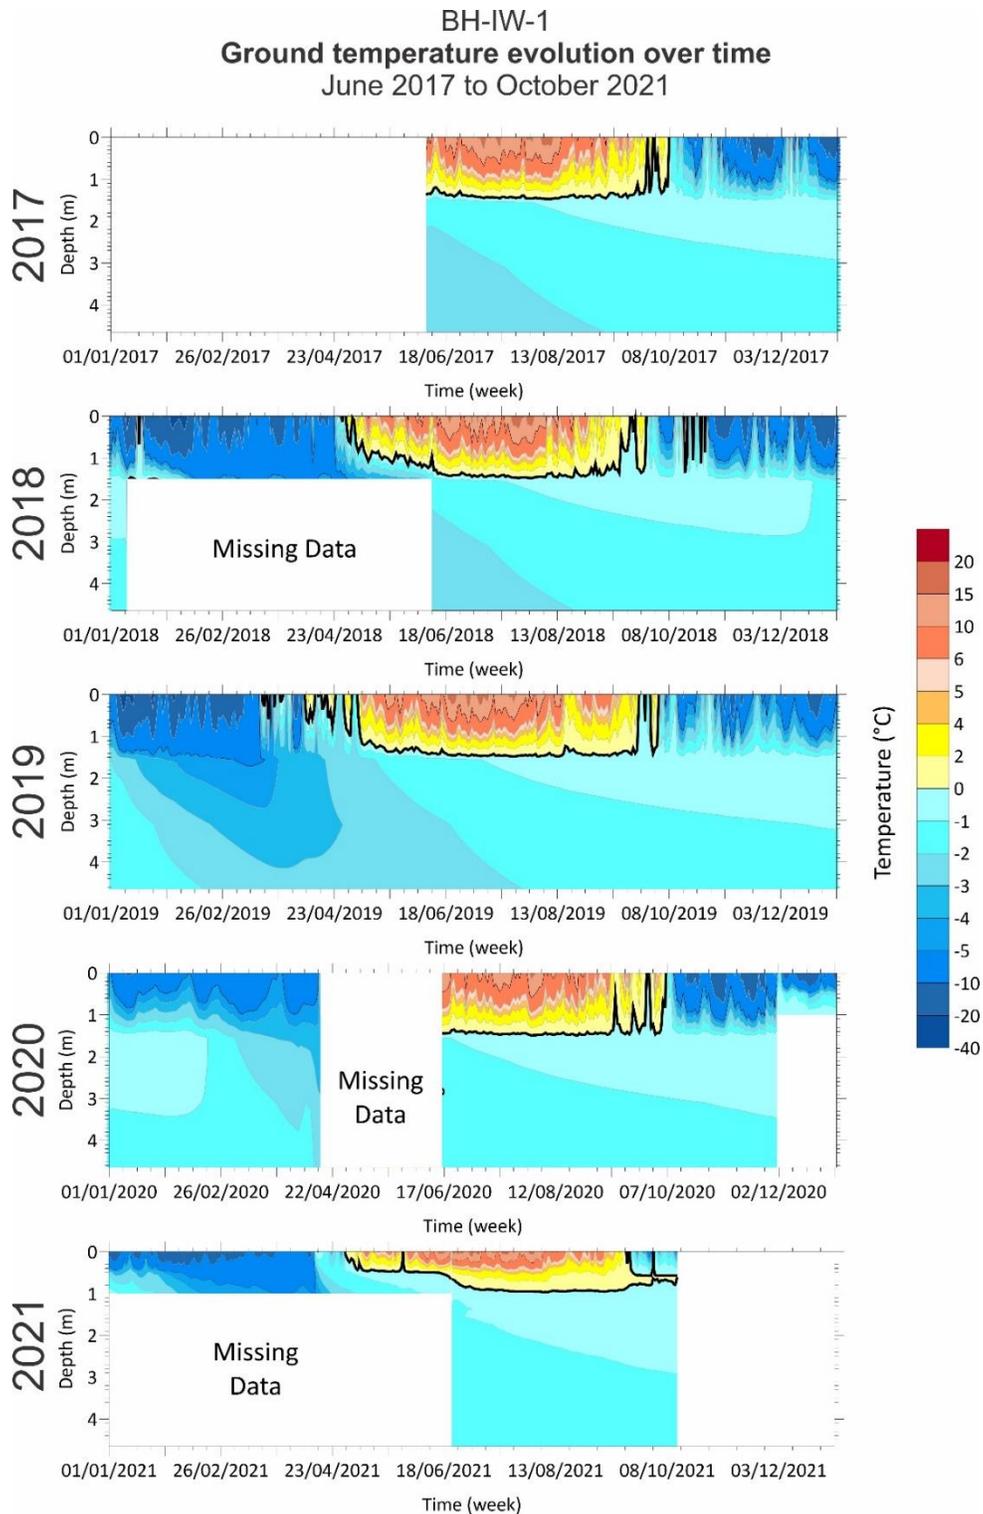
Figure 53 Ground thermal regime in borehole Bh-IW-1 from 2018 to 2021.

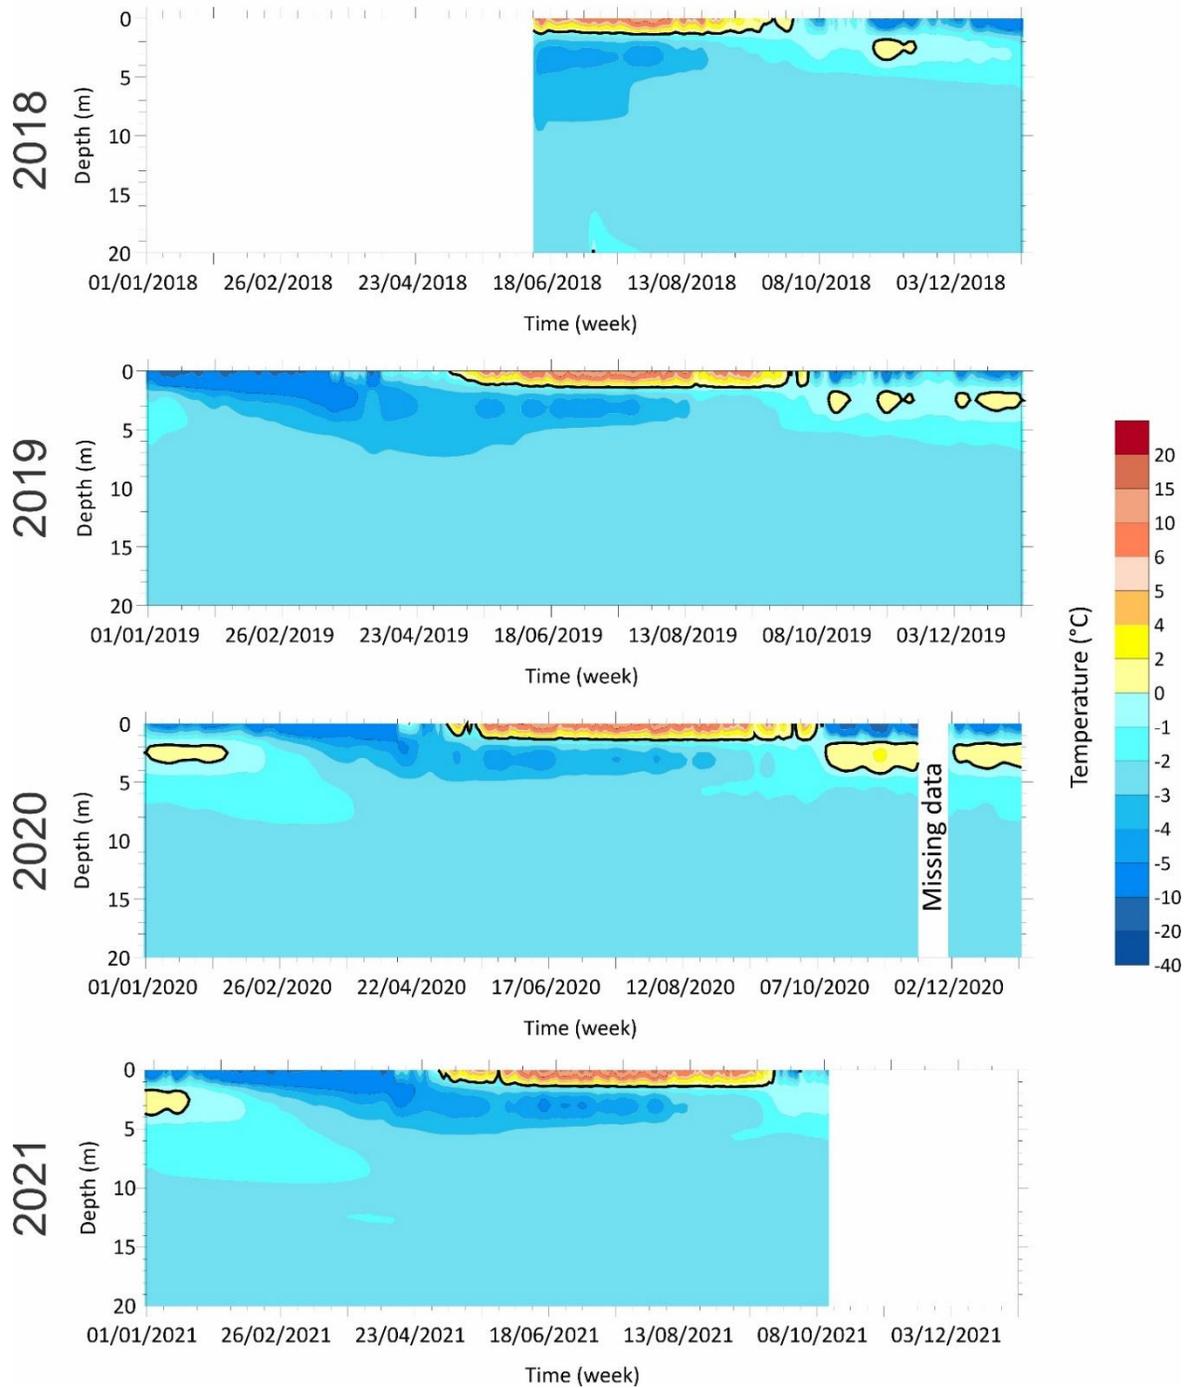
Figure 55 Ground thermal regime in borehole Bh-BI-1 from 2018 to 2021.

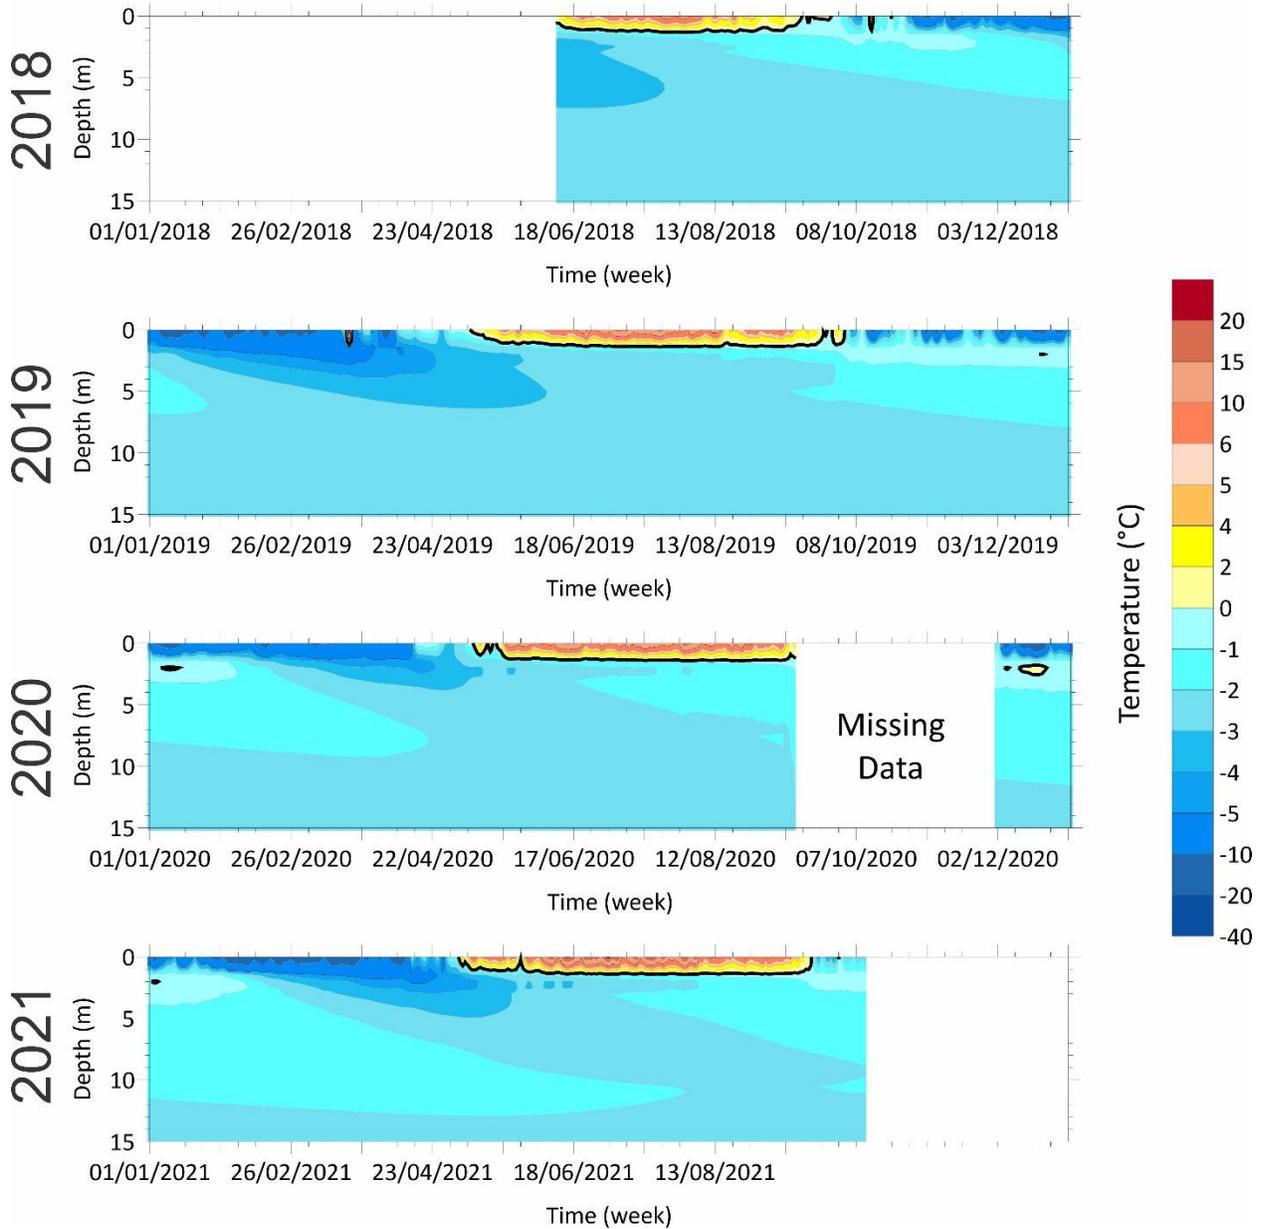
Figure 57 Ground thermal regime in borehole Bh-IW-2 from 2018 to 2021.

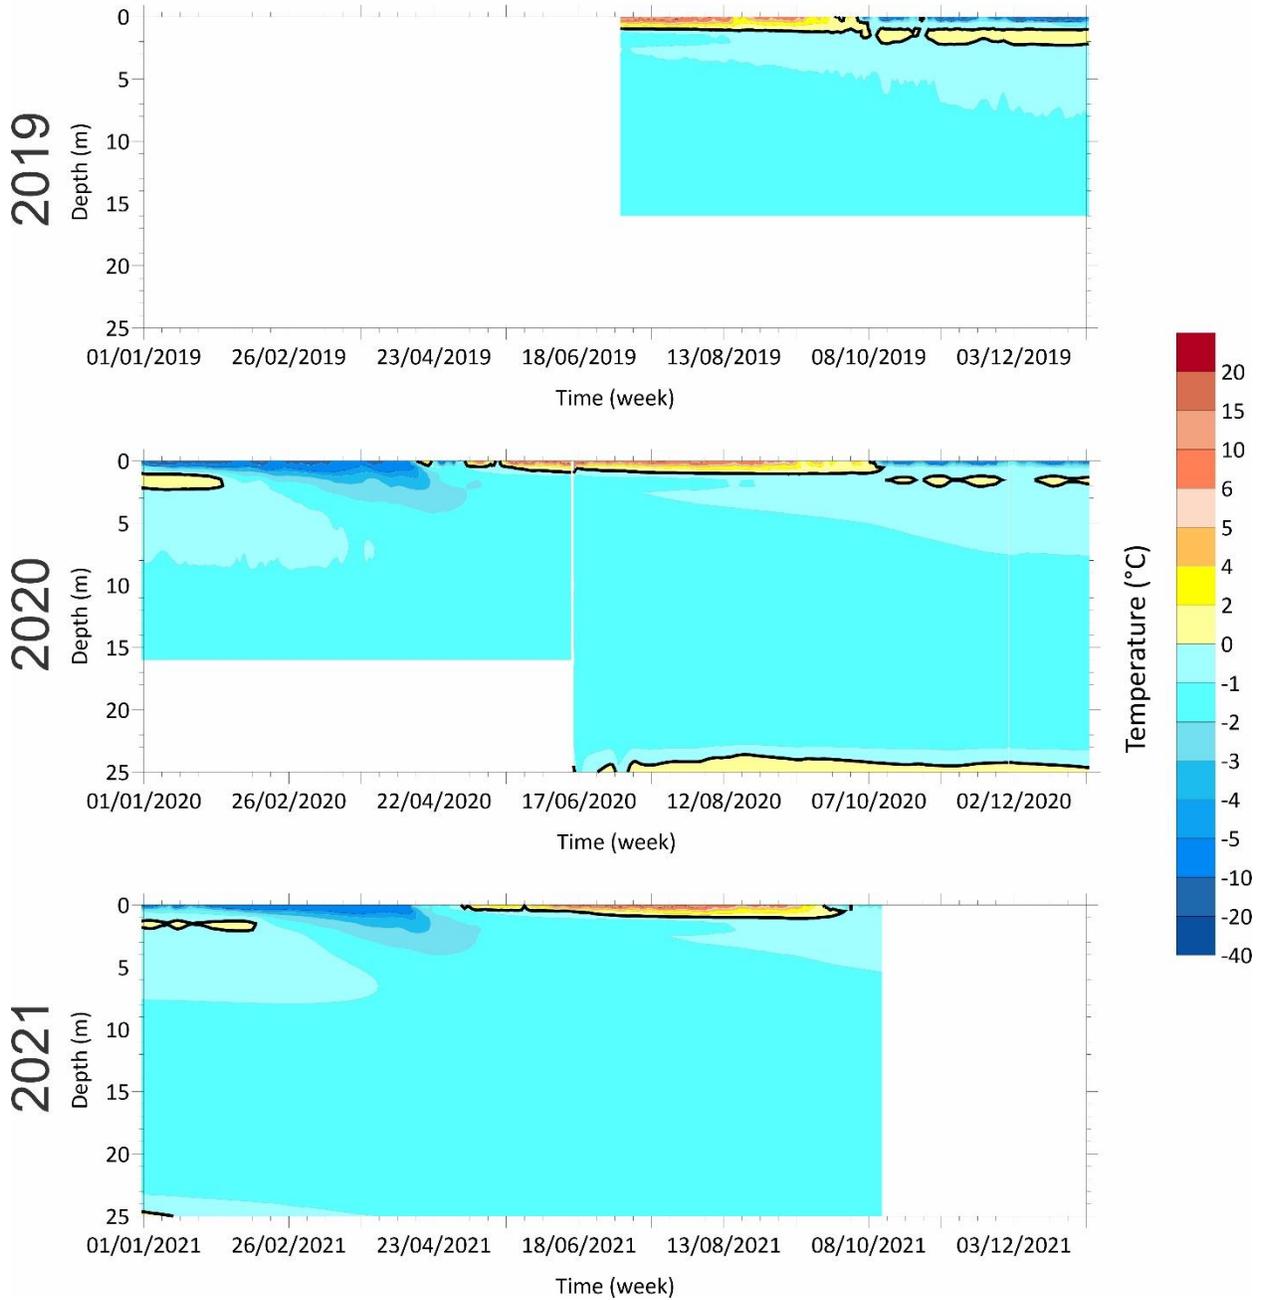
Figure 59 Ground thermal regime in borehole Bh-BI-2 from 2019 to 2021.

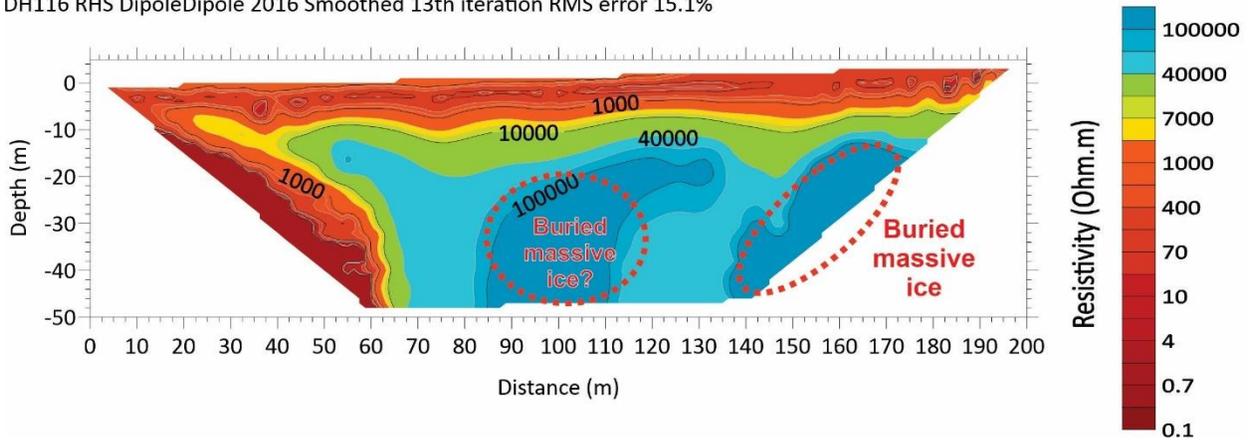
Figure 62 Dipole-dipole ERT surveys at site DH116, right-hand side (RHS) from 2016, using robust and smoothed inversion processes.

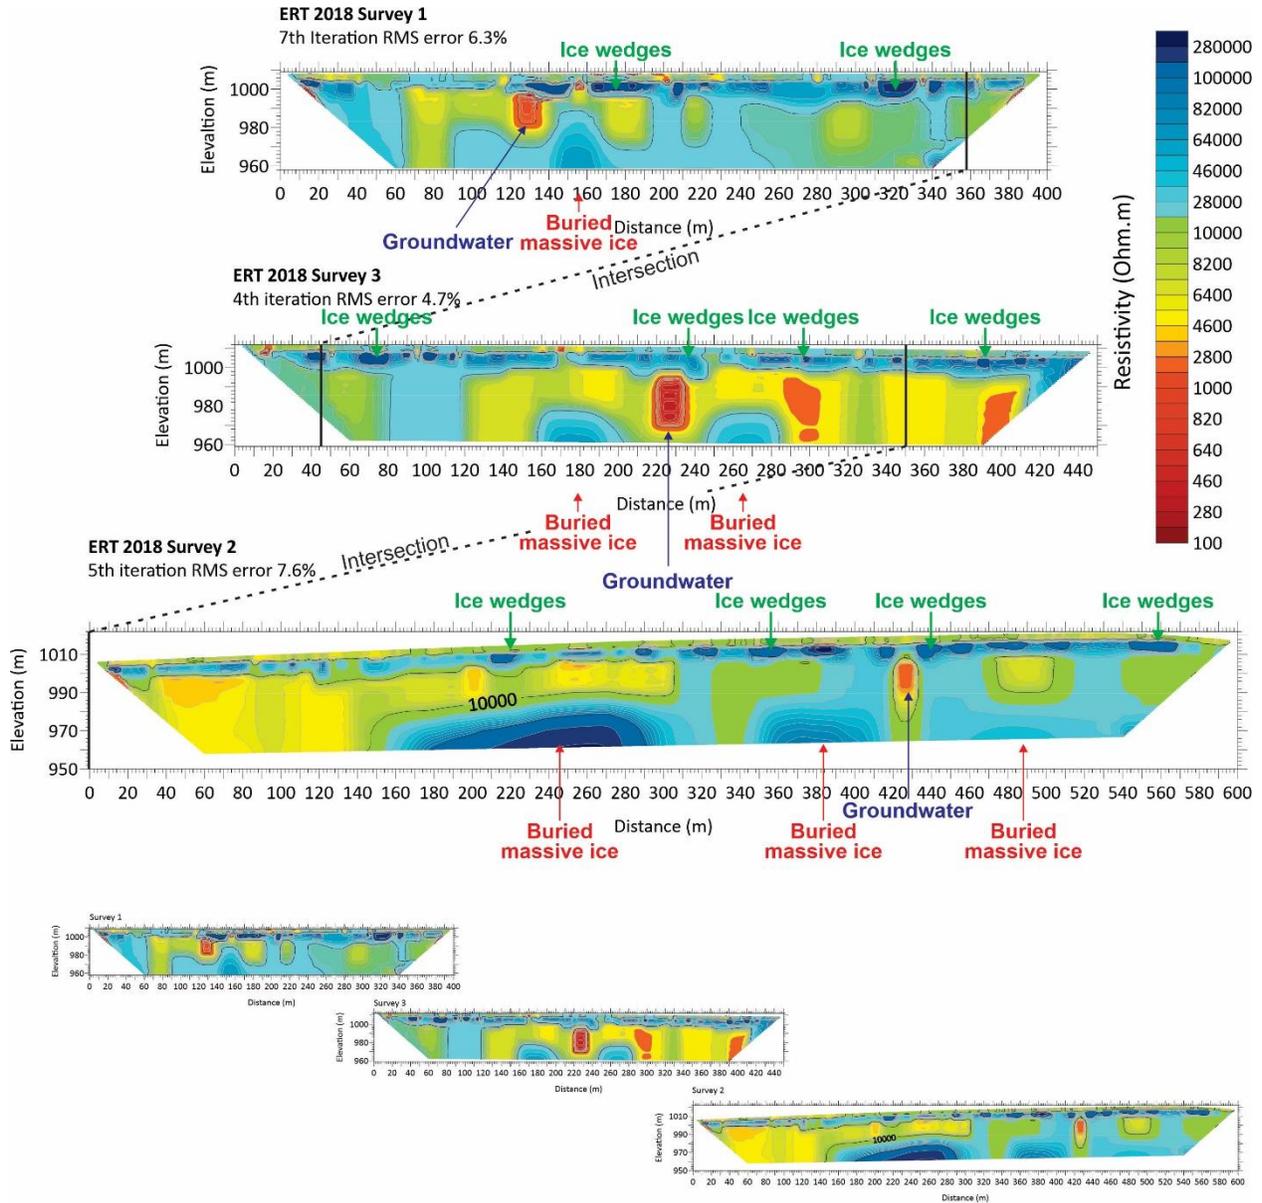
Figure 64 Dipole-dipole 2018 ERT surveys at site DH116, LHS from 2018.

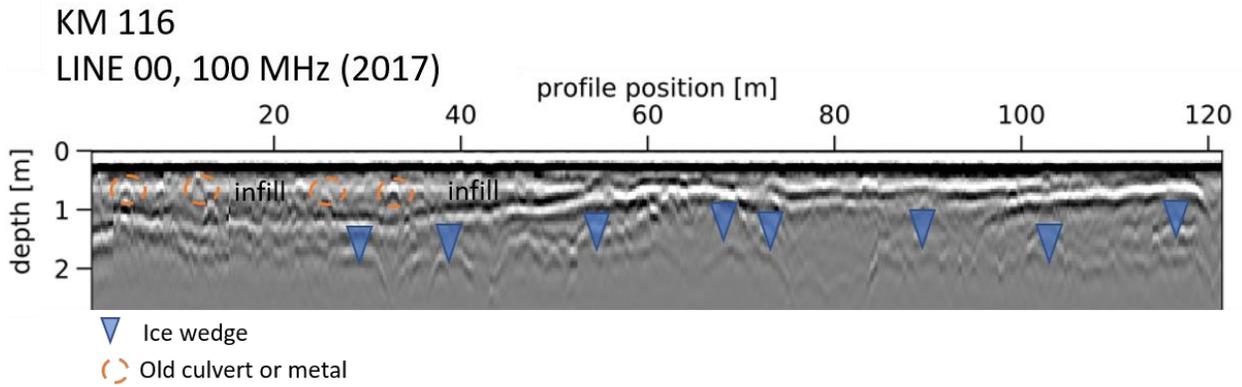
Figure 67 GPR line 00 (2017) at RHS of Km 116 (100 MHz), migrated to 0.1 m/ns.

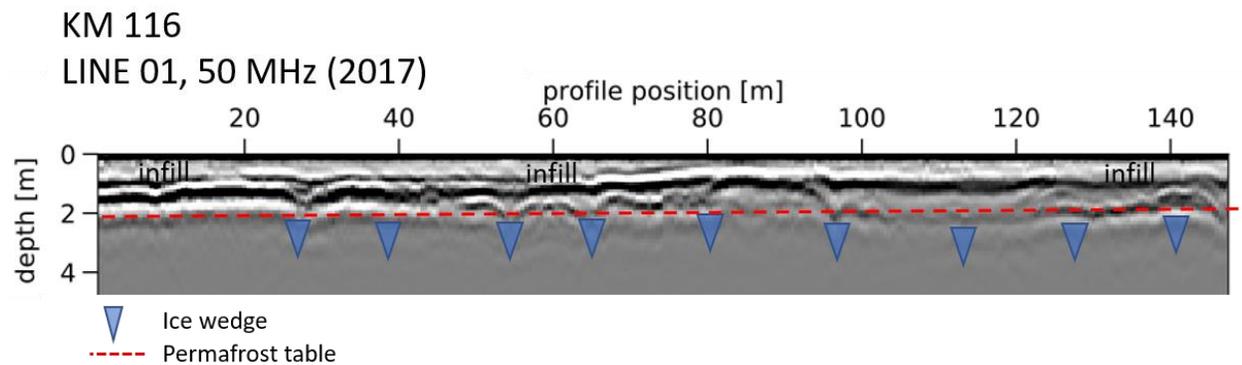
Figure 68 GPR line 01 (2017) at RHS of Km 116 (50 MHz), migrated to 0.1 m/ns.

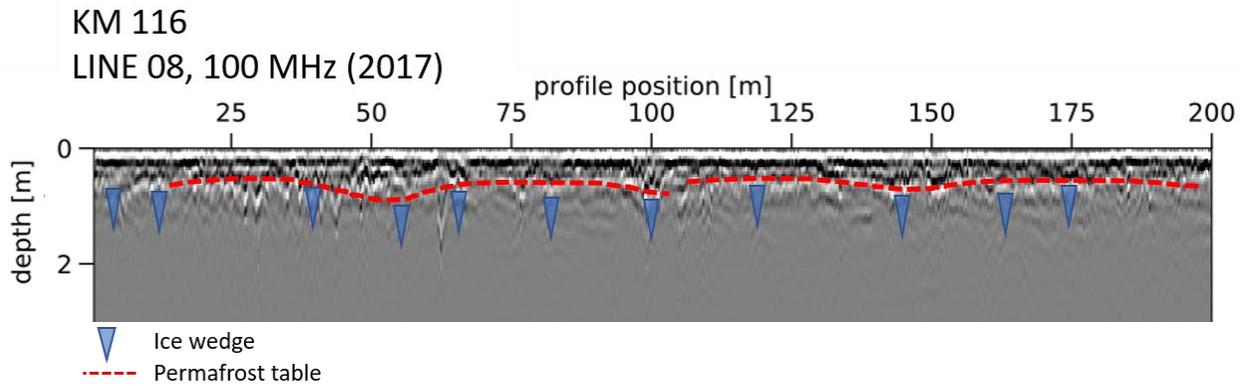
Figure 69 GPR line 08 (2017) at LHS of Km 116 (100 MHz), migrated to 0.1 m/ns.

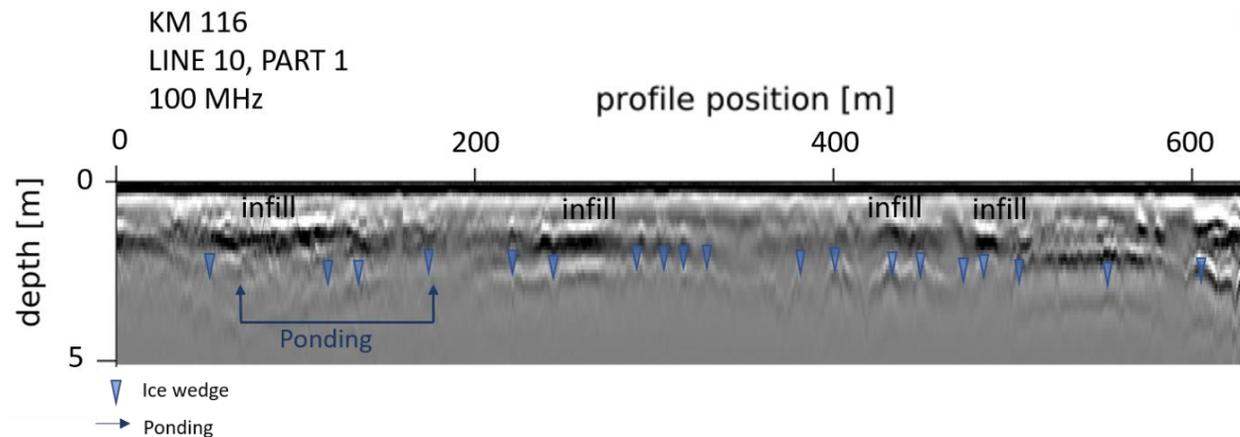
Figure 74 GPR line 10 part 1 at Km 116 (100 MHz), migrated to 0.1 m/ns.

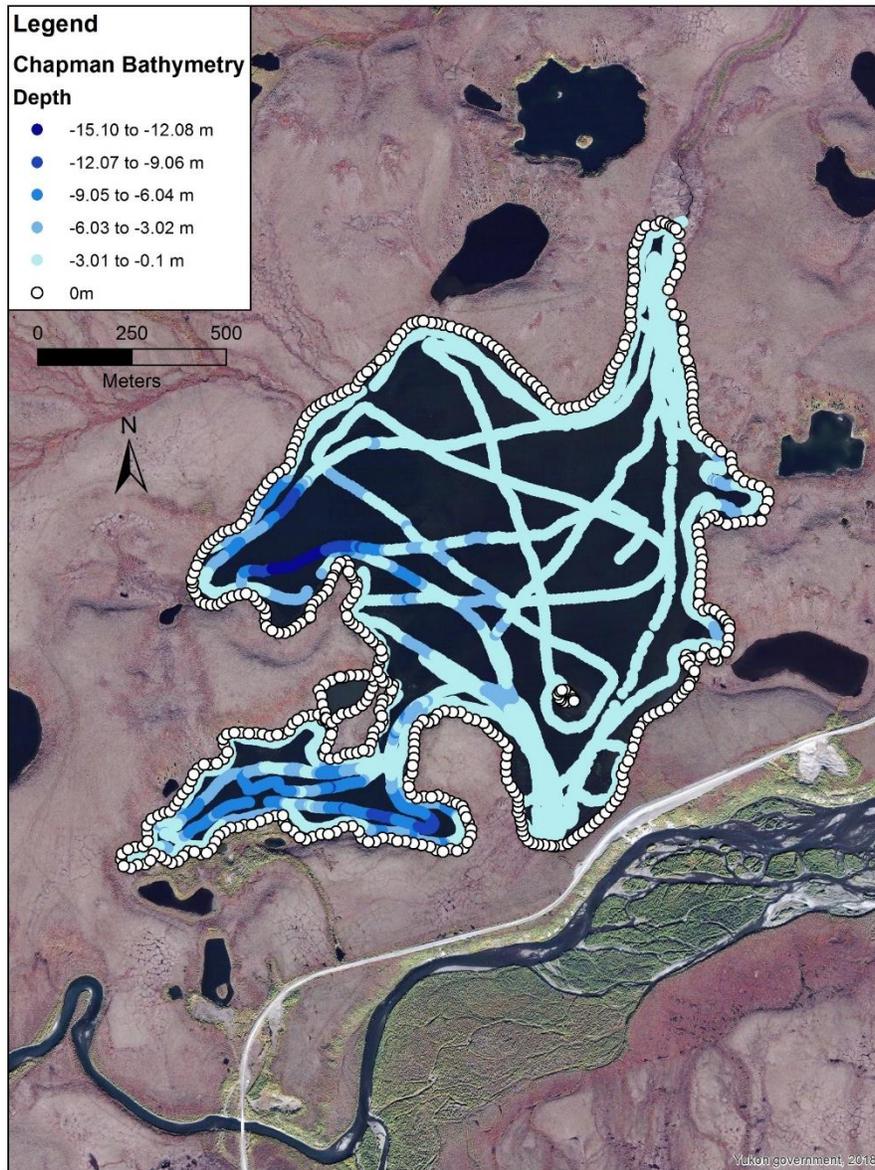
Figure 76 Chapman Lake bathymetric and shore survey, with depth measurement range for each data point.

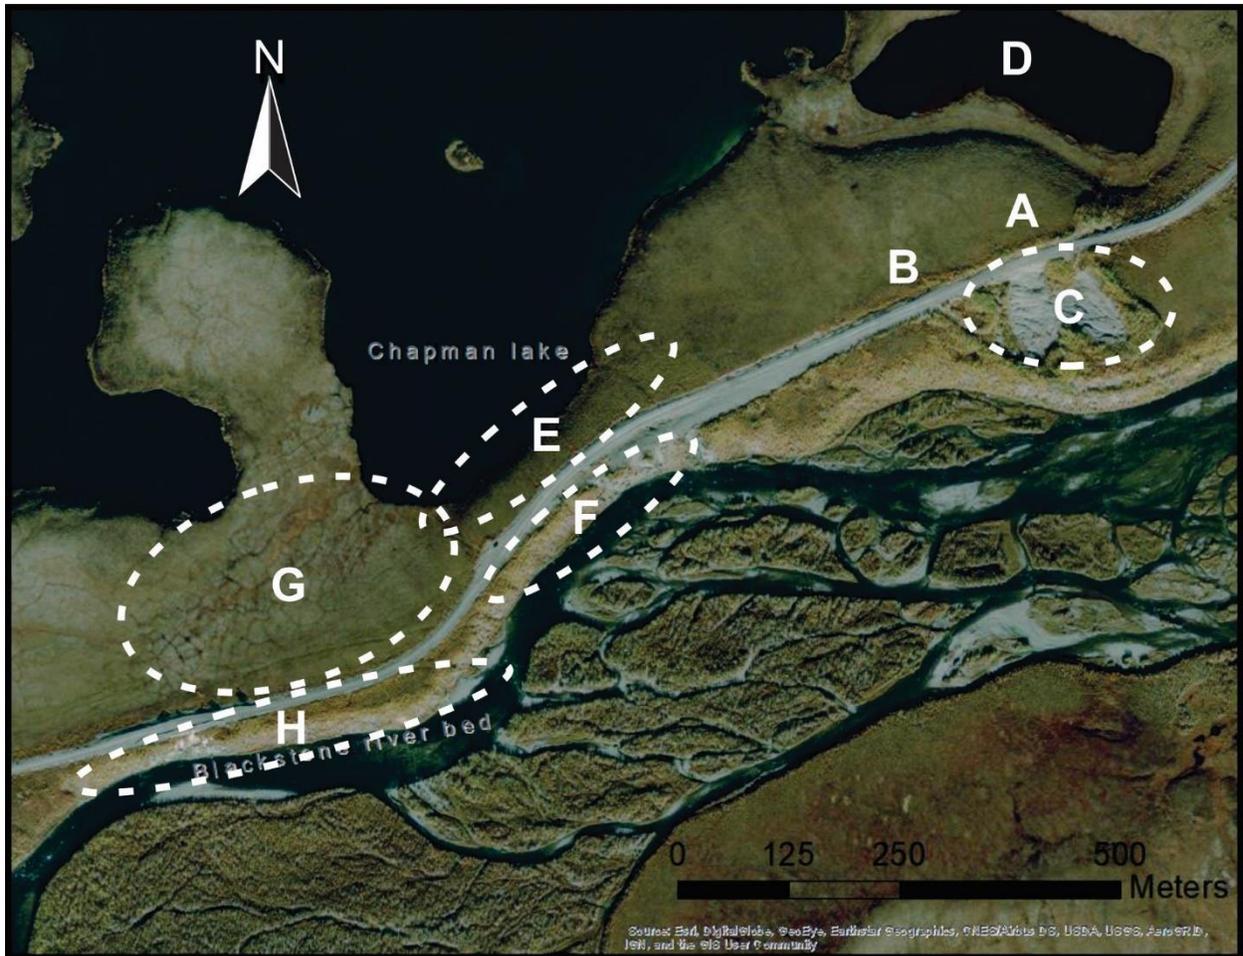
Figure 78 Localization of the eight discriminated zones of the topographical analysis.

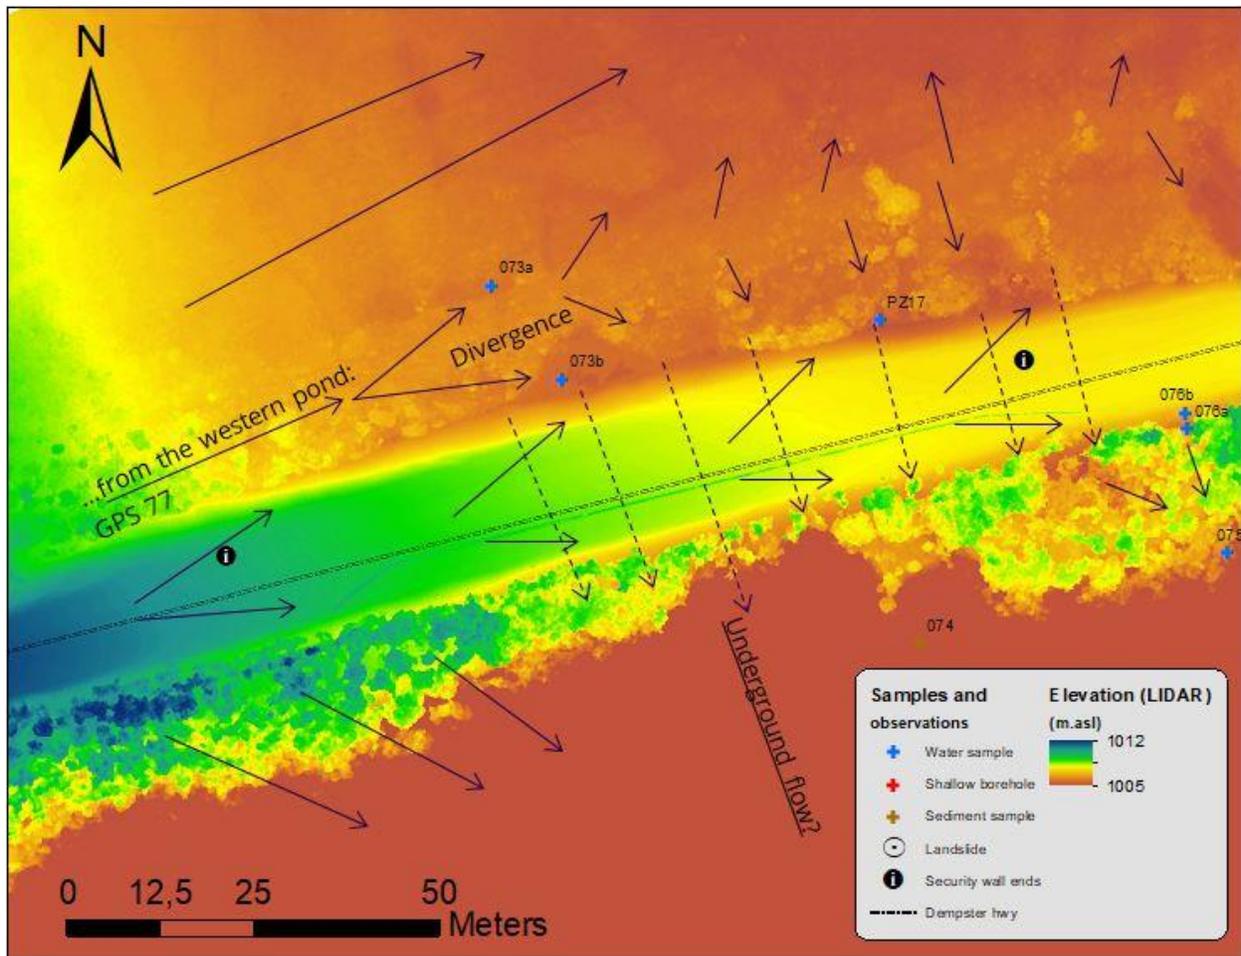
Figure 80 Surface water direction map of the zoom window R1 (see Figure 79) printed on the elevation model from the same source. Note the zone on the left-hand side of the road where the water pond, a good picture of this area is found in Figure 38.
