Design and implementation of early detection and warning systems for transportation infrastructure impacted by permafrost-related geohazards

January 31 2022

This report presents the results of a project aiming to develop an automated alarm system to warn transportation infrastructure operators of permafrost-related geohazards. While linear infrastructure like roads or airstrips can themselves cause disturbances to surrounding permafrost, so can climate change. As temperatures warm and precipitation patterns change, permafrost thaw-related geohazards such as ground subsidence and landslides are increasingly likely, which could lead to dangerous conditions and the possibility of isolating communities. To address these hazards, the research team has developed an automated system to collect data in real-time to continuously assess conditions of the ground and infrastructure using site-specific algorithms to define risk levels. Elevated risk levels are automatically communicated to infrastructure operators for action to be taken. This report outlines the three primary components of the project including: 1) conception of the system; 2) site characterizations and analyses; and 3) imple

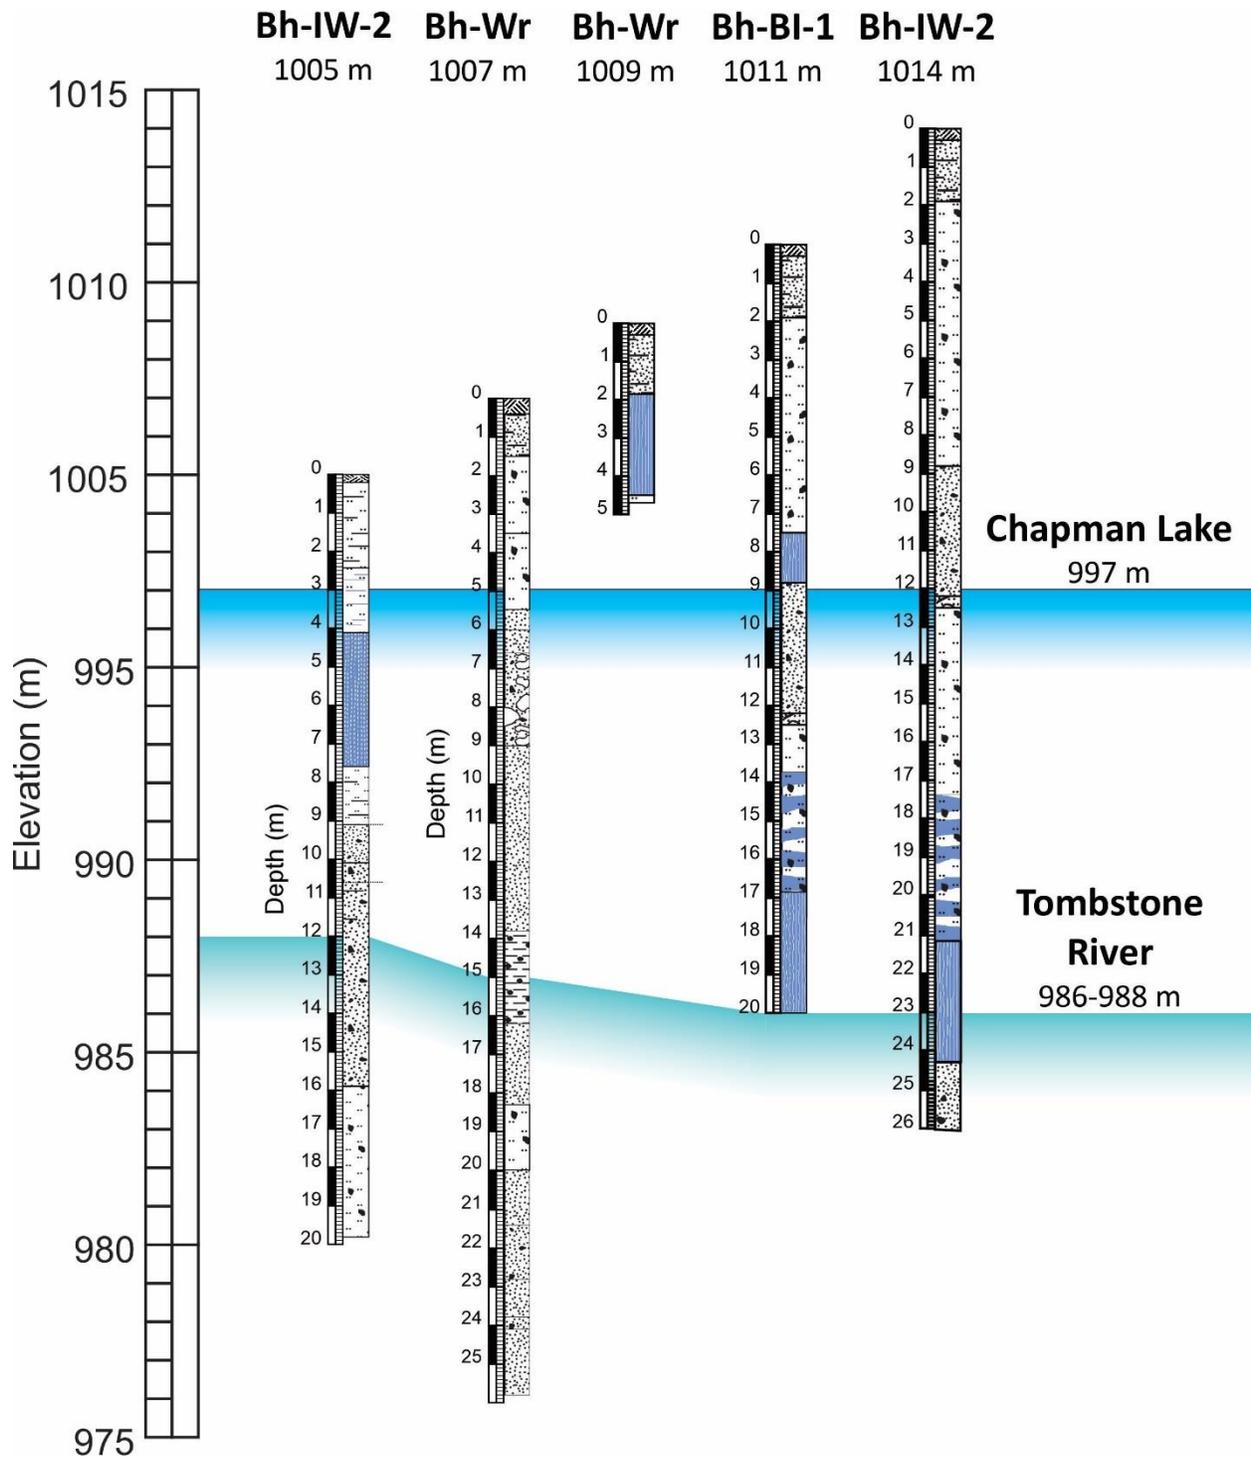
Figure 83 Bh-BI-1 borehole log compared to Blackstone River and Chapman Lake water levels.

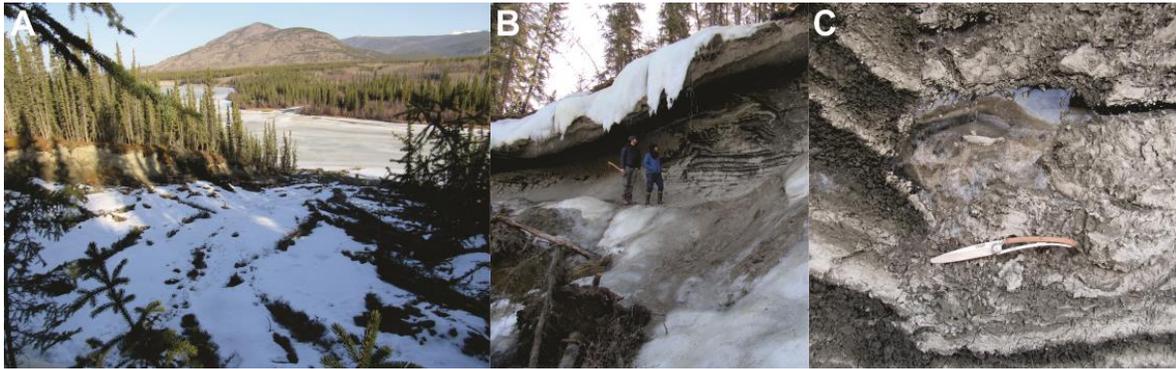
Figure 86 A) View of the RTS; B) Headwall of the RTS exposing ice-rich permafrost; C- 10 cm thick ground ice lenses.

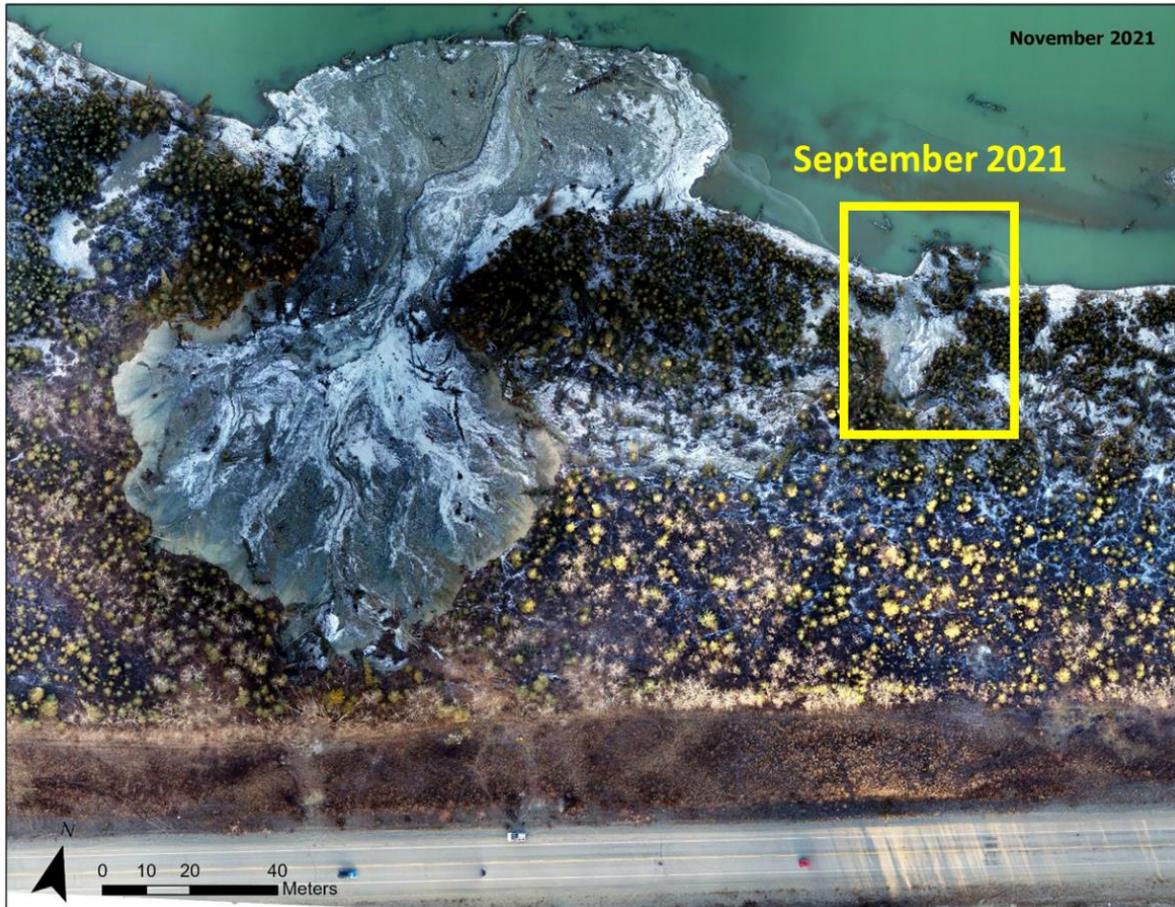
Figure 90 New retrogressive thaw slump forming east of the main RTS.

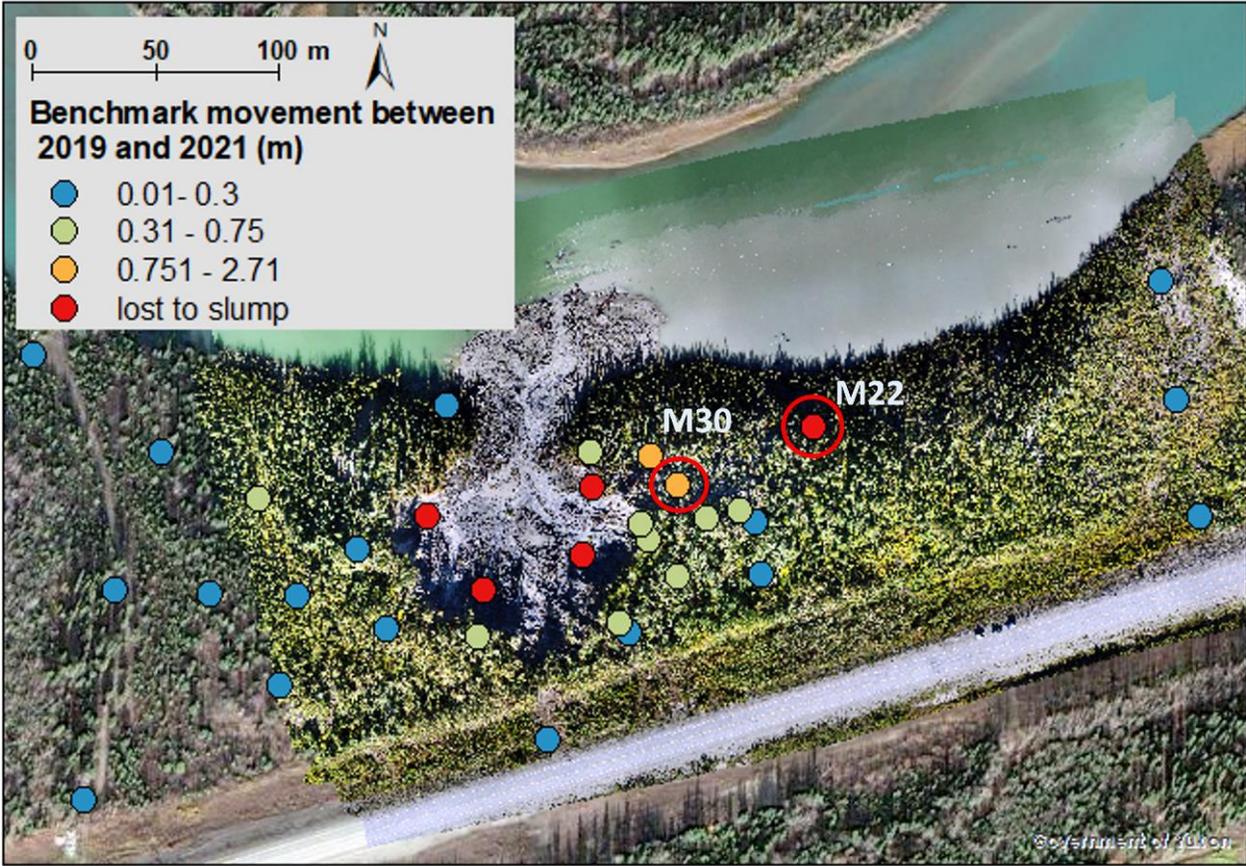
Figure 91 Benchmark movement between 2019 and 202, with the M30 and M22 benchmarks highlighted.

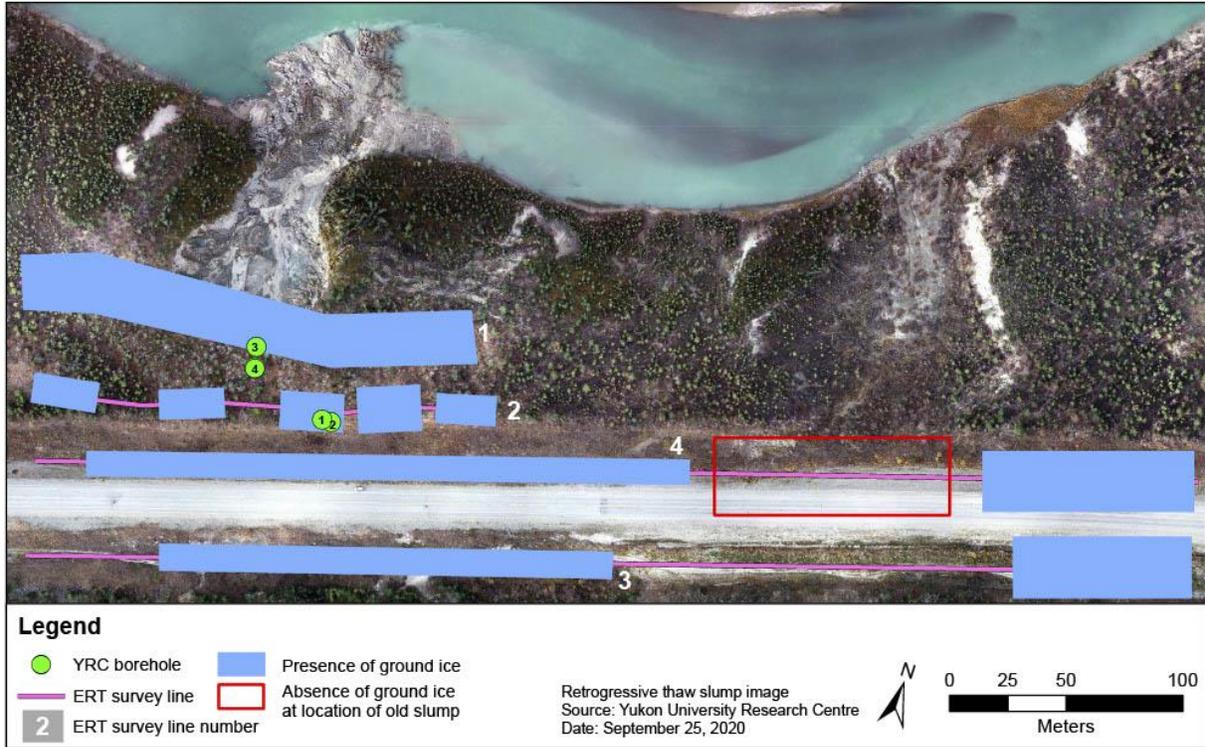
Figure 95 Approximate position of ground ice based on ERT profiles.

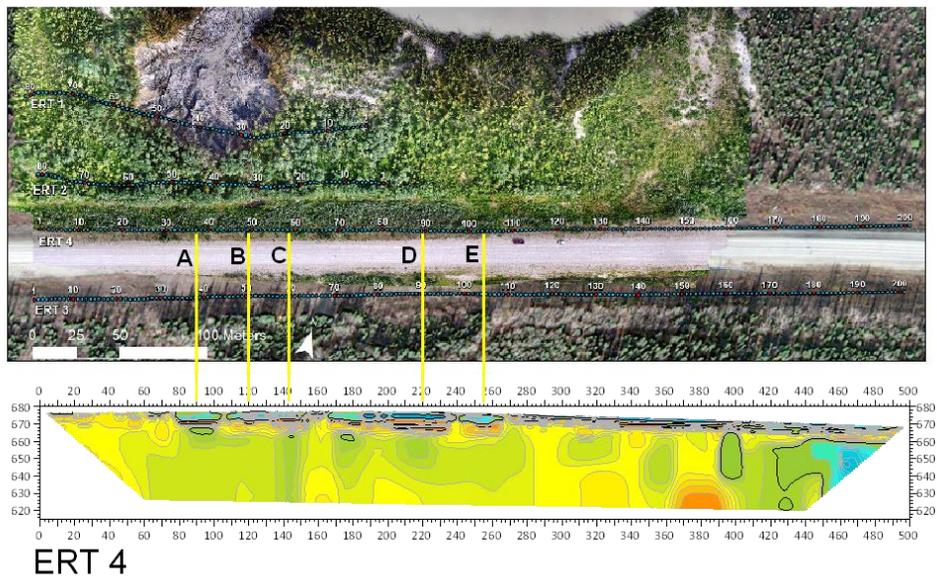
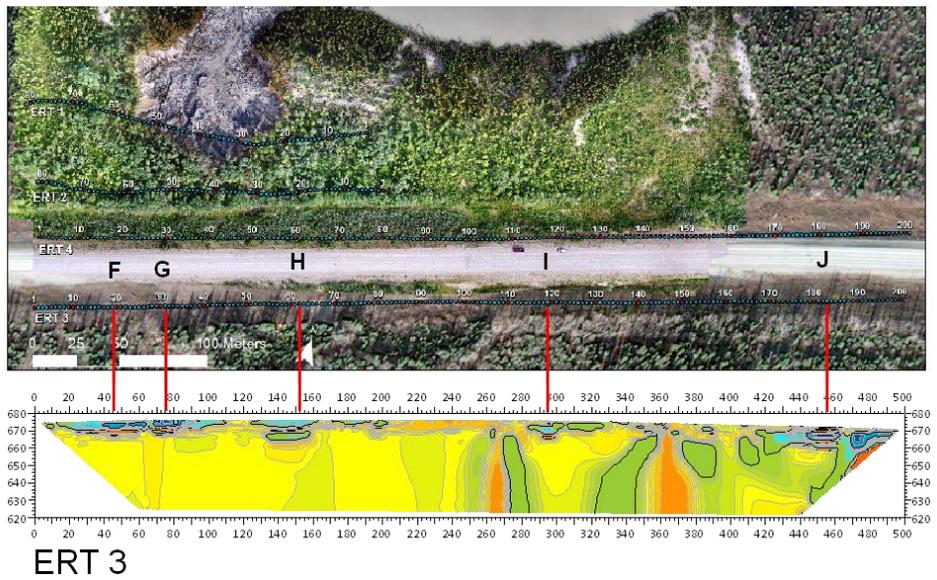
Figure 96 Selection of the borehole locations based on ERT surveys.

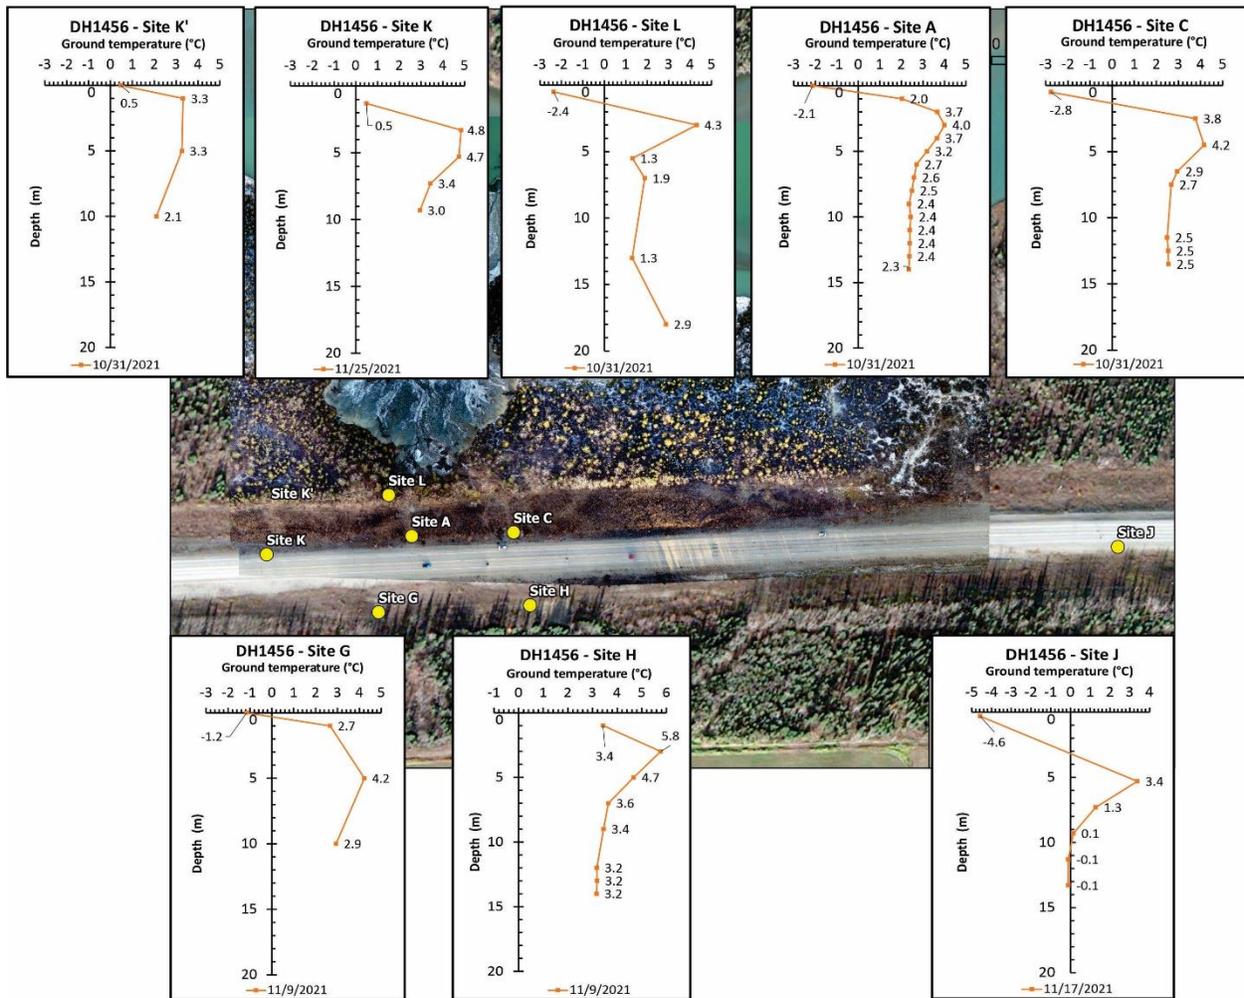
Figure 109 Ground Site K temperature record in the ROW borehole at the Takhini RTS site.

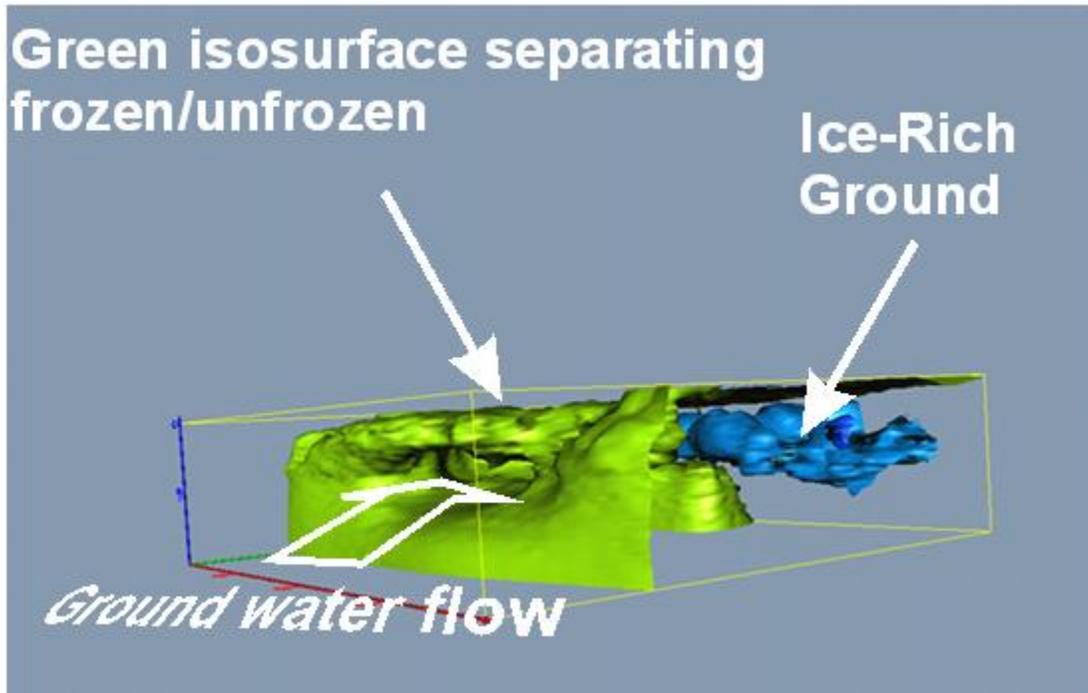
Figure 111 3-D ERT survey at km 1456 of the Alaska Highway. The blue bodies are ice-rich permafrost zones while the greenish iso-curve separate warm and/or wet and/or unfrozen areas from frozen ground.

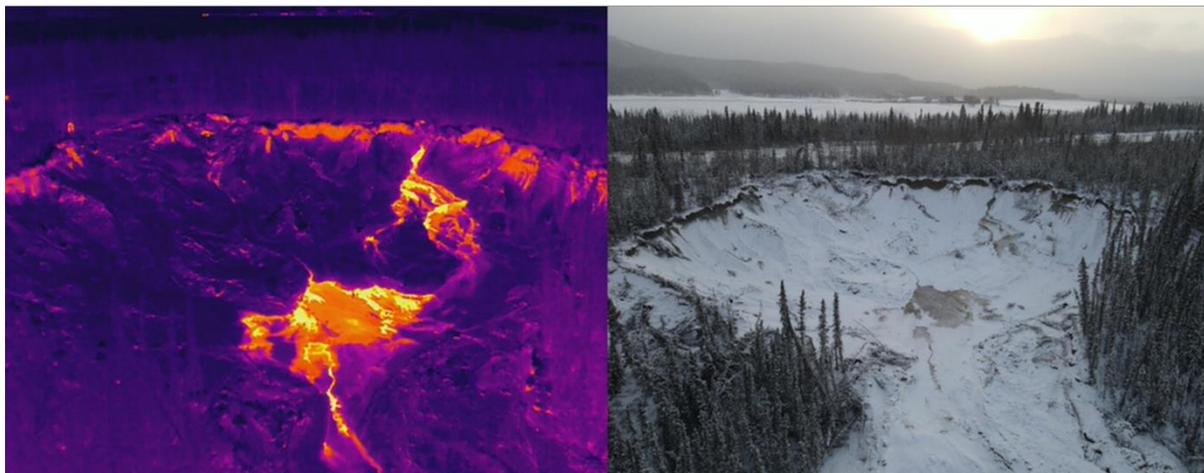
Figure 112 Oblique air photo of the Takhini RTS using Thermal (left) and RGB imagery (right) at the. In the thermal image, the red-yellow hues represent groundwater flowing.

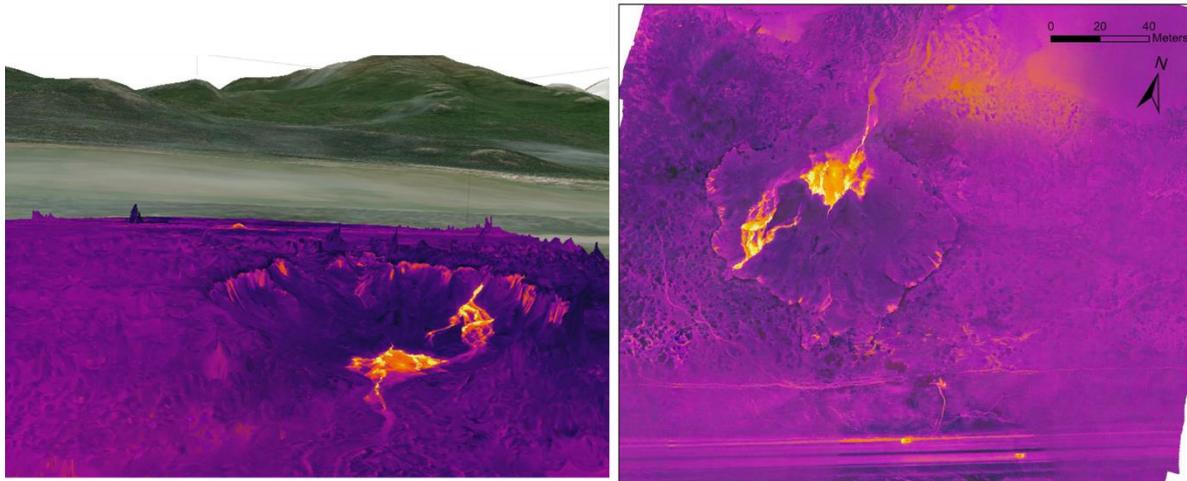
Figure 113 Thermal imagery from Takhini RTS form November 24th, 2021. Left - imagery warped over a digital elevation model; right - vertical ortho-mosaic photo from UAV thermal imagery.

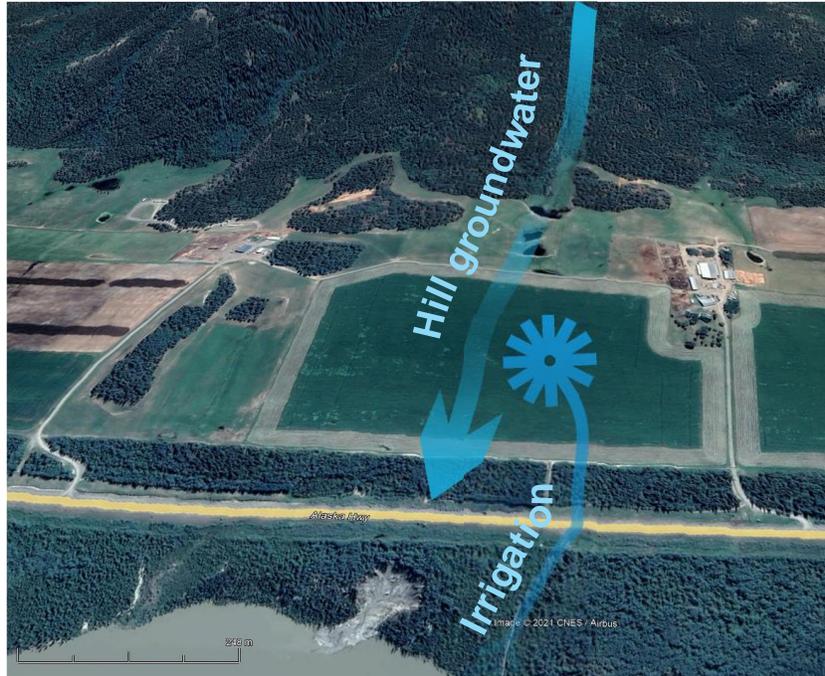
Figure 114 Groundwater sources, from hills and irrigation (vertical exaggeration: 3)

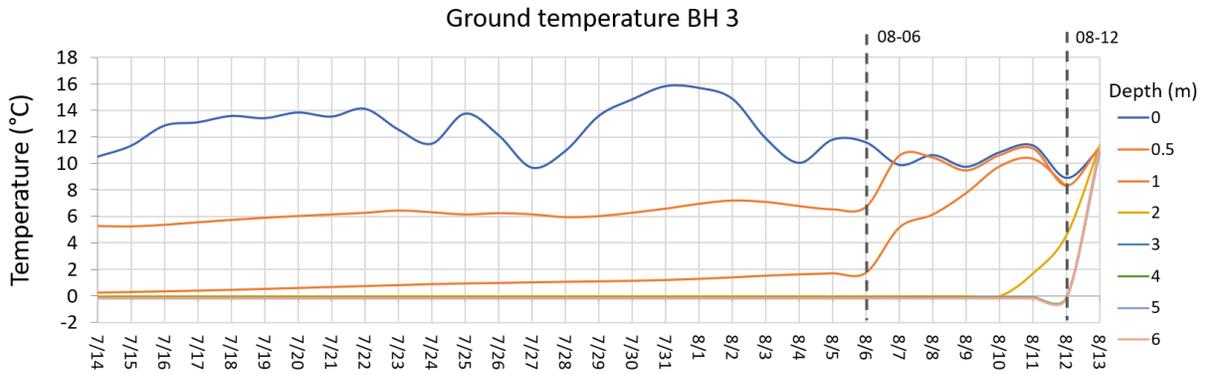
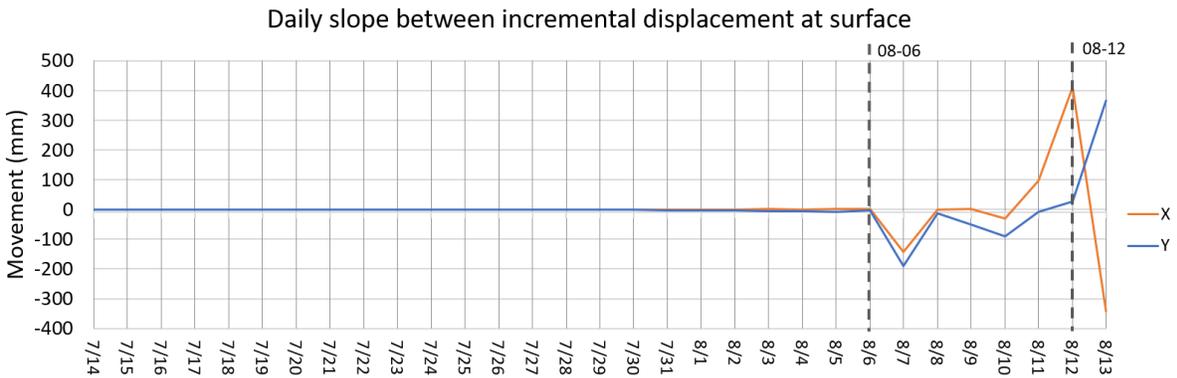
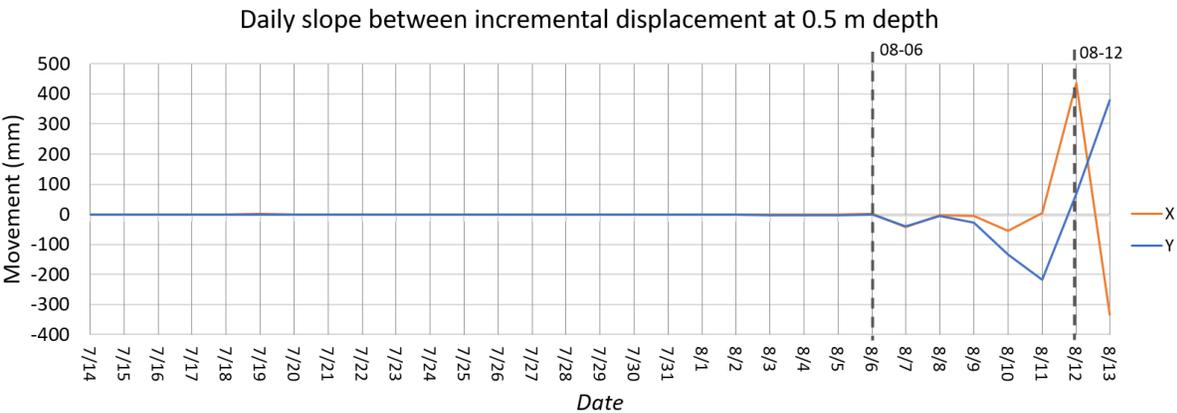
Figure 115 Comparison between ground temperature and displacement recorded by the inclinometer in BH3 at 0m and 0.5 m.

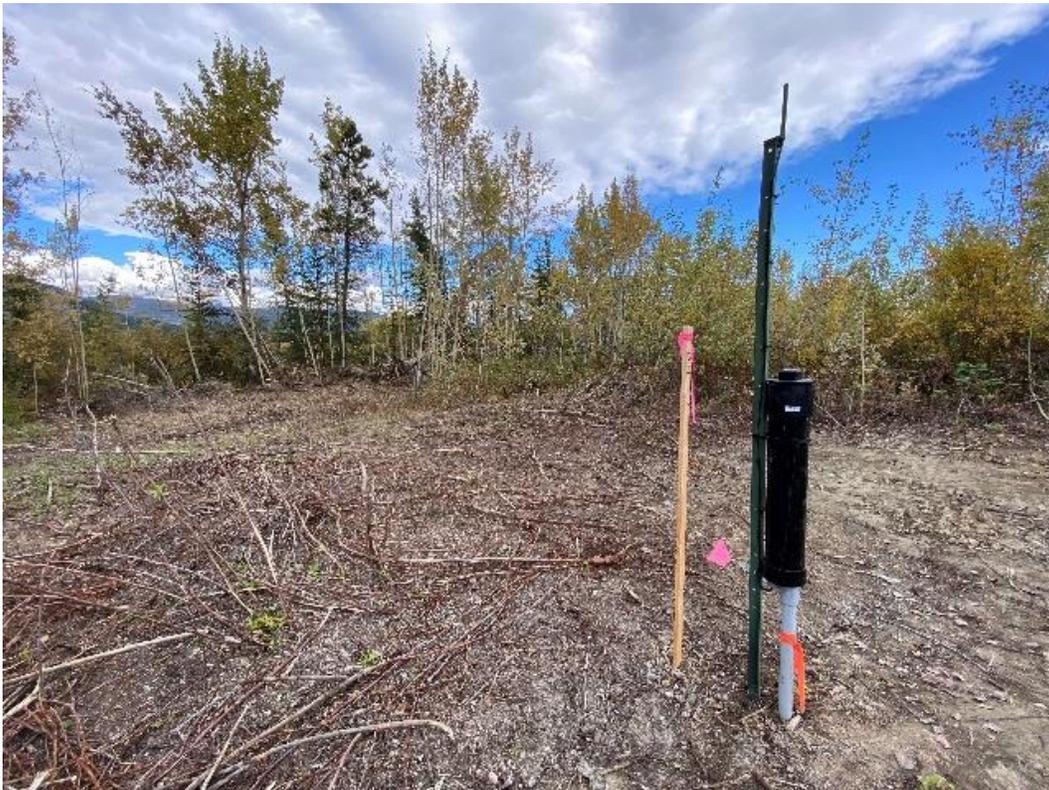
Figure 116 LogR Systems ULOGC32 LoRa+ logger inside ABS casing at Borehole A. The antenna connected to the logger allows communication with the Gateway using long range spectrum modulation.

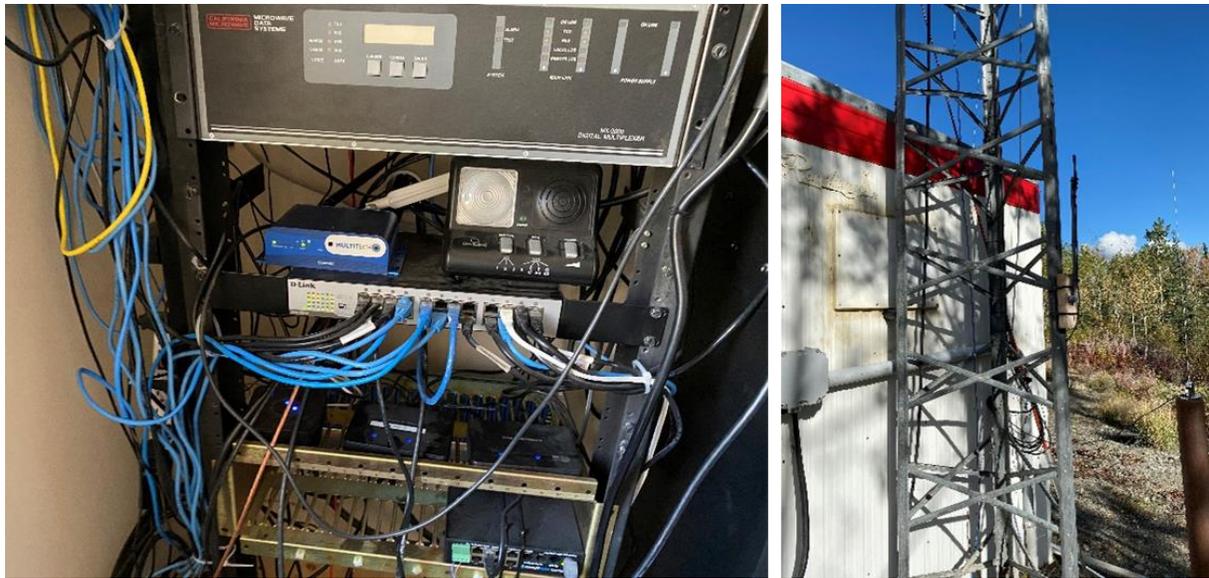
Figure 118. Multitech gateway installation. Left - Gateway (blue box) connected to the internet at local farm. Right - Gateway antenna communicating with LogR Systems ULOGC32 LoRa+ logger located 1060 m away.

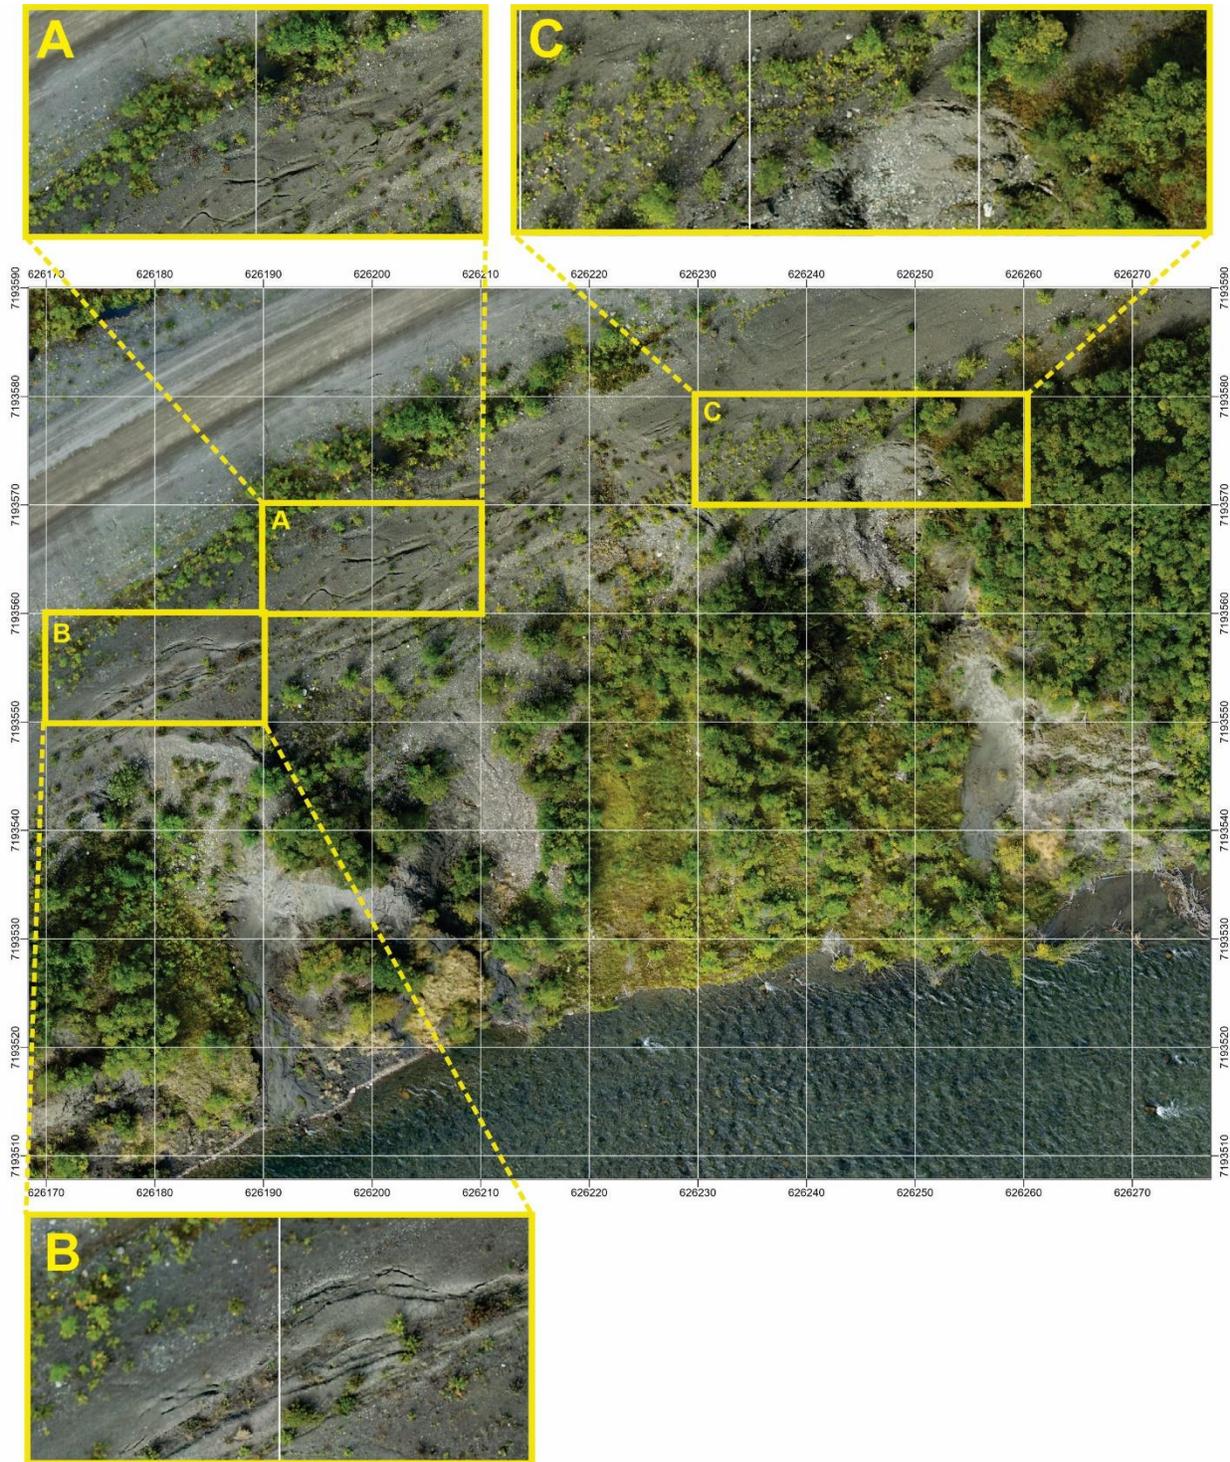
Figure 124 2006 RTS at km 116 of the Dempster Highway in August 2021; A, B and C show pre-failure tension cracks.

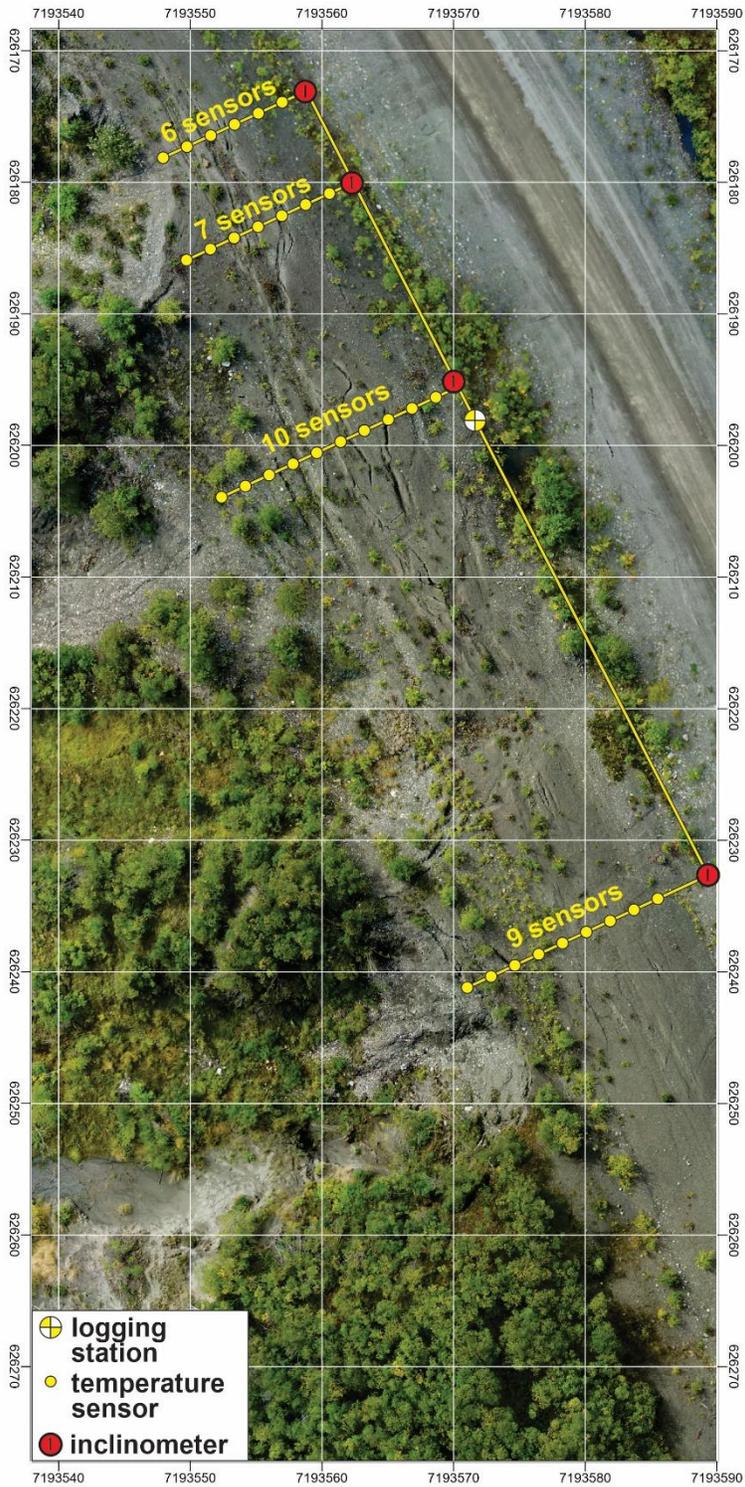
Figure 125 Proposed monitoring array at the 2006 RTS at km 116 of the Dempster Highway.

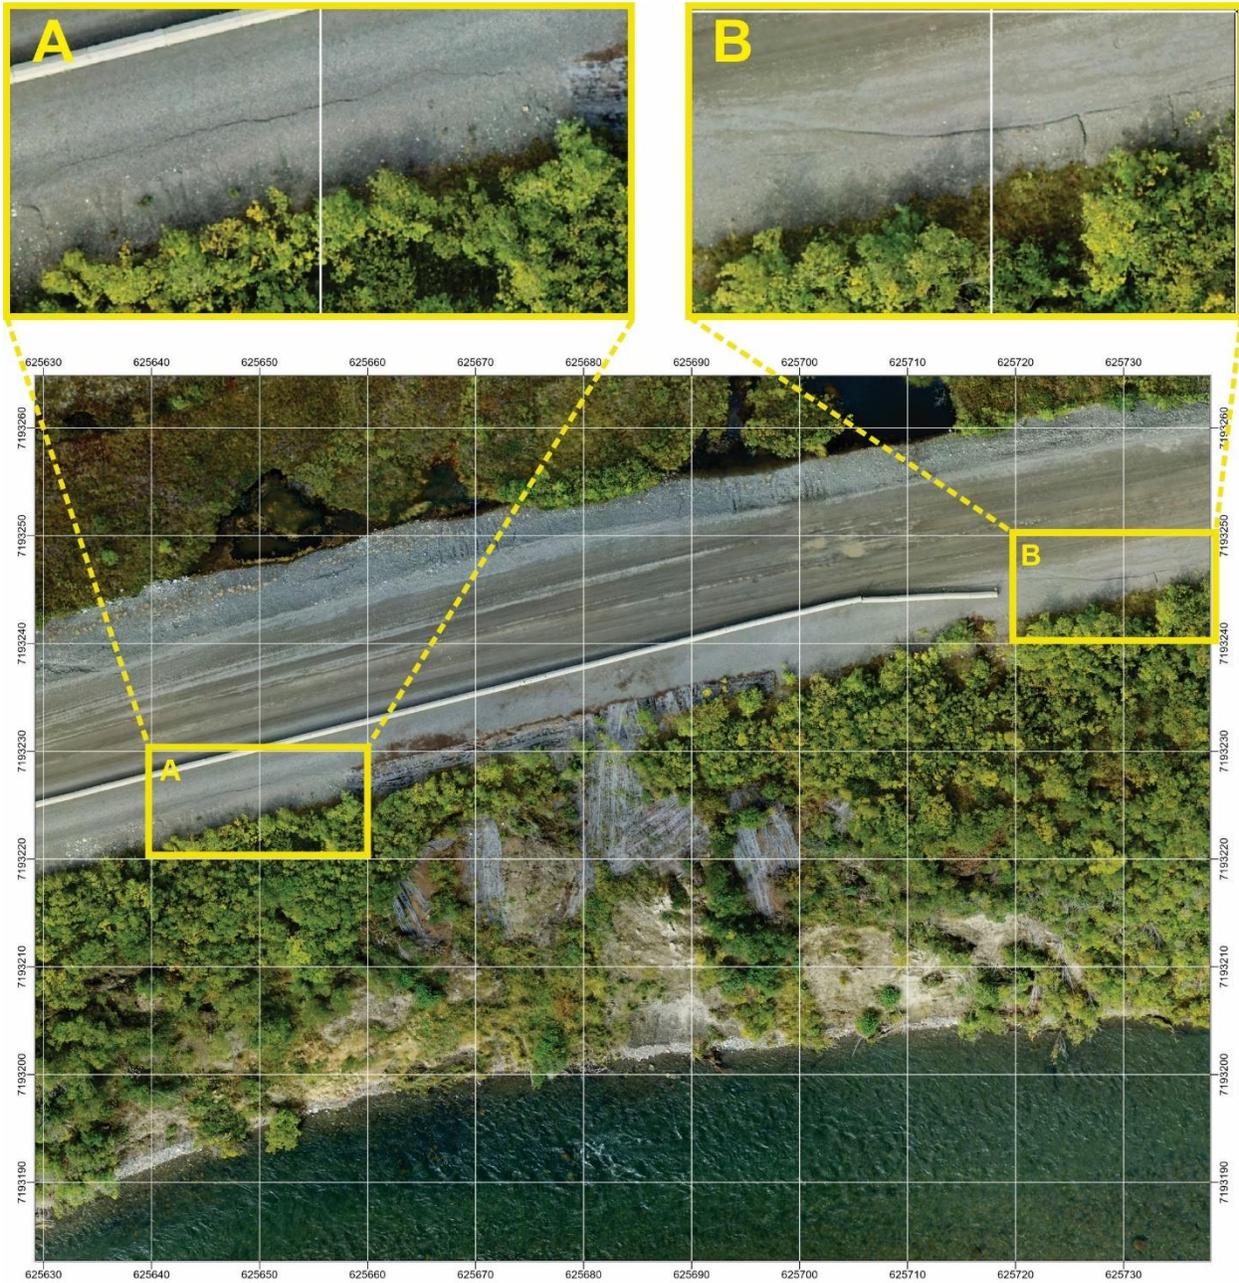
Figure 126 2017 RTS at km 116 of the Dempster Highway in August 2021; A and B show pre-failure tension cracks.

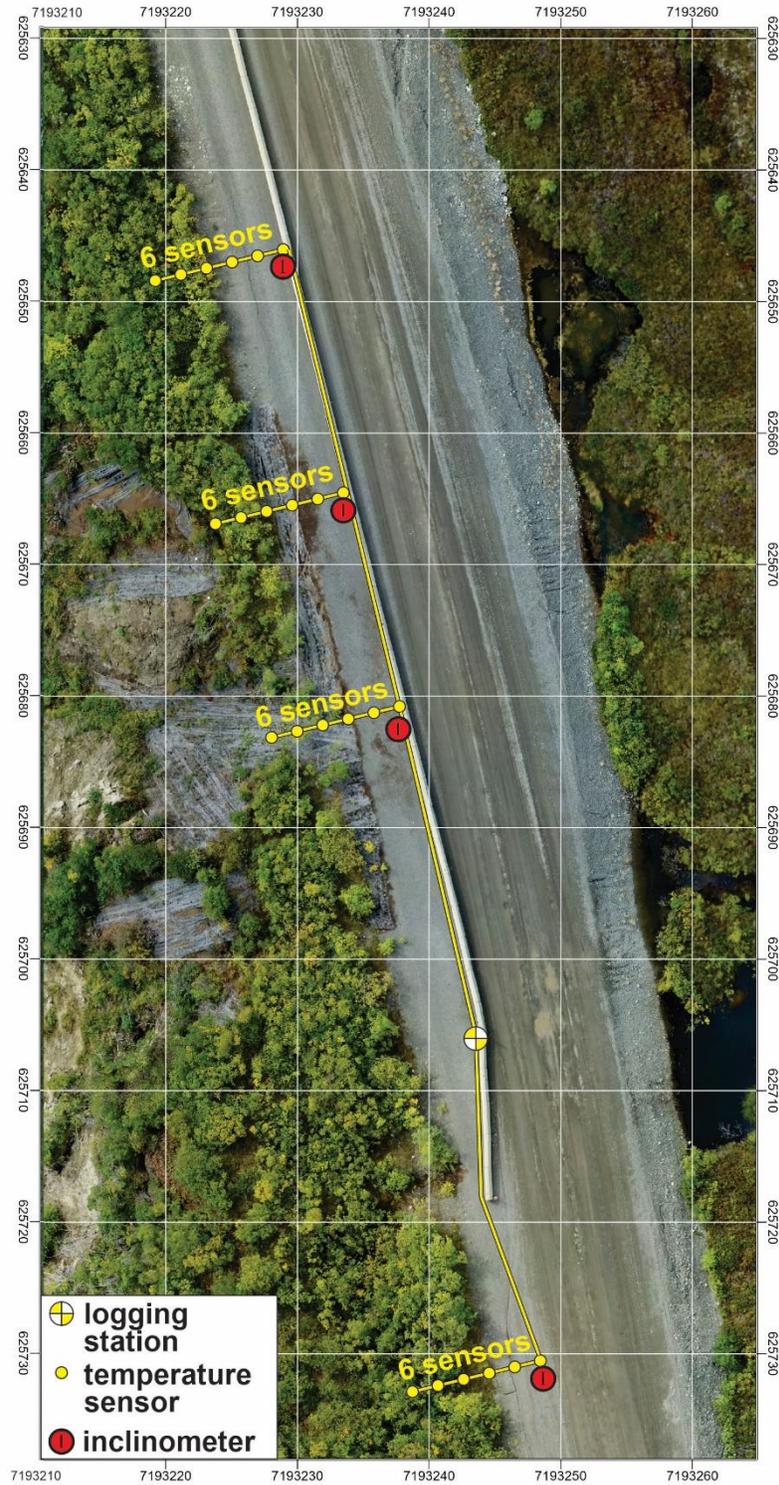
Figure 127 Proposed monitoring system at the 2017 RTS at km 116 of the Dempster Highway.
