Investigation of Dempster Highway Sinkholes km 82 and Two Moose Lake

Northern Climate ExChange
YUKON RESEARCH CENTRE • Yukon College

Investigation of Dempster Highway Sinkholes

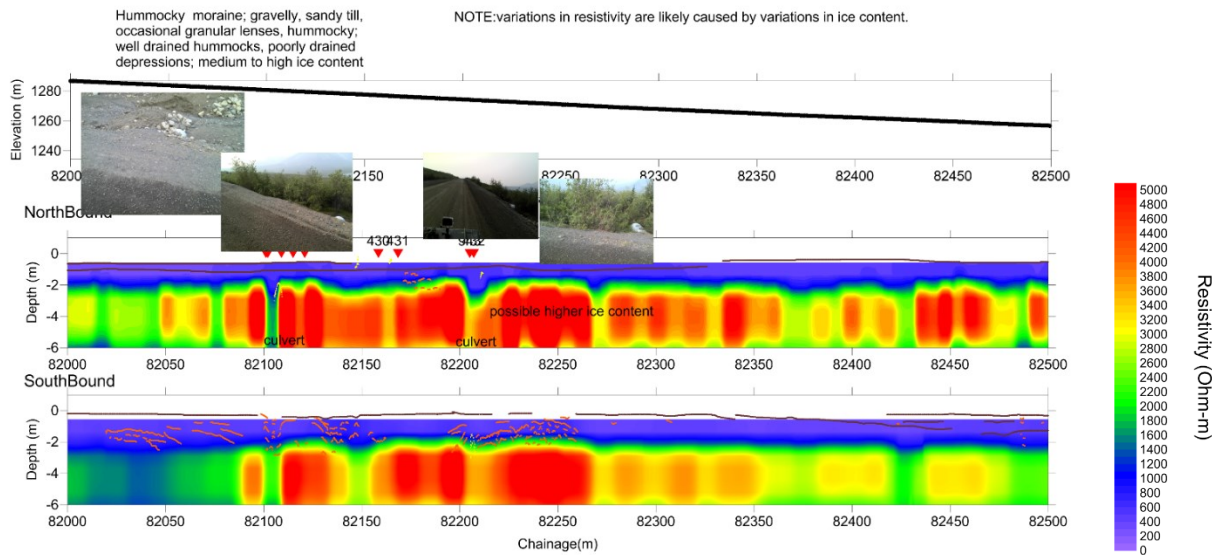
Figure 4.2. DC resistivity and GPR profiles at KM82 (from DTM Geosciences Ltd., 2015)

Figures showing the processed and inverted data for each kilometer of highway surveyed were provided. Km 82 was interpreted as an area with pockets of possible high ice content 10-30m wide and occasional areas of possible high ice 100-300m wide (Figure 4.2). It needs to be acknowledged that using OhmMapper data, there are limits to the resolution of the geophysical methods employed. The resolution that can be achieved depends on thickness, depth of burial and contrast of the various layers and bodies relative to the parameters such as spread length and receiver spacing used in the geophysical surveys.

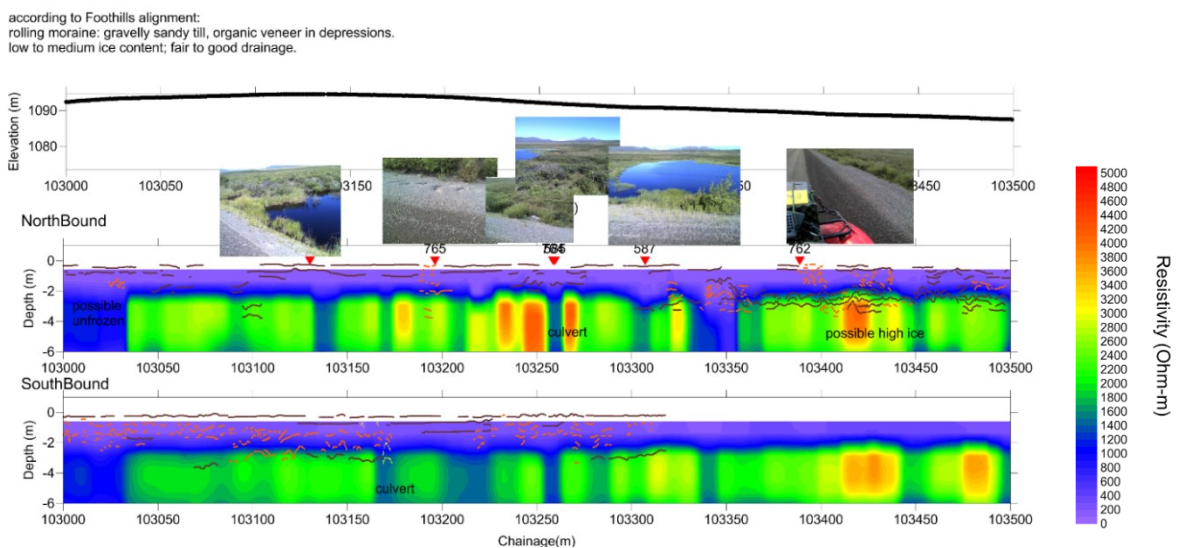
Figure 4.3. DC resistivity and GPR profiles at KM103 (from DTM Geosciences Ltd., 2015)

Km 102-103 was interpreted as an area with lower resistivity with a few small possible high ice areas and several possible unfrozen areas (Figure 4.3). It was noted that due to the lack of borehole data, it might be necessary to revisit the interpretation once more drill control is obtained and calibrate the assumptions better to local conditions. The MASW interpretation would benefit from the input of geotechnical information.

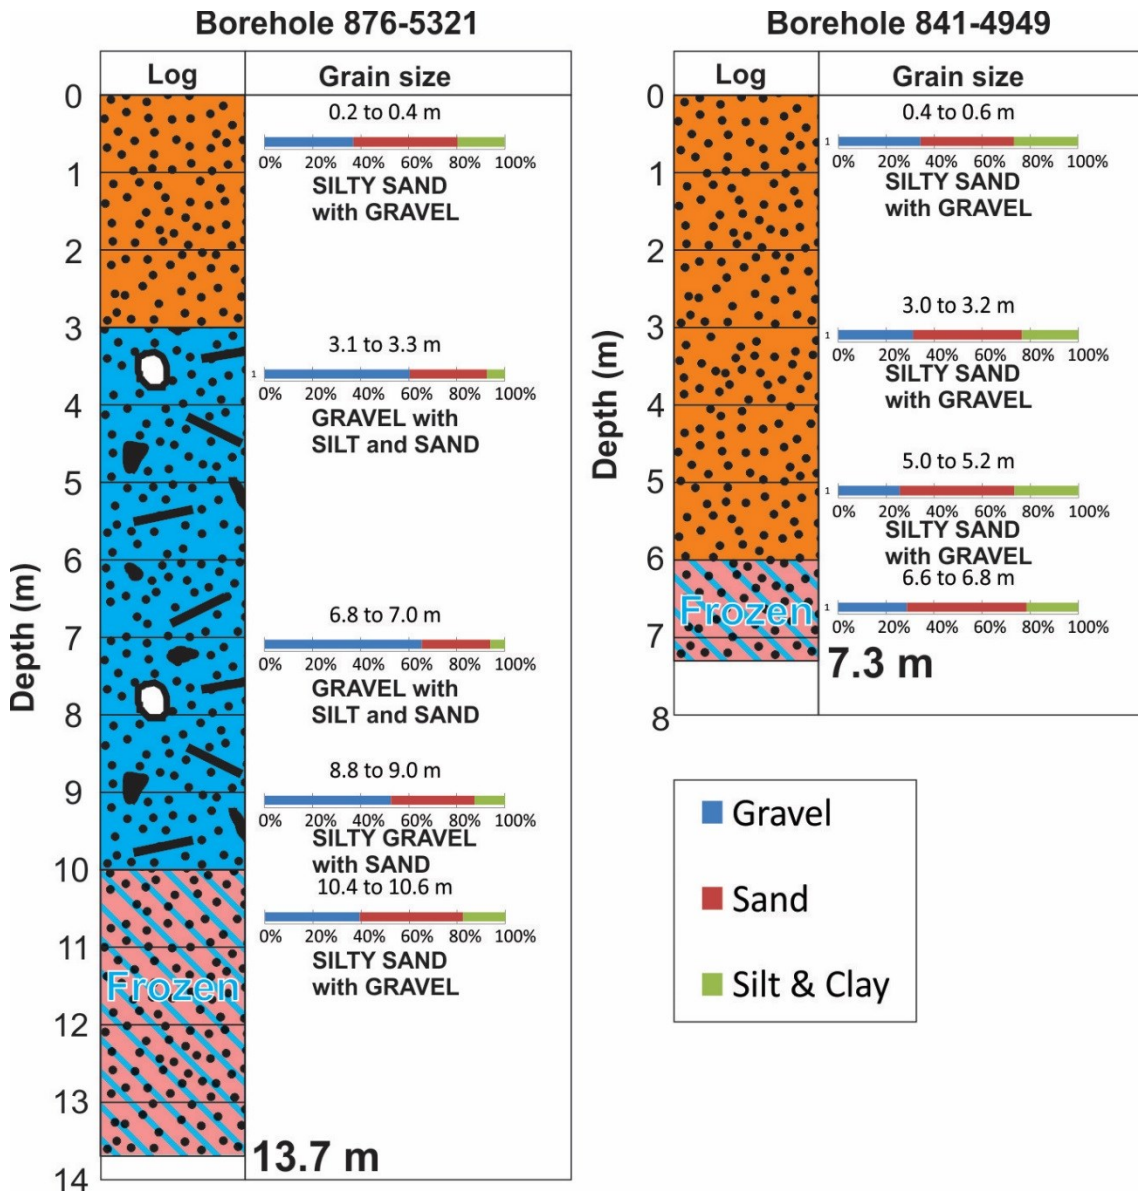
Figure 5.3. Logs for boreholes 841-4949 and 876-5321 with grain size distribution

of the soil in 841-4949 consisted of silty sand with gravel, the grain size distribution being constant along the profile. In 876-5321 the soil was also silty sand with gravel near the surface but evolved into a gravel with silt and sand with depth, with a maximal gravel content of 65.3% at about 7 m, and then progressively revert to silty gravel with sand at about 9 m and a silty sand with gravel at about 10.5 m (Figure 5.3).

The two boreholes are about 35 m apart – close enough that similar stratigraphy would be expected for the two. However, borehole 876-5321 shows an impoverishment in fine sediment from about 3 to 10 m, while the ratio remains constant in 841-4949 all along the profile. In the absence of other obvious causes, this suggests that fine sediment have been leached out at 876-5321, the location where sinkholes have occurred, but not in 841-4949. Another interesting fact is that no ground ice was sampled in either borehole, even in still frozen material.

The localized decrease of fine material content observed in the borehole log 876-5321 versus stable fine content in borehole log 841-4949 suggest leaching of sediments by ground water.

No ground ice was sampled or reported in either borehole; this suggests that ground ice melt is not the cause of the observed subsidence and subsequent sinkhole formation.

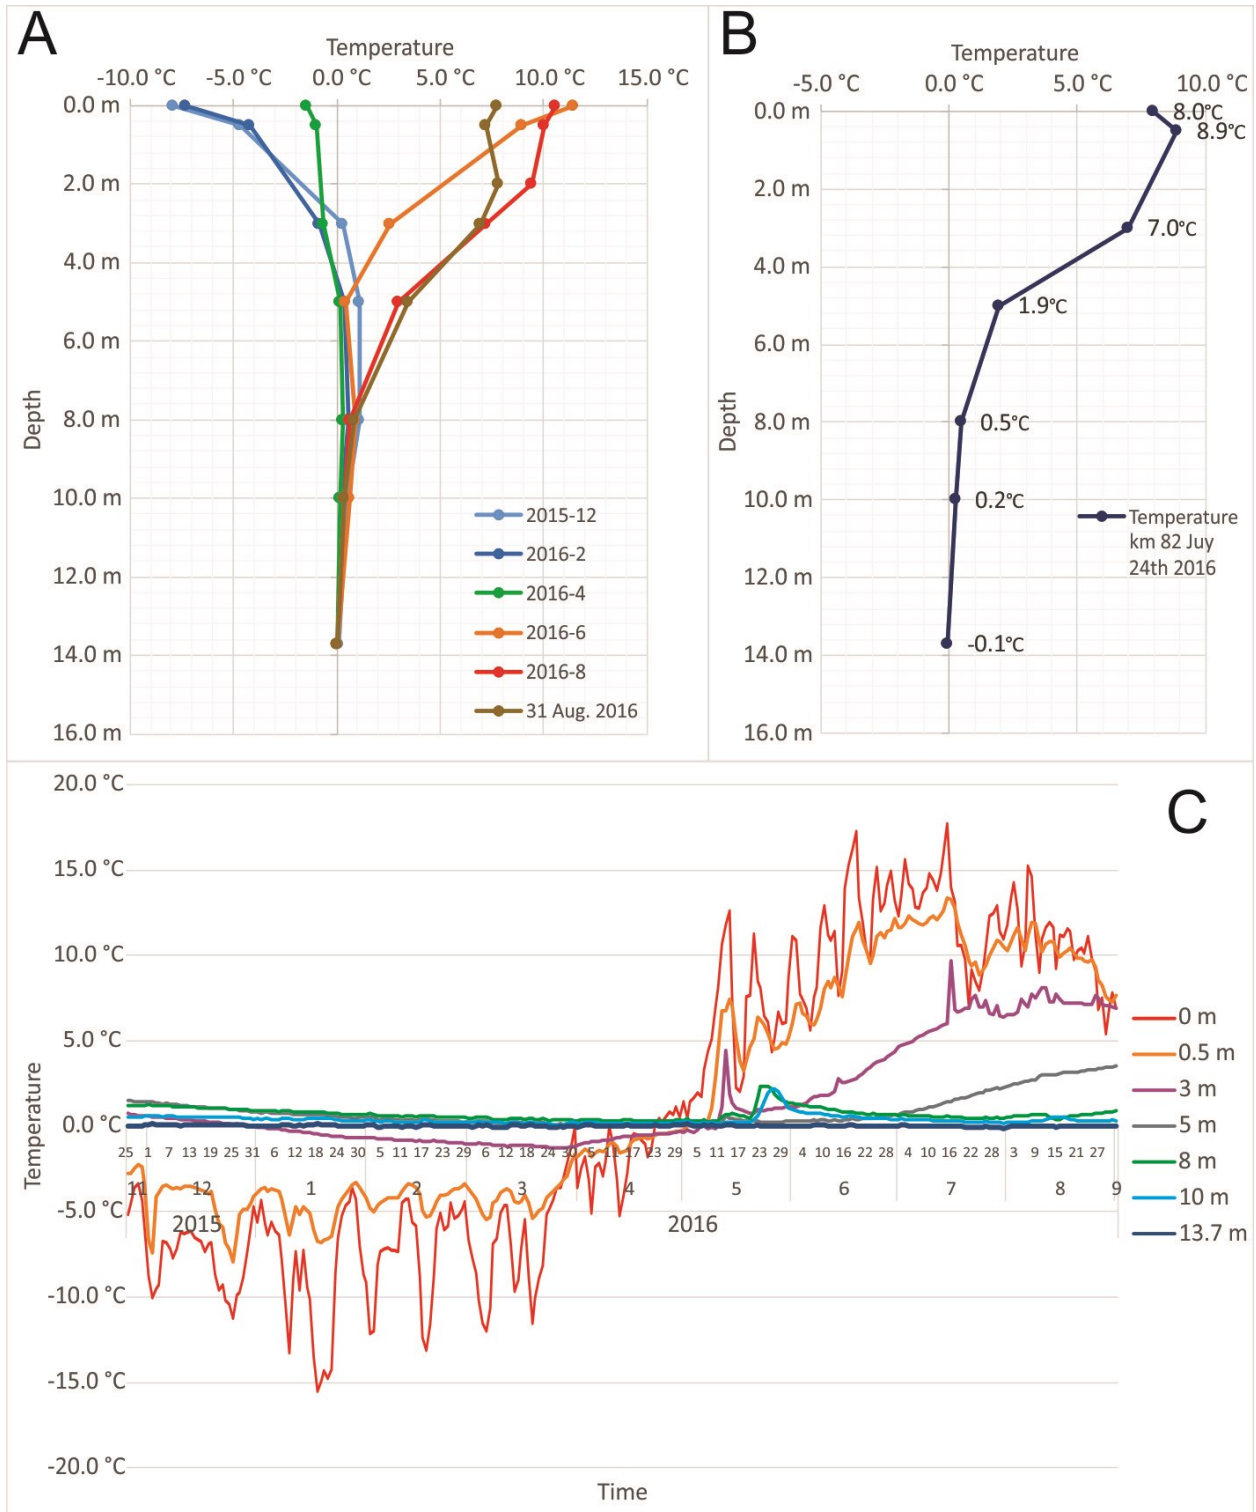
Figure 5.4. Ground temperature at km 82. A- Monthly mean temperature profiles; B- temperature profile at time of ERT survey 3; C- ground temperature curves at 0, 0.5, 3, 5, 8, 10, and 13.7 m.

Higher frequency variation of temperature observed in the curves for shallower depths (Figure 5.4C) can be attributed to air temperature variations and the infiltration of ground water originating from freshet and precipitation. Unfortunately, there are not sufficient climate data available to allow comparison between ground temperature and precipitation records. Figure 5.5 presents ground temperature recorded at km 82 at 0 and 0.5 m with precipitation in Dawson City for June, July, and August 2016. A relationship appears to exist between temperature and precipitation peaks, with a delay of the precipitation of one to three days. This apparent relationship implies that: 1- precipitation has a major warming effect on the temperature profile at the site; and 2- the high reactivity of the temperature profile suggests high permeability as underground water seems to flow relatively quickly.

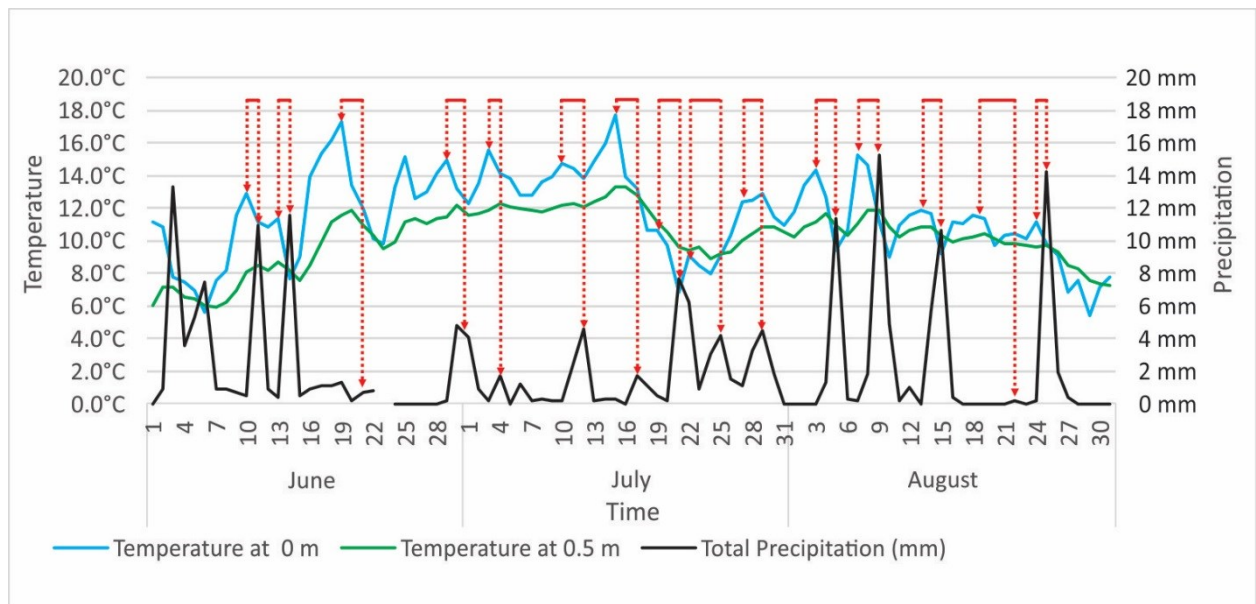
Figure 5.5. Ground temperature recorded at km 82 at 0 and 0.5 m and precipitation in Dawson City for June, July, and August 2016.

In summary, the investigation of borehole logs, ground temperature and climate records indicate that ground water movement in the active layer is warming ground temperature and may be inducing permafrost thaw. It may also be responsible for leaching of fine sediment.

Ground temperature profiles suggest a thermal effect of subsurface water movement on ground temperature. Comparison with precipitation records from Dawson City Airport, 80 km away, suggests that the infiltration can be fast and that there might be a flow sufficient to either thermally erode permafrost and/or leach out fine sediment particles.
