Vulnerability of the north Alaska Highway to permafrost thaw

Design options and climate change adaptation

Northern Climate Exchange
YUKON RESEARCH CENTRE • Yukon College

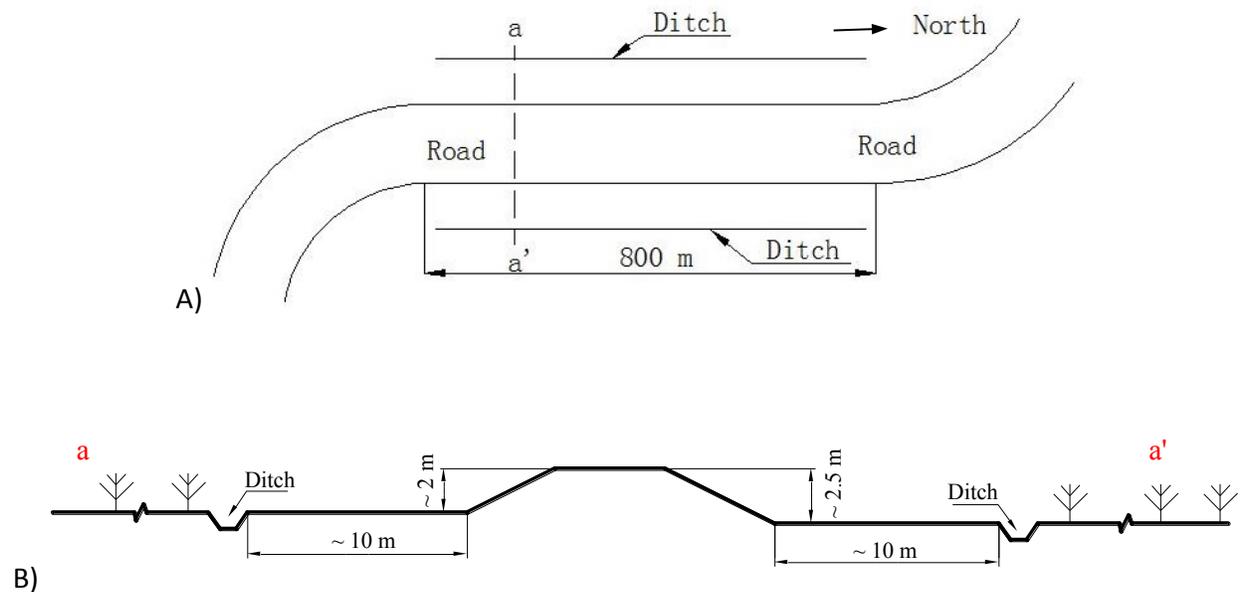
Figure 4.4.9. Schematic illustration of the field site A) Localisation of proposed embankment cross section in transverse profile; and B) a-a' embankment cross section km 1896.3

Two interceptor ditches have been dug about 10 m away from toe of the embankment on each side. Ditches only extend along the straight section of this road (Figure 4.4.10). The width and the height of both ditches are about 4 m and 1.5 m, respectively. Water was flowing in both ditches at the time of a site visit on October 15, 2015. The general topography of the terrain is relatively flat but the site crosses a valley between two hills. The general direction of the drainage crosses the road from left to right.

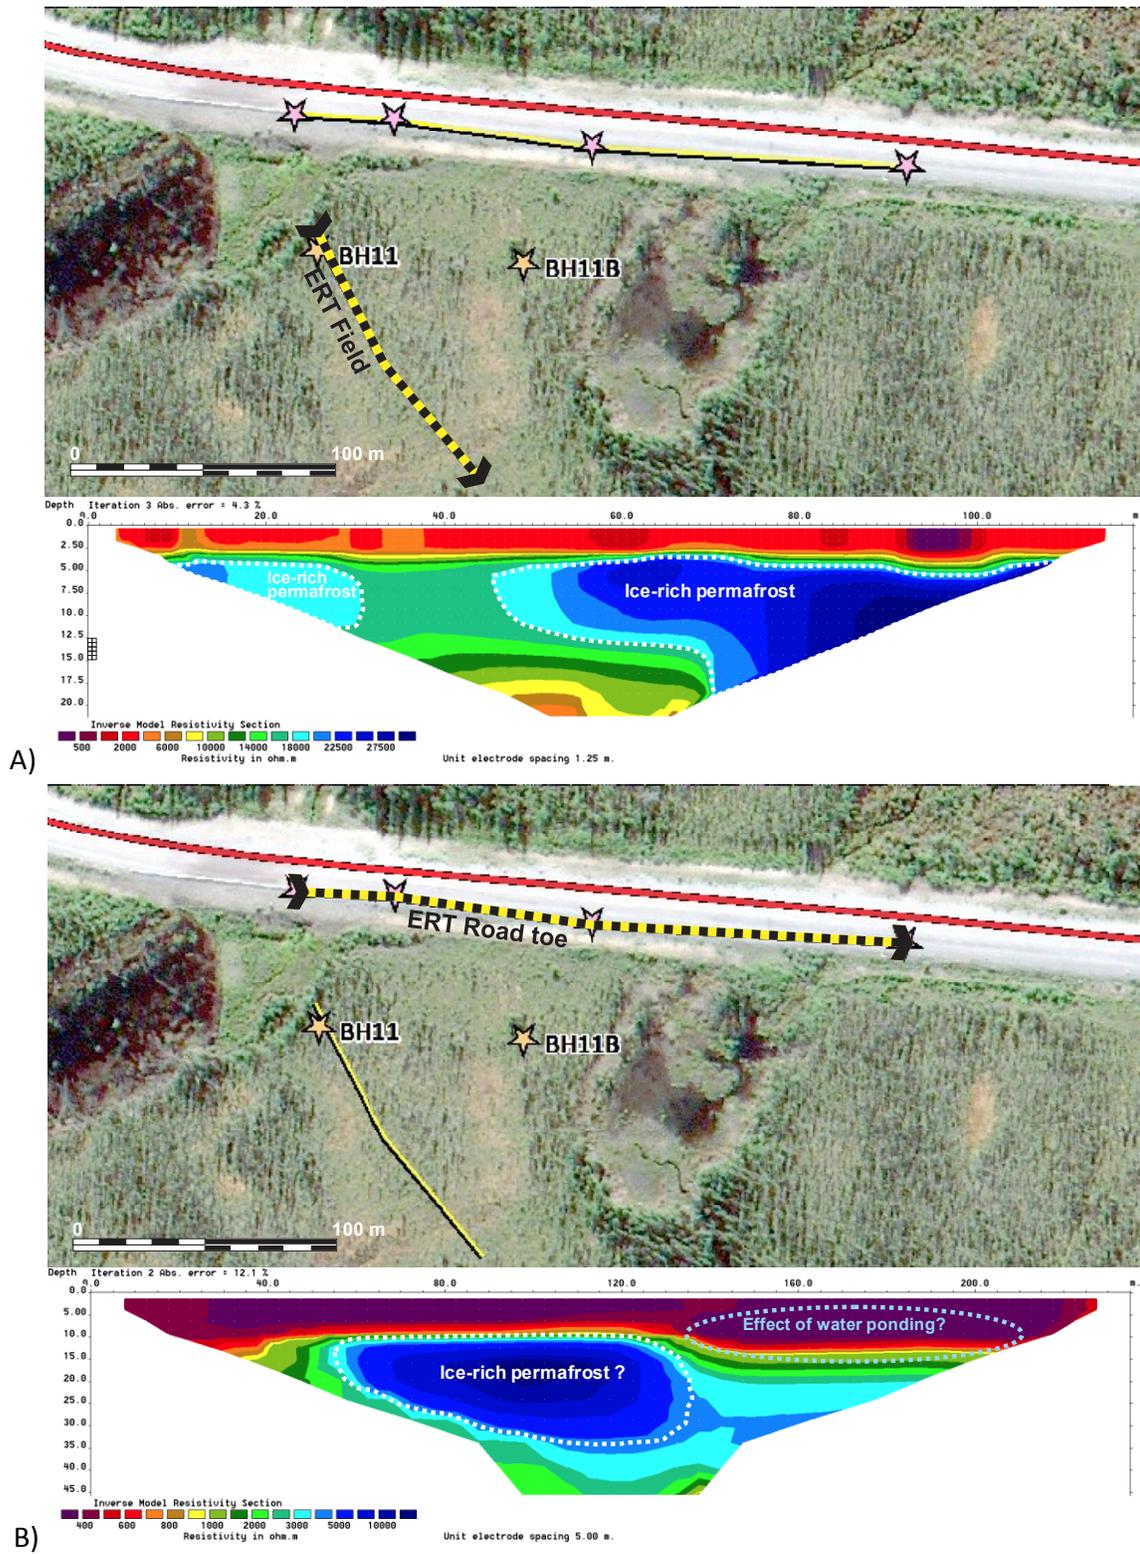
Figure 4.5.6. ERT Surveys performed at site of BH11 for A) the field; and B) the toe of the highway embankment.

Two ERT surveys were performed at the site; one in the field, starting from the frost mound at BH11a and ending in the open field, and one along the embankment. Both surveys are shown in Figure 4.5.6. The survey performed in the field shows areas of high resistivity approximately between 2.5 m and 11-13 m depth. Based on borehole observations, these highly resistive values likely represent ice-rich, relatively fine-grained material. While no wedge ice was clearly reported, observations in the area suggest the possibility of ice wedge complexes between about 5 and 15 m depth. The survey made along the embankment is inconclusive, showing highly resistive material below 10 m, which contradicts borehole observation. Yet it suggests a thermal effect of ponding water on the northern side of the survey.

An ERT survey conducted in the field suggest that ice-rich permafrost may extend as deep as 15 m, and possibly deeper. The local context and aerial imagery suggest the presence of ice wedge complexes.

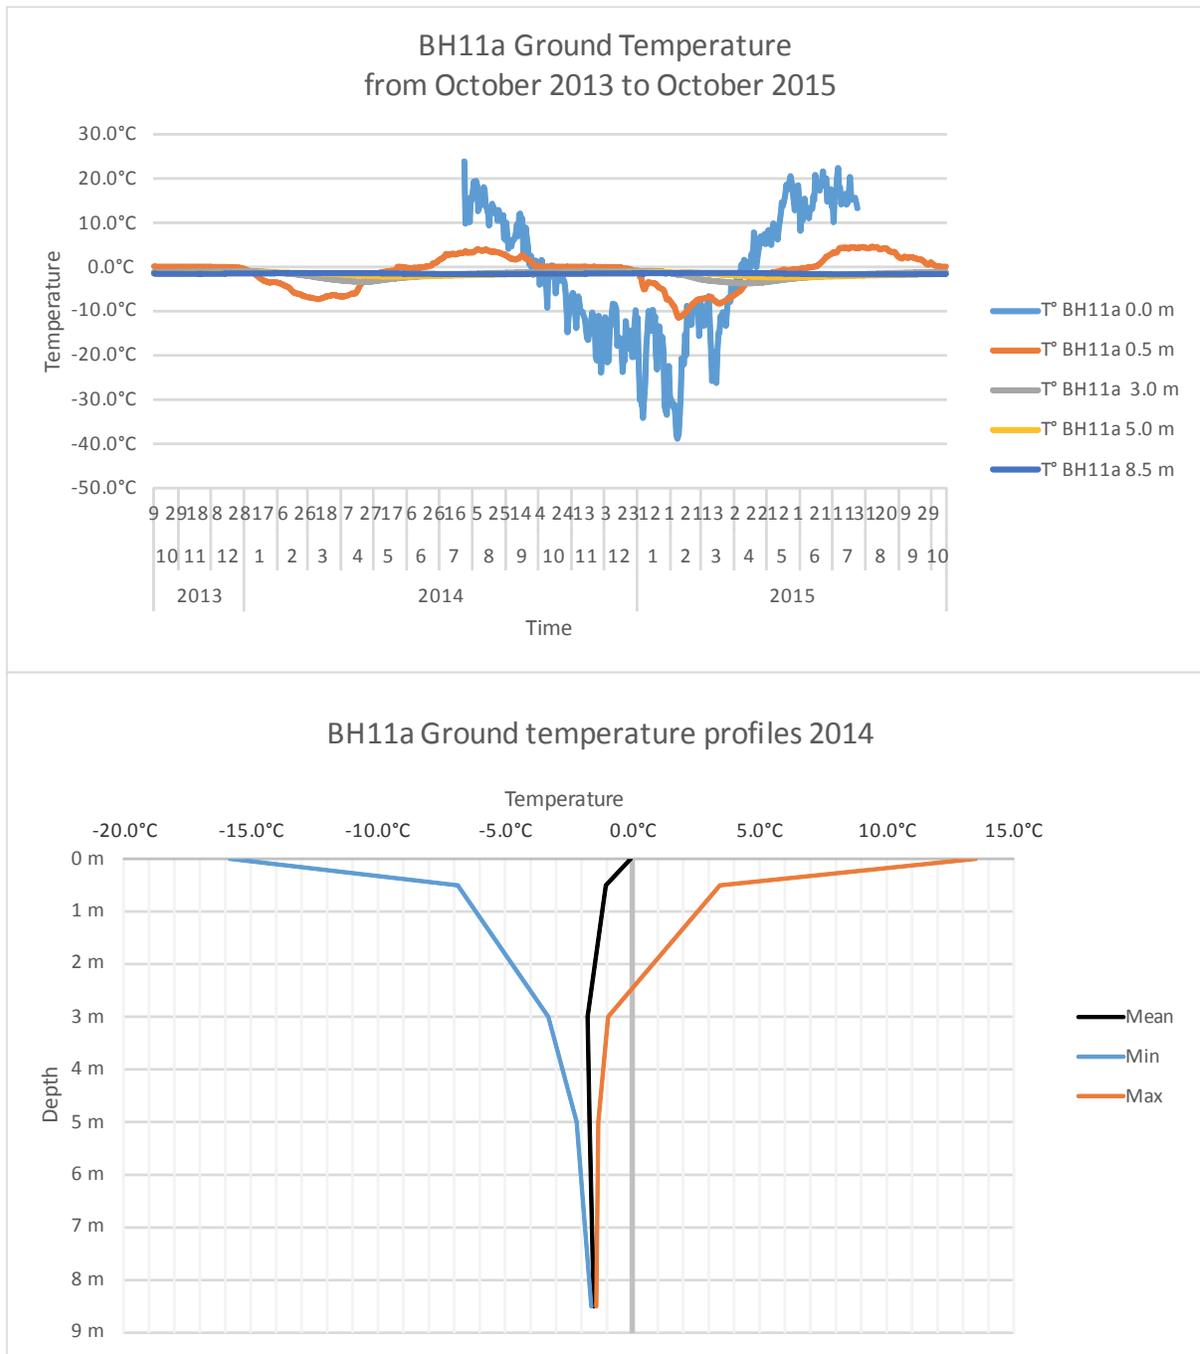
Figure 4.5.7. Ground temperature recorded in BH11a from October 2013 to October 2015.

Ground temperatures were recorded at borehole BH11a and BH11b that were drilled to a depth of 8.5 and 10.4 m, respectively, with a water jet drill. BH11a was instrumented with one 4-channel logger in October 2013 and BH11b was instrumented with two 4-channel loggers in May 2015 to allow ground temperature measurement at 4 and 8 different depths, respectively. The mean monthly ground temperature for the recording periods are presented in Table 4.5.1 A and 4.5.1 B, while ground temperature curves and profiles are shown in Figures 4.5.7 and 4.5.8 for each borehole. Permafrost appears to be relatively resilient with temperatures of -1.4°C and -1.5°C at depths of 8.5 and 10.4 m for BH11a and BH11b, respectively. Using the temperature profile in October 2015 from BH11b, the base of the permafrost can be tentatively extrapolated to a depth of about 46 m based on the thermal gradient of $+0.1^{\circ}\text{C}$ per 2.4 m, between 8 and 10.4 m. An extrapolation made on 2014 mean annual ground temperature curve from 3 to 8.5 m lead to a permafrost base located at 42.5 m (Figure 4.5.9).

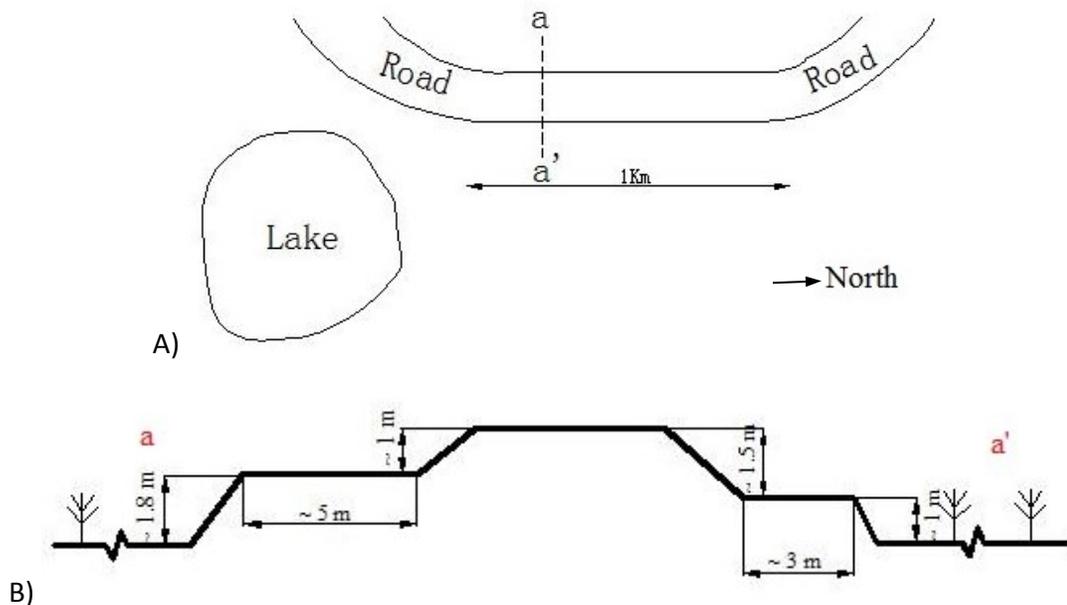
Figure 4.5.10. Schematic illustration of the Mirror Creek adaptation site A) Localisation of proposed embankment cross section in transverse profile; and B) a-a' embankment cross section, km 1886.1

As shown in Figure 4.5.10, the embankment height varies approximately between 2.5 m at right hand side and 2.8 m at the left hand side. There are no ditches on either side of the road. A large culvert, replaced in 2014, passes under the road. The area is very wet; a large thermokarst lake is present at the east end curve of the section, close to the right hand side (when facing north). Another smaller pond (not shown in the figure) is present at km 1886.2, also on the right hand side.

Many of the criteria to apply mitigation techniques that are described at the beginning of Section 3 apply to Site 5. Permafrost has a temperature below -1°C, the excess ice content exceeds 40%, and the base of permafrost is located deeper than 20 m. Also, the section is on tangent, without horizontal and vertical curves. However, the presence of significant lateral water flows and the presence of substantial water bodies near the site may eliminate the effect of thermal stabilisation techniques. As a result, this site is not recommended for the application of a thermal stabilisation technique.

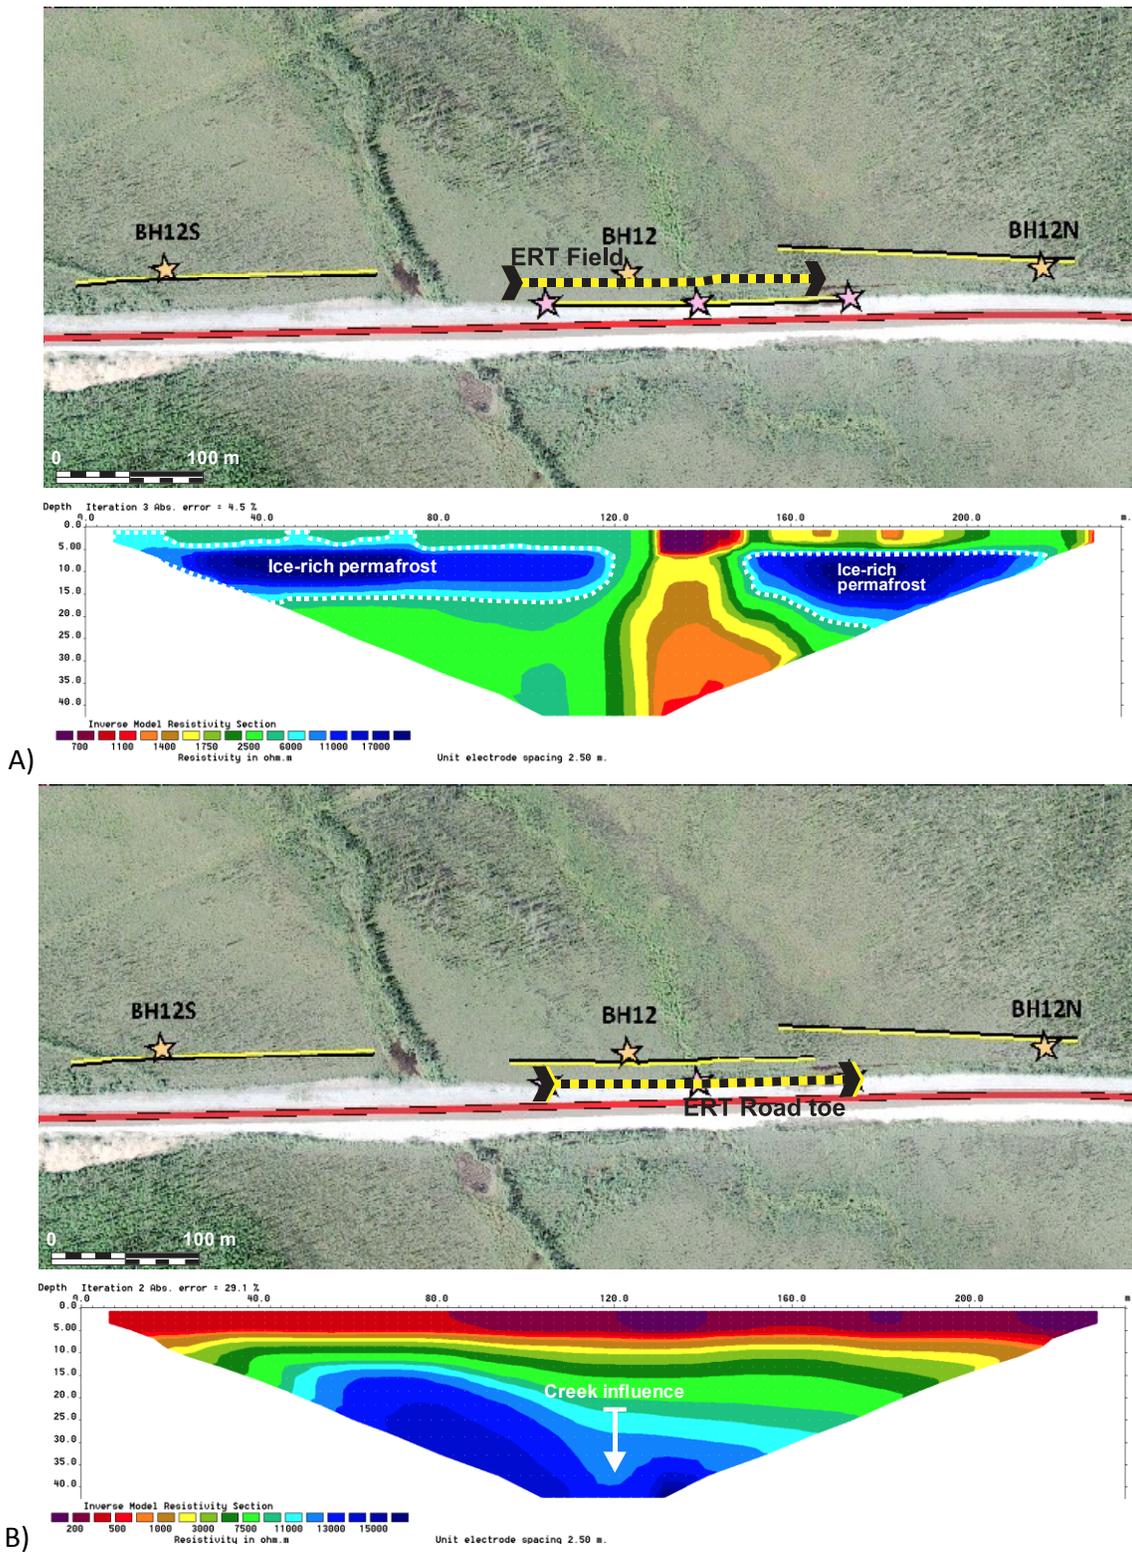
Figure 4.6.7. ERT Surveys performed at borehole BH12 for A) the field; and B) the toe of the highway embankment.

ERT surveys suggest that permafrost can be ice-rich down to 20 m. This would be due to the presence of syngenetic ice wedge complexes. The recorded ground temperature oscillates between -3.0 and -3.6°C at the depth of 9.5 m.

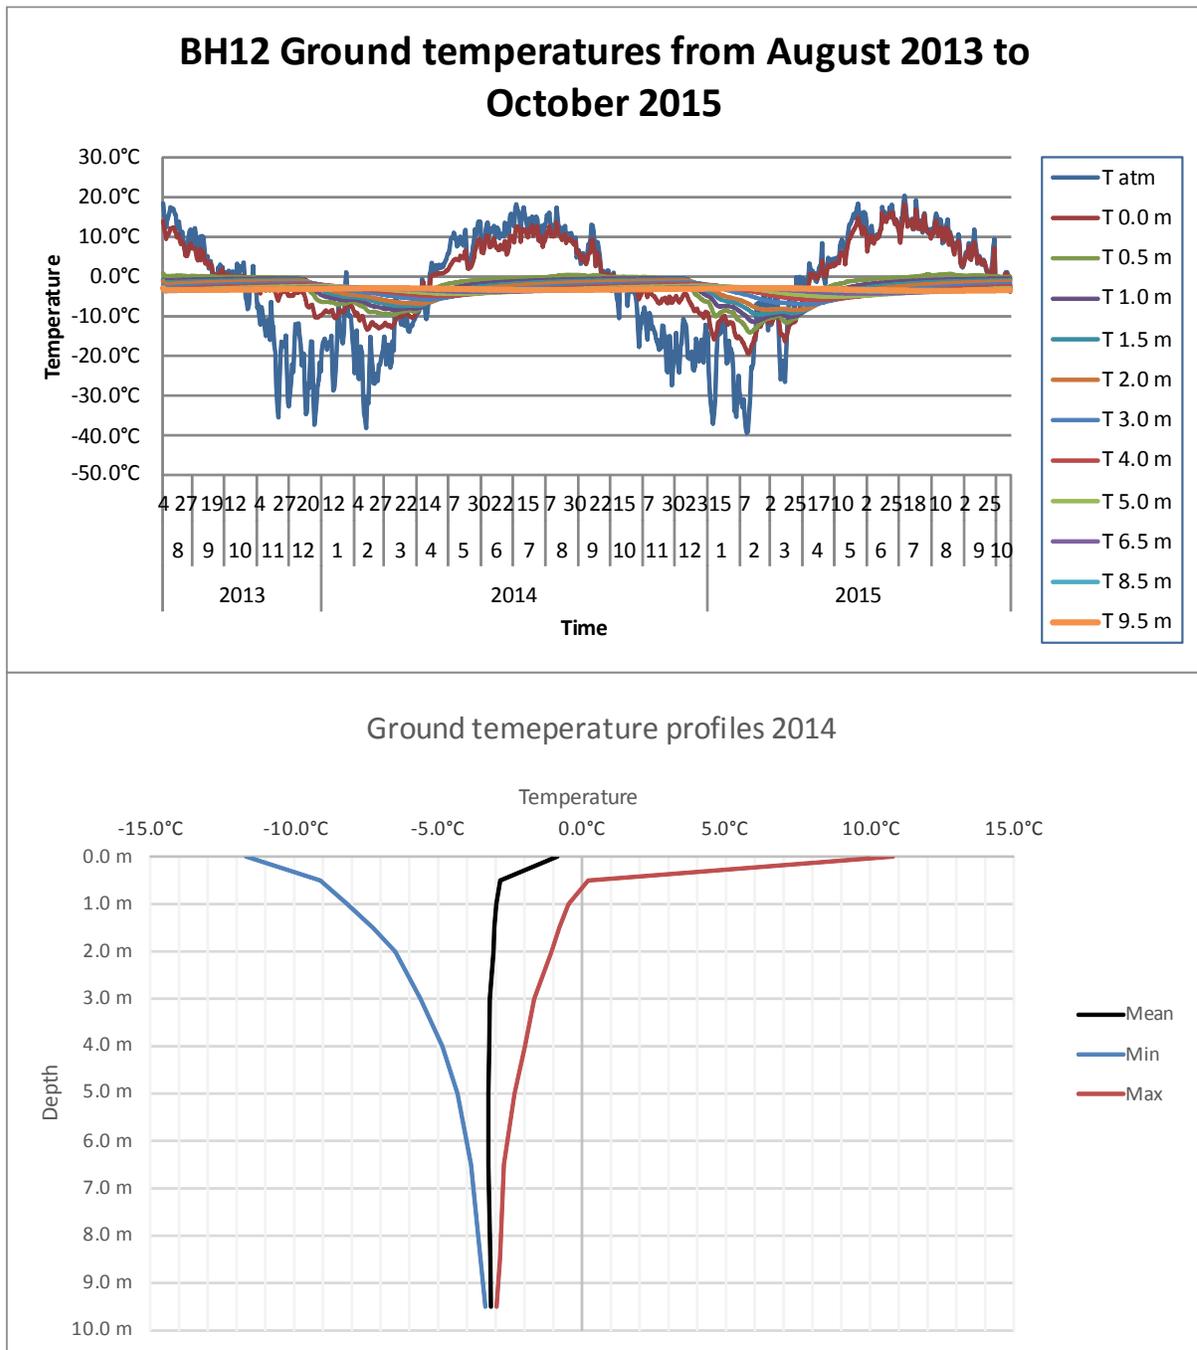
Figure 4.6.8. Ground temperature recorded in borehole BH12 from August 2013 to October 2015.

Temperature has been monitored since August 2013. The mean monthly ground temperatures for the recording period are presented in Table 4.6.1, while ground temperature curves and profiles are shown in Figure 4.6.8. Permafrost appears to be cold; oscillating between -3.0 and -3.6°C at the depth of 9.5 m.

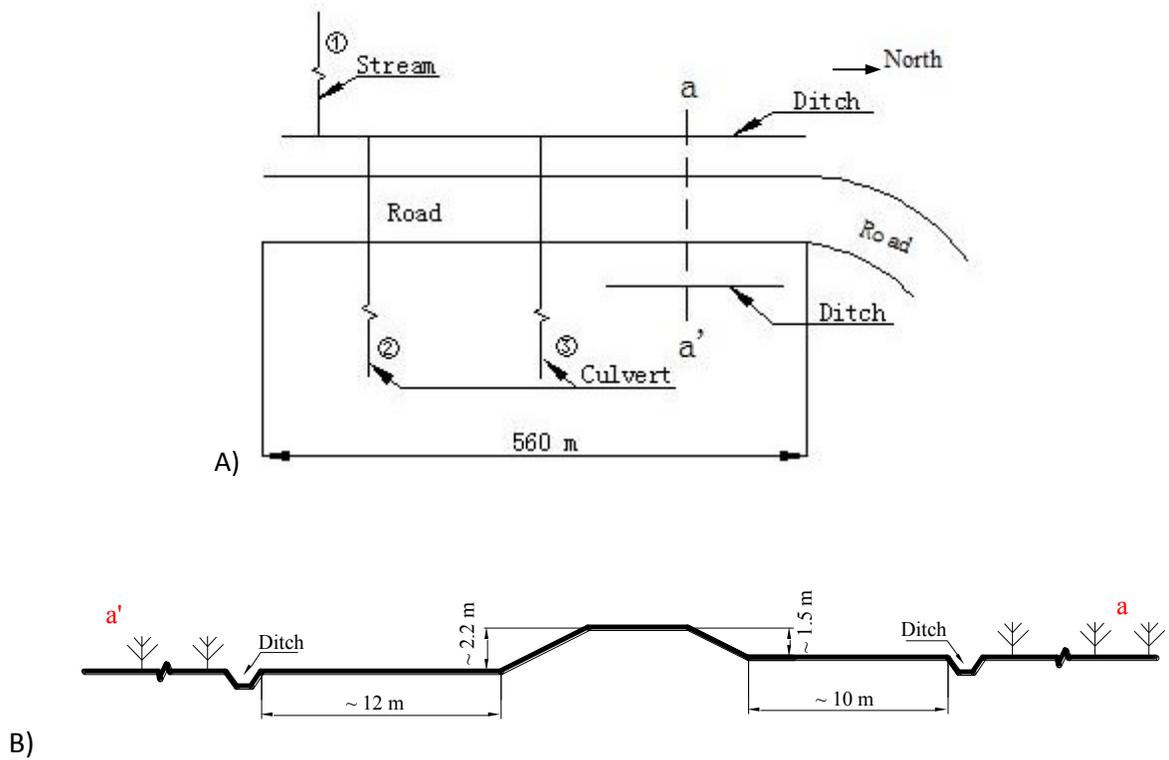
Figure 4.6.9. Schematic illustration of the North of Beaver Creek adaptation site for A) Localisation of proposed embankment cross section in transverse profile; and B) a-a' embankment cross section, km 1894.8

Some notable features of this site are two ditches that were dug in 2013, parallel to the road. The distance between the toe of the embankment and the ditches, are about 12 m at the left hand side, and 10 m at the right hand side. They are 4 m wide and 1.5 m deep, the shortest one being at the right hand side (Figure 4.6.9). A camera has been fixed near the long ditch to monitor the development of the ditch slump. The result shows that this ditch is strongly affected by thermal erosion and is becoming wider (Figure 4.6.10). A stream (① in Figure 4.6.9A) is intercepted by the ditch at the left hand side, flowing perpendicular to the ditch. Yet the ditch cut an ice wedge, at the same level as the stream that is also perpendicular to the ditch and the embankment. From spring to fall, the stream is fed by runoff water, and erodes the ice wedge. Now, thermal erosion has developed and is incising the terrain starting from the ditch to the west, exposing additional ice-rich permafrost and wedge ice. Besides stream (①), water also was flowing through culverts (② and ③ in Figure 4.6.9A) at the time of site visit in October 2015.
