# Enhancing Yukon Trade Corridor Resilience to Northern Geohazards:

## Hydrology Report 3 - Erosion Assessment, Monitoring, and Mitigation

Final | September 2026

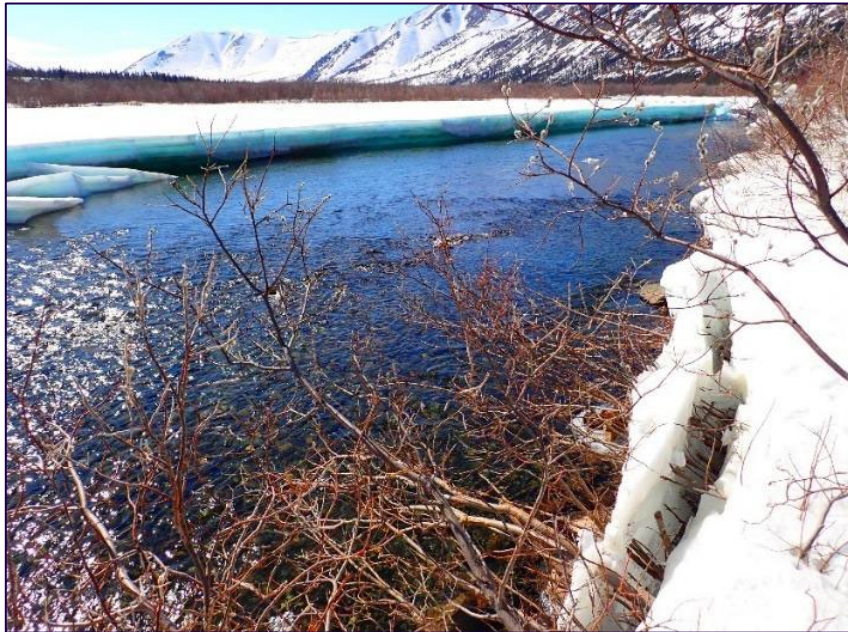
River ice is a primary geomorphological agent in the Yukon, often exerting more significant erosive forces than open-water flood events. Key ice processes include the formation and melt of aufeis (icings, **Figure 2.2**) and dynamic river ice breakup events causing ice jams and ice runs. Soon after freeze-up and until spring onset, the gradual formation of aufeis can block culverts and channel cross-sections, causing significant uplifting forces and deflecting the flow onto the floodplain (Turcotte et al., 2026a).

**FIGURE 2.2. AUFEIS COLLAPSE AND CALVING ALONG THE BLACKSTONE RIVER.**

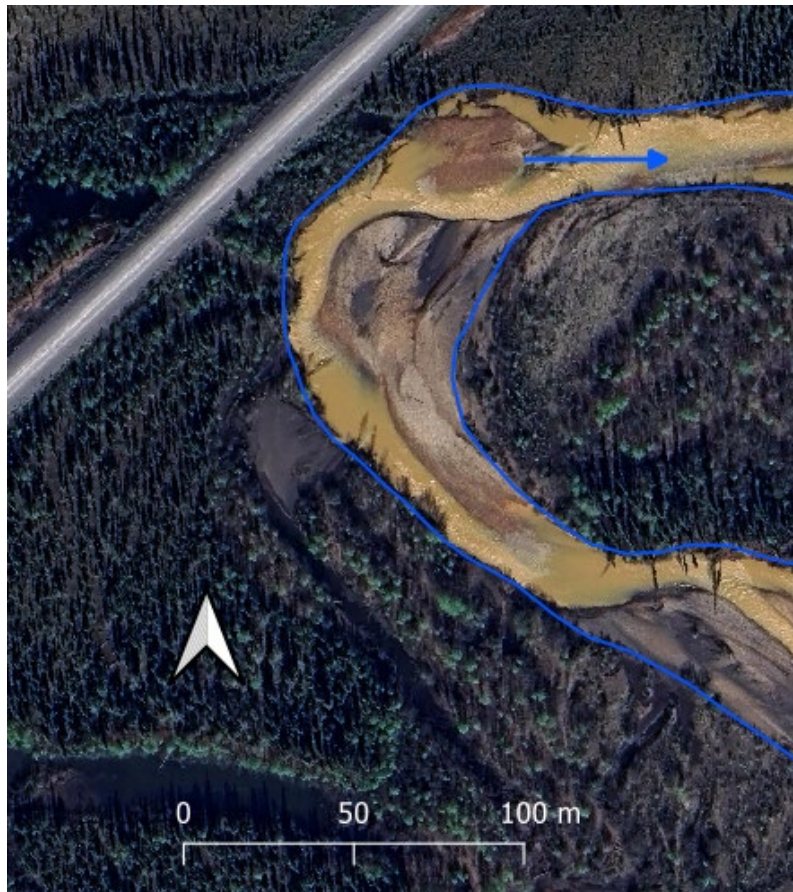
**FIGURE 4.2. EXAMPLE OF TOP OF BANK DELINEATION (2023) AT DEMPSTER HIGHWAY KM 183.3.**

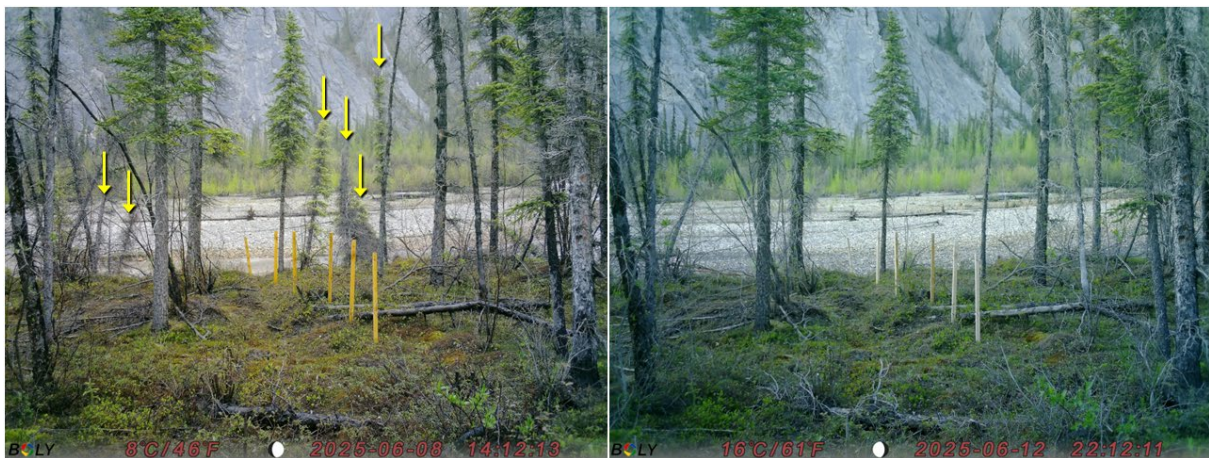
The objective of this subsection is not to present a comprehensive dataset but a result subset of erosion monitoring approaches tested during this project. **Figure 5.1** presents a sequence of two pictures from a remote camera, taken 4 days apart, looking perpendicularly towards a fast-migrating meander of Engineer Creek located at Km 194.0 of the Dempster Highway. During that runoff event, a row of trees (see yellow arrows pointing at small spruces) was lost as high-flow induced erosion occurred. **Figure 5.2** presents a view of the same site, looking downstream a couple of months later, and showing the trees that gradually collapsed into the channel. A real-time camera at that location, although more costly to operate in the absence of a cellular network (as stated in **Table 5.1**), would have informed highway crews of current bank movement, triggering a targeted or multi-site investigation. This erosion event coincided with (was caused by) a rain-driven runoff event that generated a higher peak flow than the preceding snowmelt event, as shown in **Figure 5.2** (water level only).

**FIGURE 5.1. PICTURES FROM A REMOTE CAMERA REVEALING THE LOSS OF SEVERAL SMALL RIPARIAN TREES TO THE CREEK CHANNEL BETWEEN JUNE 8 AND JUNE 12, 2025 (DEMPSTER H., KM 194.0). FIVE WOOD STAKES ARE VISIBLE ON THE LEFT IMAGE. NO STAKE WAS LOST DURING THIS EROSION EVENT.**

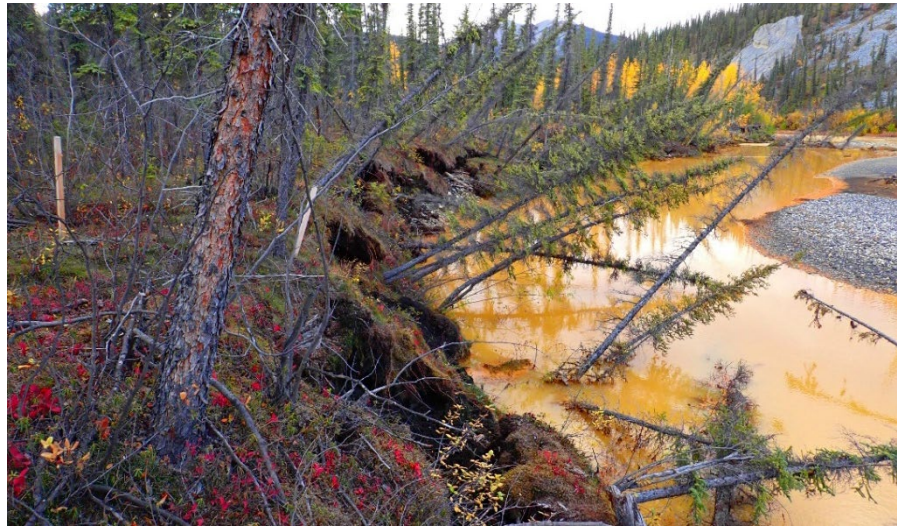
**FIGURE 5.2. DOWNSTREAM VIEW OF KM 194.0 SHOWING SEVERAL TREES THAT ARE GRADUALLY FALLING INTO ENGINEER CREEK (SEPTEMBER 2025).**

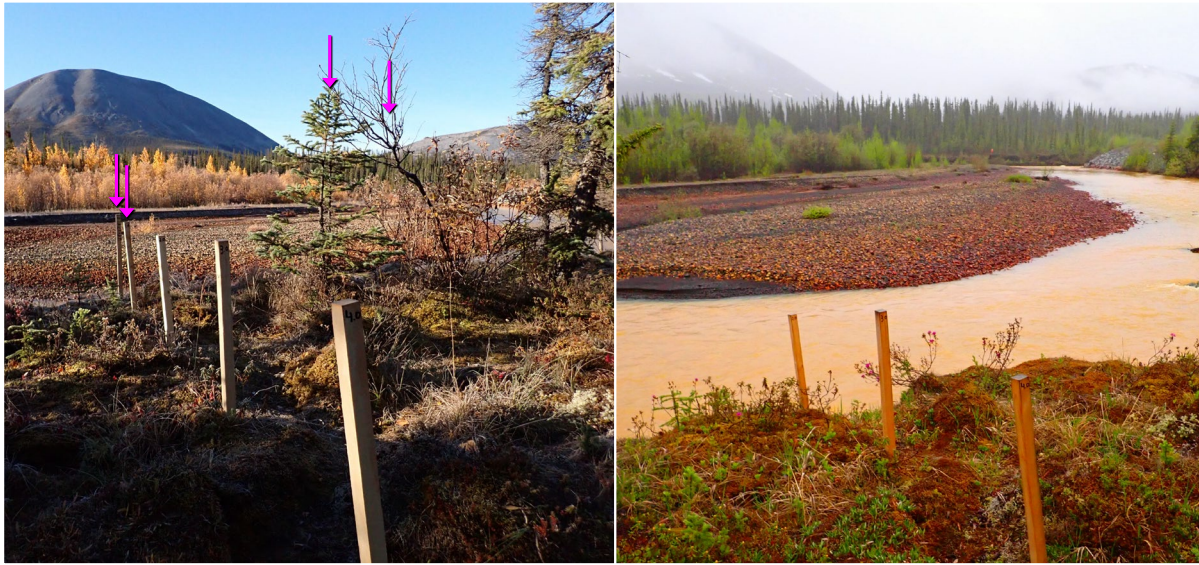
In addition to real-time or continuous monitoring strategies, annual on-site investigations enabled the documentation (quantification) of erosion (erosion rates) at all priority sites listed in **Table 4.2** (in **Section 4** of this report). **Figure 4.3** presents an example of a satellite, LiDAR, or drone-derived analysis to determine the extent and rate of bank migration. Another affordable approach to achieve similar results was to install a series of benchmarks (wood stakes) and reassess their separation distances to the eroding bank during field visits (**Table 5.1**). **Figure 5.4** presents an example where two wood stakes, installed 1 m apart, out of a line of five, were lost to erosion at Km 182.1 of the Dempster H. between 2024 and 2026.

**FIGURE 5.4. LEFT BANK OF ENGINEER CREEK IN SEPTEMBER 2024 (LEFT) AND JUNE 2026 (RIGHT) SHOWING THE LOSS OF TWO WOOD STAKES (PINK ARROWS) LOCATED AT DISTANCE 0.0 AND 1.0 M FROM THE BANK EDGE. THAT BANK RECEDED BY 2 M (STAKE 2.0 M WAS AT THE NEW BANK EDGE) IN 1.5 YEARS. PICTURES WERE TAKEN DURING SITE VISITS BY YUKONU AND ALSO REVEAL THE LOSS OF TWO SMALL TREES (OTHER PINK ARROWS).**

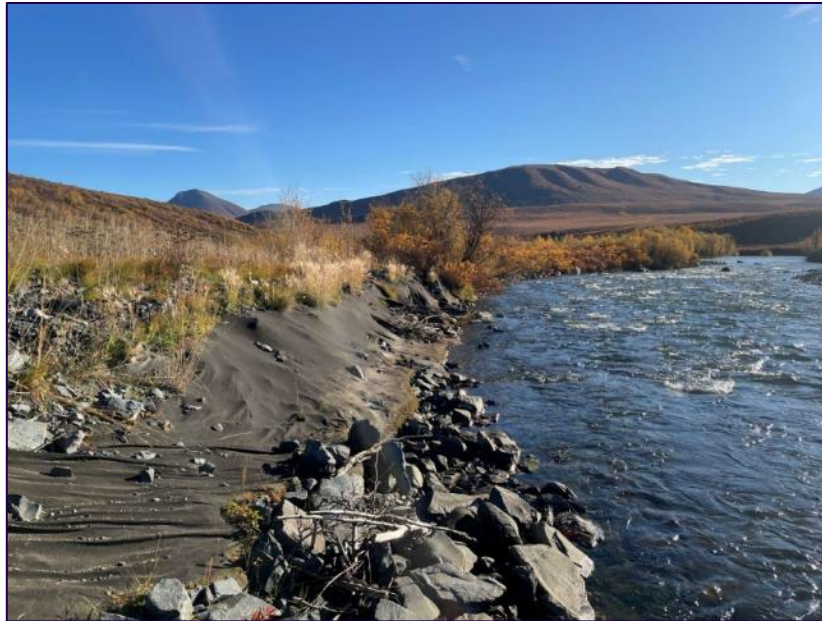
- **Geotextile Slip Planes:** Placing heavy riprap directly on top of smooth, non-woven geotextile fabric on steep embankment slopes has historically created a low-friction "slip plane" (**Figure 6.1**). Without proper terracing or a granular filter layer, the entire rock revetment can slide *en masse* into the channel under its own weight or when subjected to dynamic ice loading.

**FIGURE 6.1. RIPRAP HAS BEEN DISPLACED ATOP GEOTEXTILE AT DEMPSTER HIGHWAY KM 107.8.**

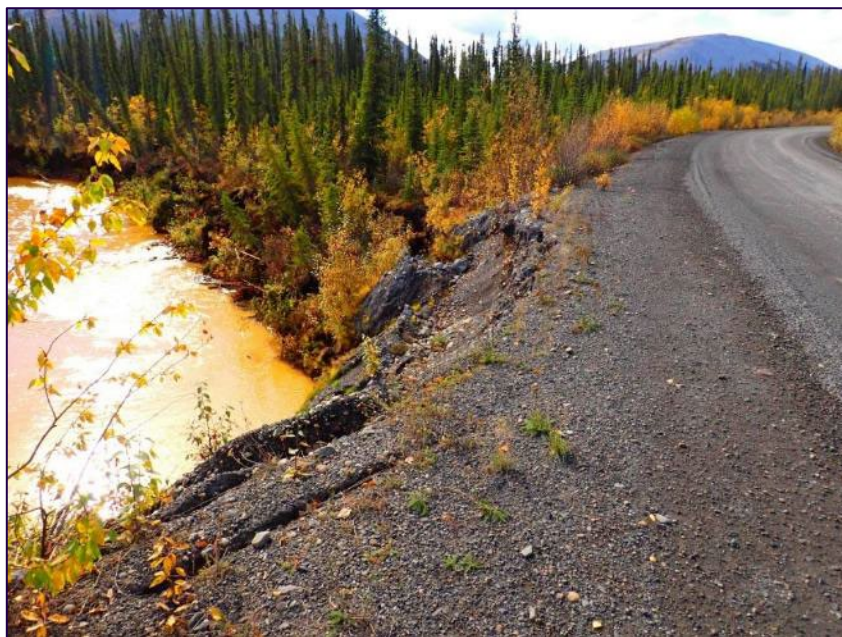
- **Scour Upstream of Riprap:** Due to material scarcity and budget constraints, historical riprap placements have often lacked sufficient longitudinal length. When the armouring does not extend far enough upstream, high-velocity flows attack the unprotected bank immediately above the structure (**Figures 2.4, 6.2, and 6.3**). This process, known as "outflanking," allows the river to erode behind the riprap.

**FIGURE 6.3. SCOUR UPSTREAM OF THE PREVIOUSLY PLACED RIPRAP AT DEMPSTER HIGHWAY KM 182.1**

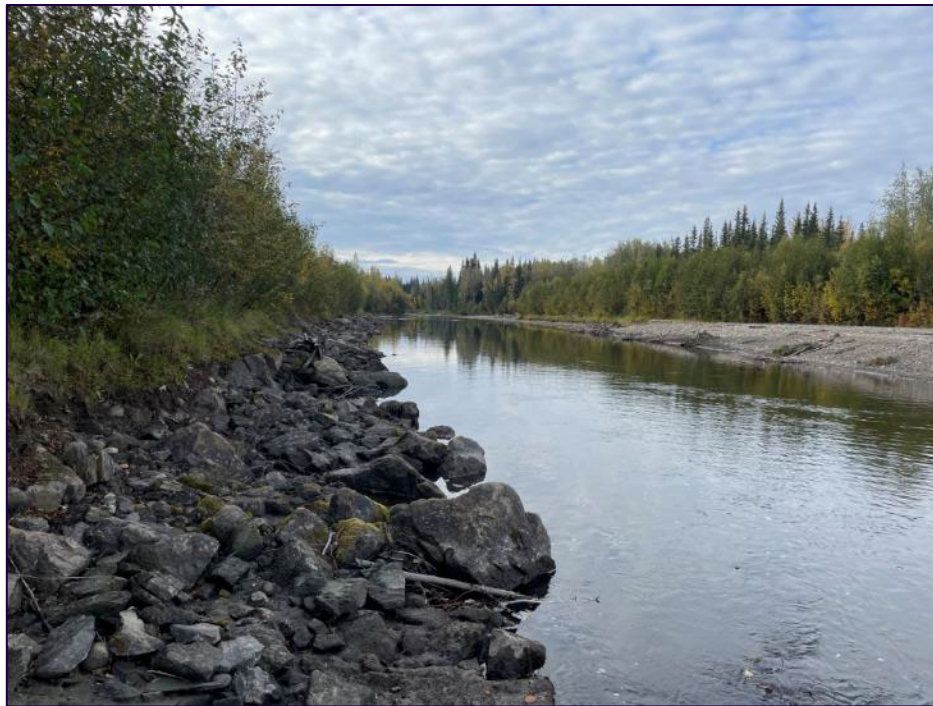
**FIGURE 6.6. RIPRAP PLACED ALONG THE BANK OF KLONDIKE RIVER ADJACENT THE NORTH KLONDIKE HIGHWAY DOWNSTREAM OF KM 665.8.**

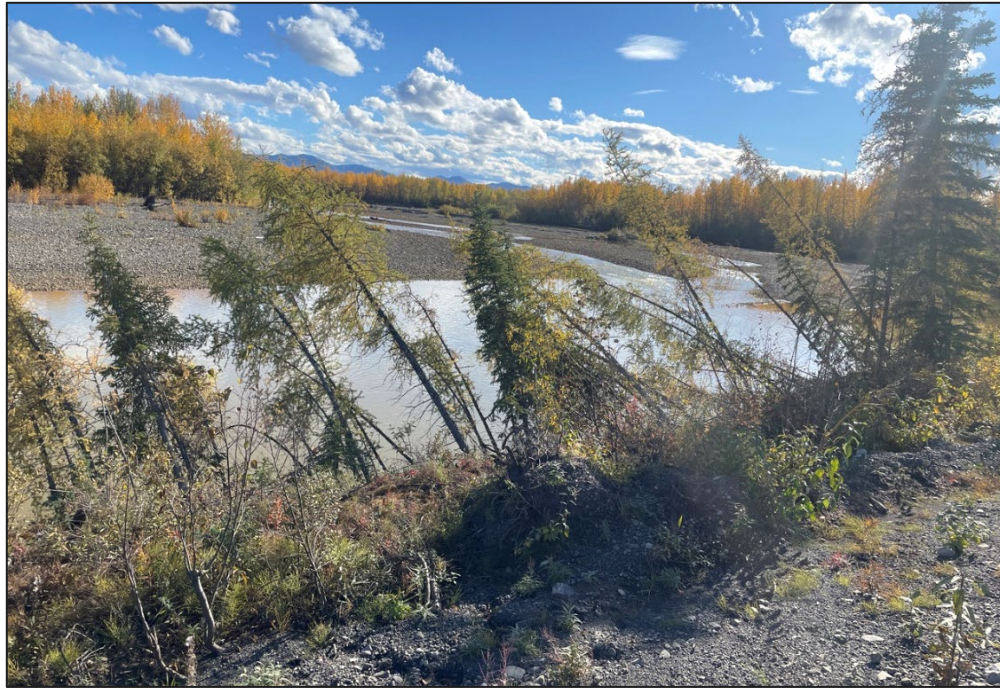
**FIGURE 6.10. AN ERODING BANK OF OGILVIE RIVER IS WITHIN A FEW METRES OF THE ROAD EMBANKMENT AT DEMPSTER HIGHWAY KM 239.5 (PHOTO CREDIT: SLR, 2025). THE NEXT SIGNIFICANT HYDROLOGICAL EVENT MAY LEAD TO A ROAD WASHOUT.**

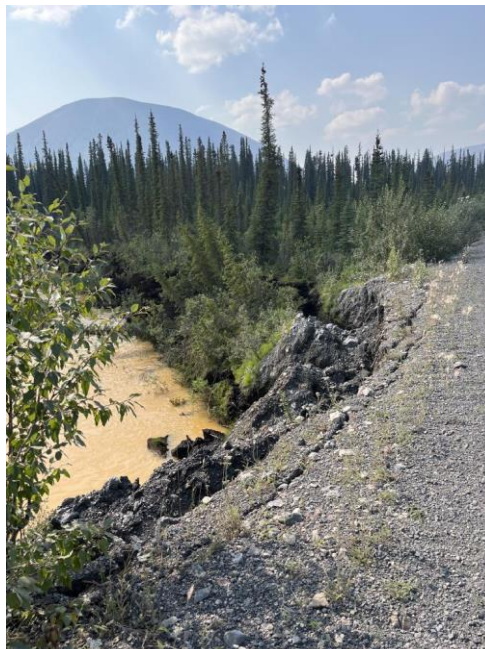
- **KM 182.1 (ID # 45) Engineer Creek** – Approximately 60 m of riprap was installed along the highway embankment prior to 2013. Erosion has occurred both upstream and downstream of the riprap. Observed erosion in the June 2023 satellite imagery and field photos suggest the highway embankment is already failing at the upstream end of the riprap (see photo below).

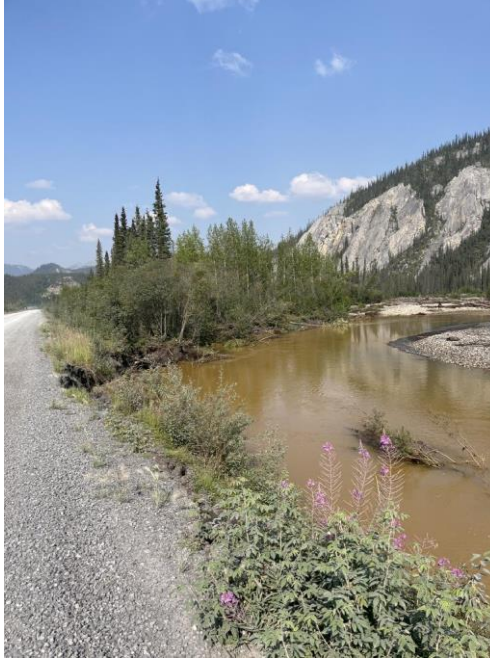
- **KM 193.4 (ID # 54) Engineer Creek** – Rapid lateral migration (45 m between 2013 and 2023) has reduced the separation distance to 0 m. No erosion mitigation is currently present. YRC-CCR informed HPW via email on August 31, 2023 of the imminent erosion risk.

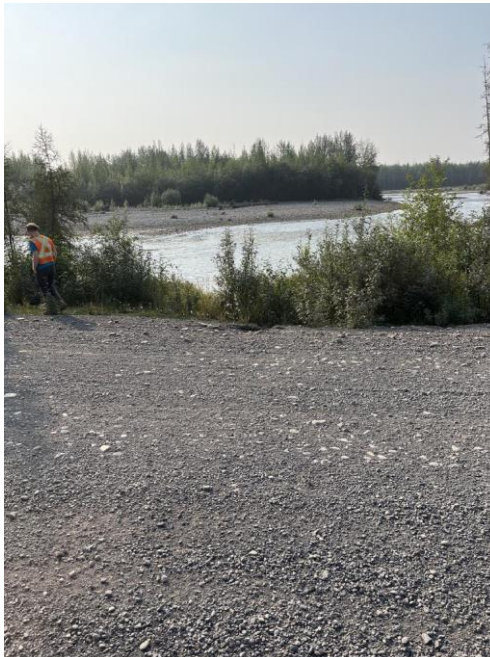
- **KM 239.5 (ID # 73) Ogilvie River** – Near this site, Ogilvie River has two prominent branches. Over the past decade, more flow has been directed into the northern branch, which has contributed to the observed rapid migration towards the highway (43 m of migration between 2013 and 2023).

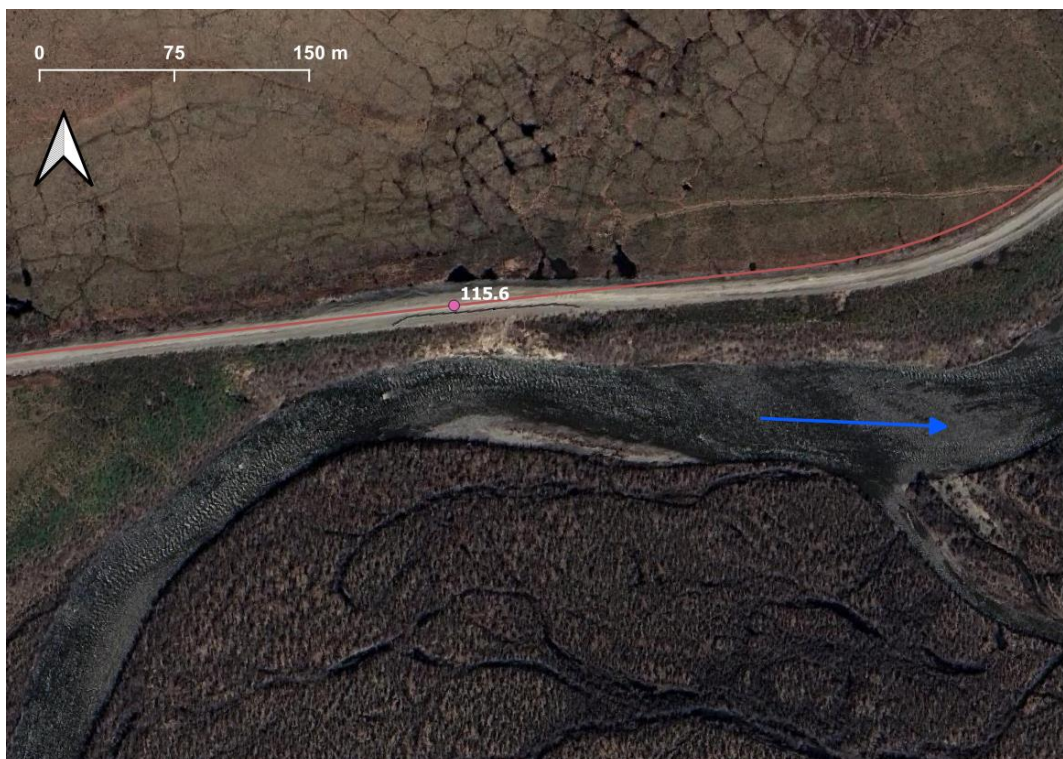
- **KM 115.6 (ID # 13) Blackstone River** – Degradation of ice-rich permafrost and river migration are leading to hillslope failure that is compromising the highway. Traffic barriers have already been placed along the highway embankment. Continued slope stability issues are expected.

**Figure 1. KM 115.6 of Dempster Highway. Separation distance = 9 m, risk rating = Very High, imagery date: June 2, 2023.**

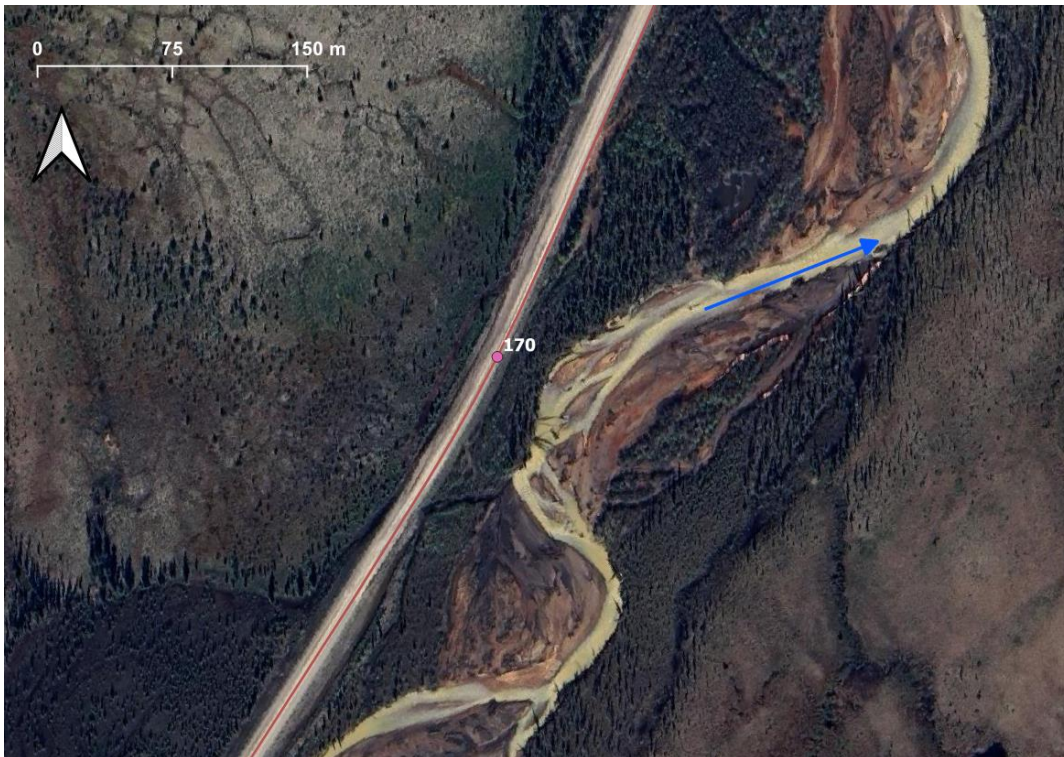
**Figure 3. KM 170.0 of Dempster Highway. Separation distance = 25 m, risk rating = High, imagery date: June 4, 2023.**

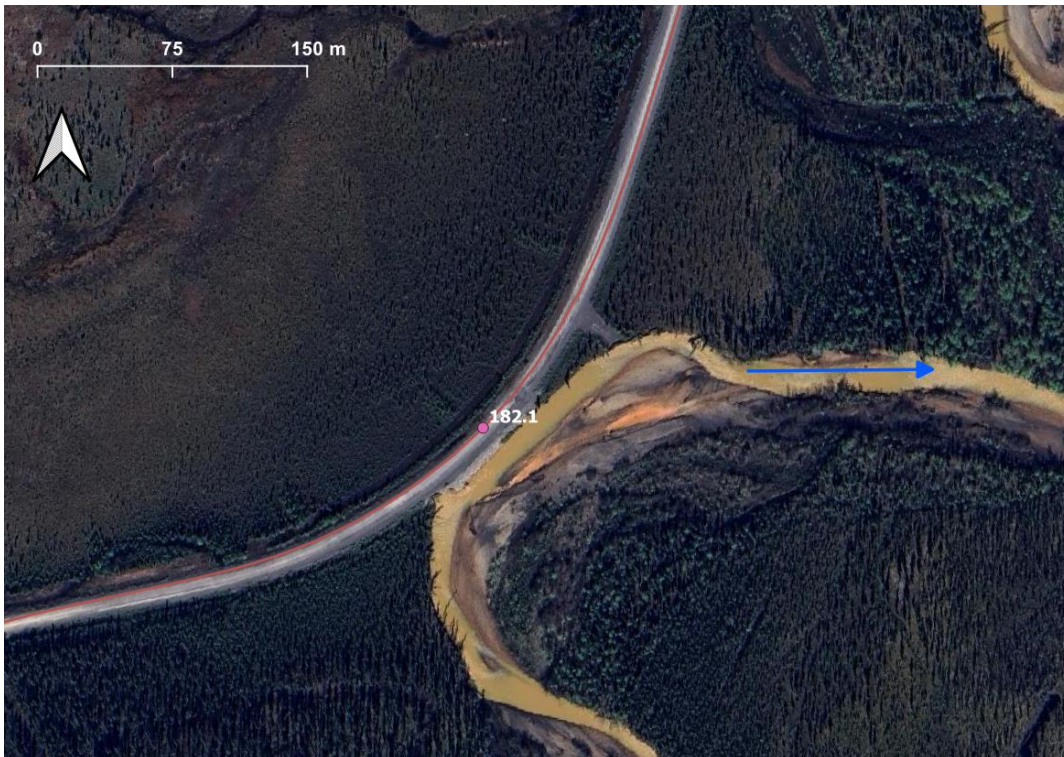
**Figure 5. KM 182.1 of Dempster Highway. Separation distance = 0 m, risk rating = Very High, imagery date: June 4, 2023.**

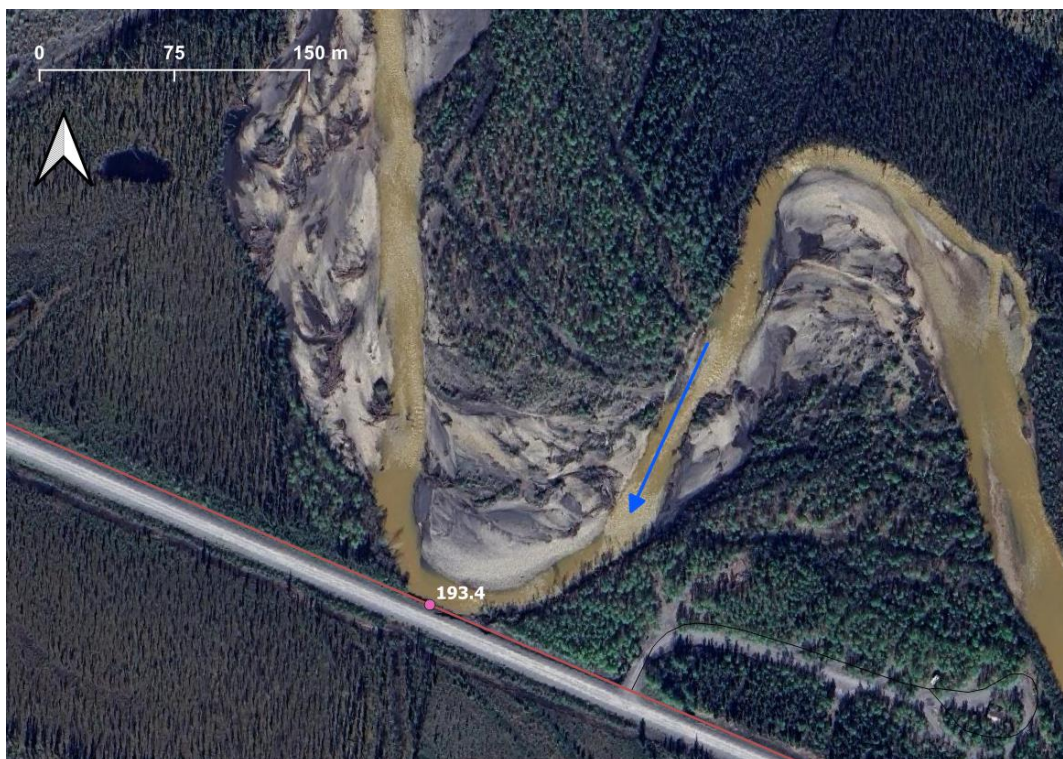
**Figure 7. KM 193.4 of Dempster Highway. Separation distance = 0 m, risk rating = Very High, imagery date: June 4, 2023.**

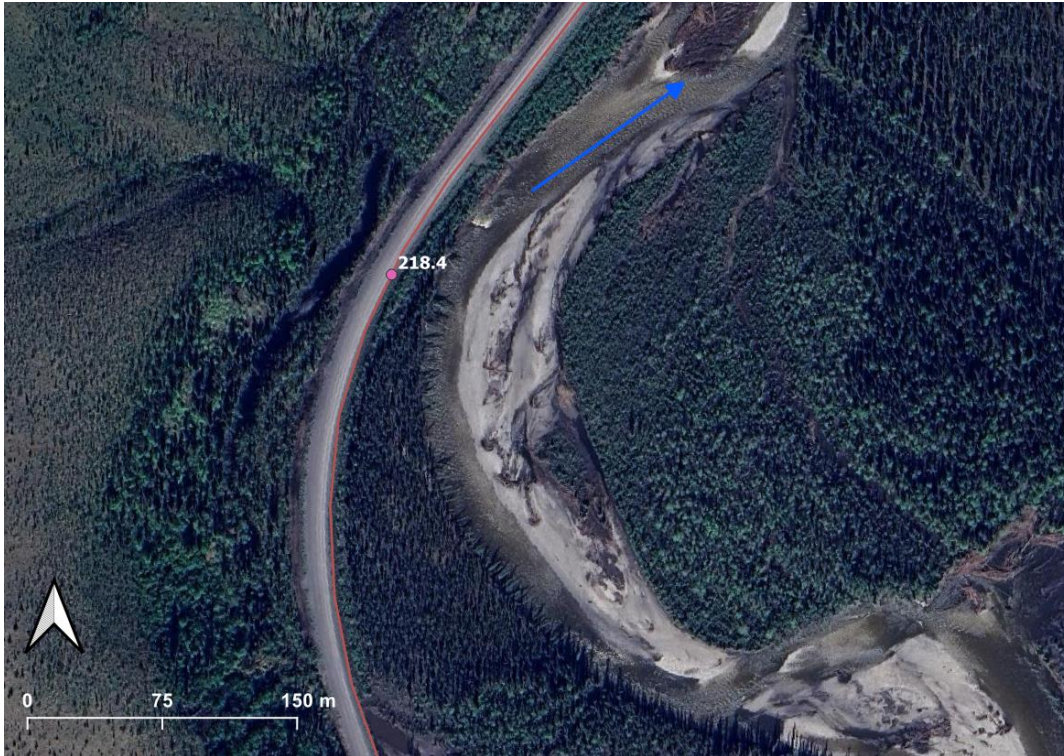
**Figure 9. KM 218.4 of Dempster Highway. Separation distance = 13 m, risk rating = High, imagery date: June 4, 2023.**

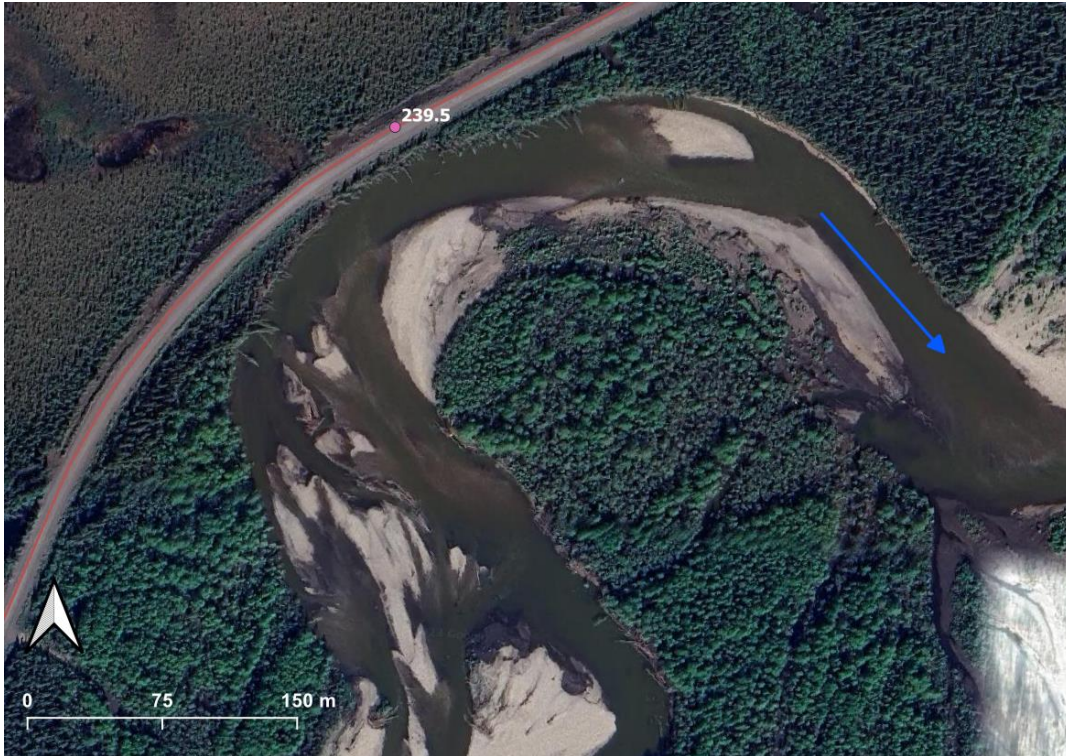
**Figure 11. KM 239.5 of Dempster Highway. Separation distance = 6 m, risk rating = Very High, imagery date: June 7, 2023.**

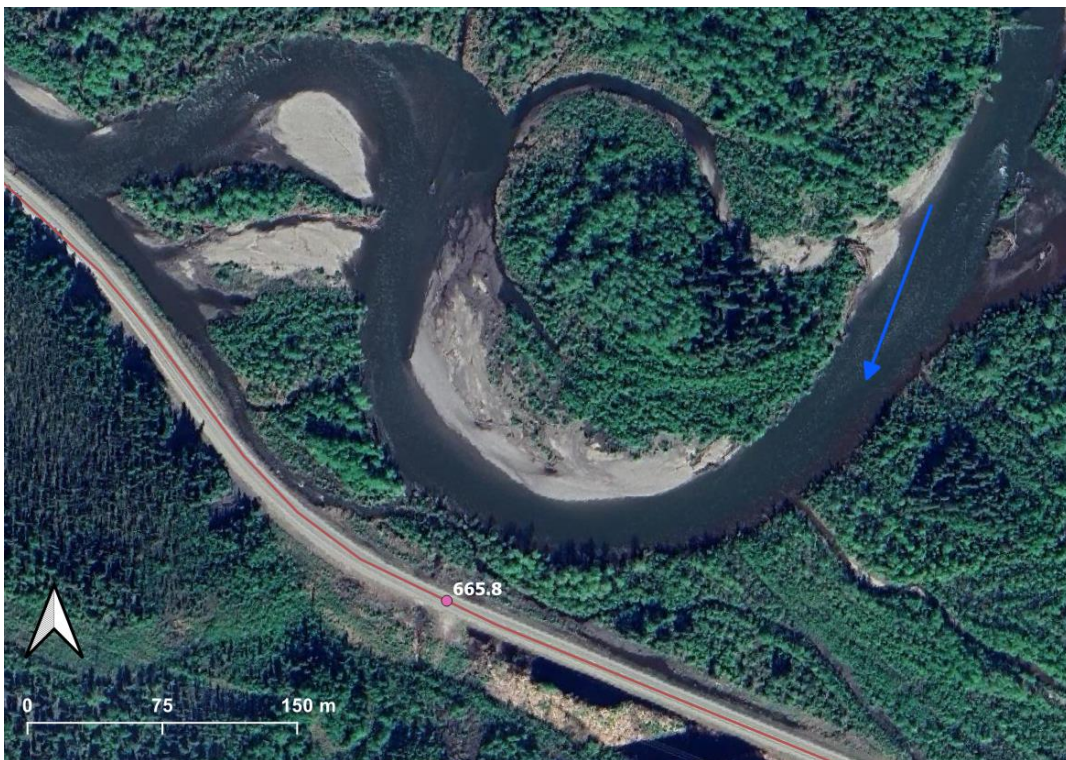
**Figure 12. KM 665.8 of Klondike Highway. Separation distance = 34 m, risk rating = Moderate, imagery date: June 4, 2023.**

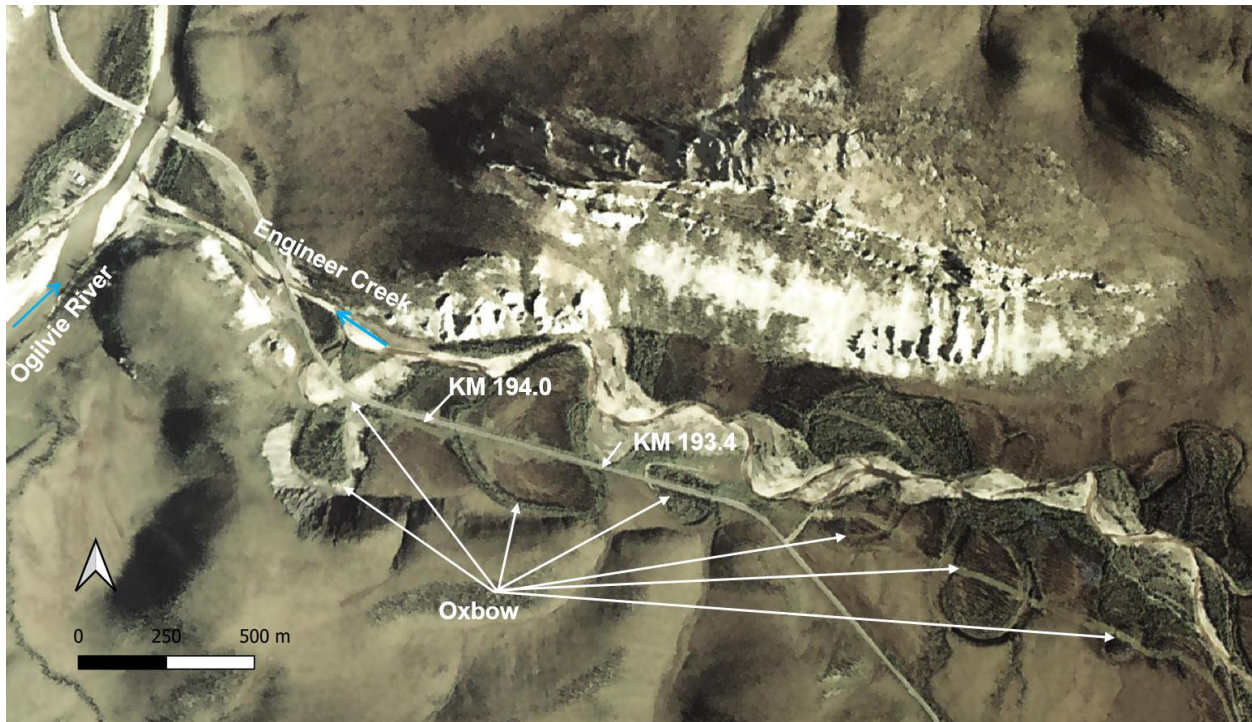
**Figure 3.** *In the 1977 aerial photographs (excerpt above), numerous oxbow features were observed along the south and north side of Engineer Creek, upstream of its confluence with Ogilvie River. It is inconclusive which oxbows were formed through natural processes and which were forced through anthropogenic straightening. It is likely some anthropogenic modifications were made to the channel to increase the separation distance between the newly constructed highway and the creek and to straighten the approach to the downstream vehicle crossing. This section of Engineer Creek has rapidly evolved in recent decades, which has led to high erosion vulnerability at KM 193.4 and KM 194.0 (Appendix A).*

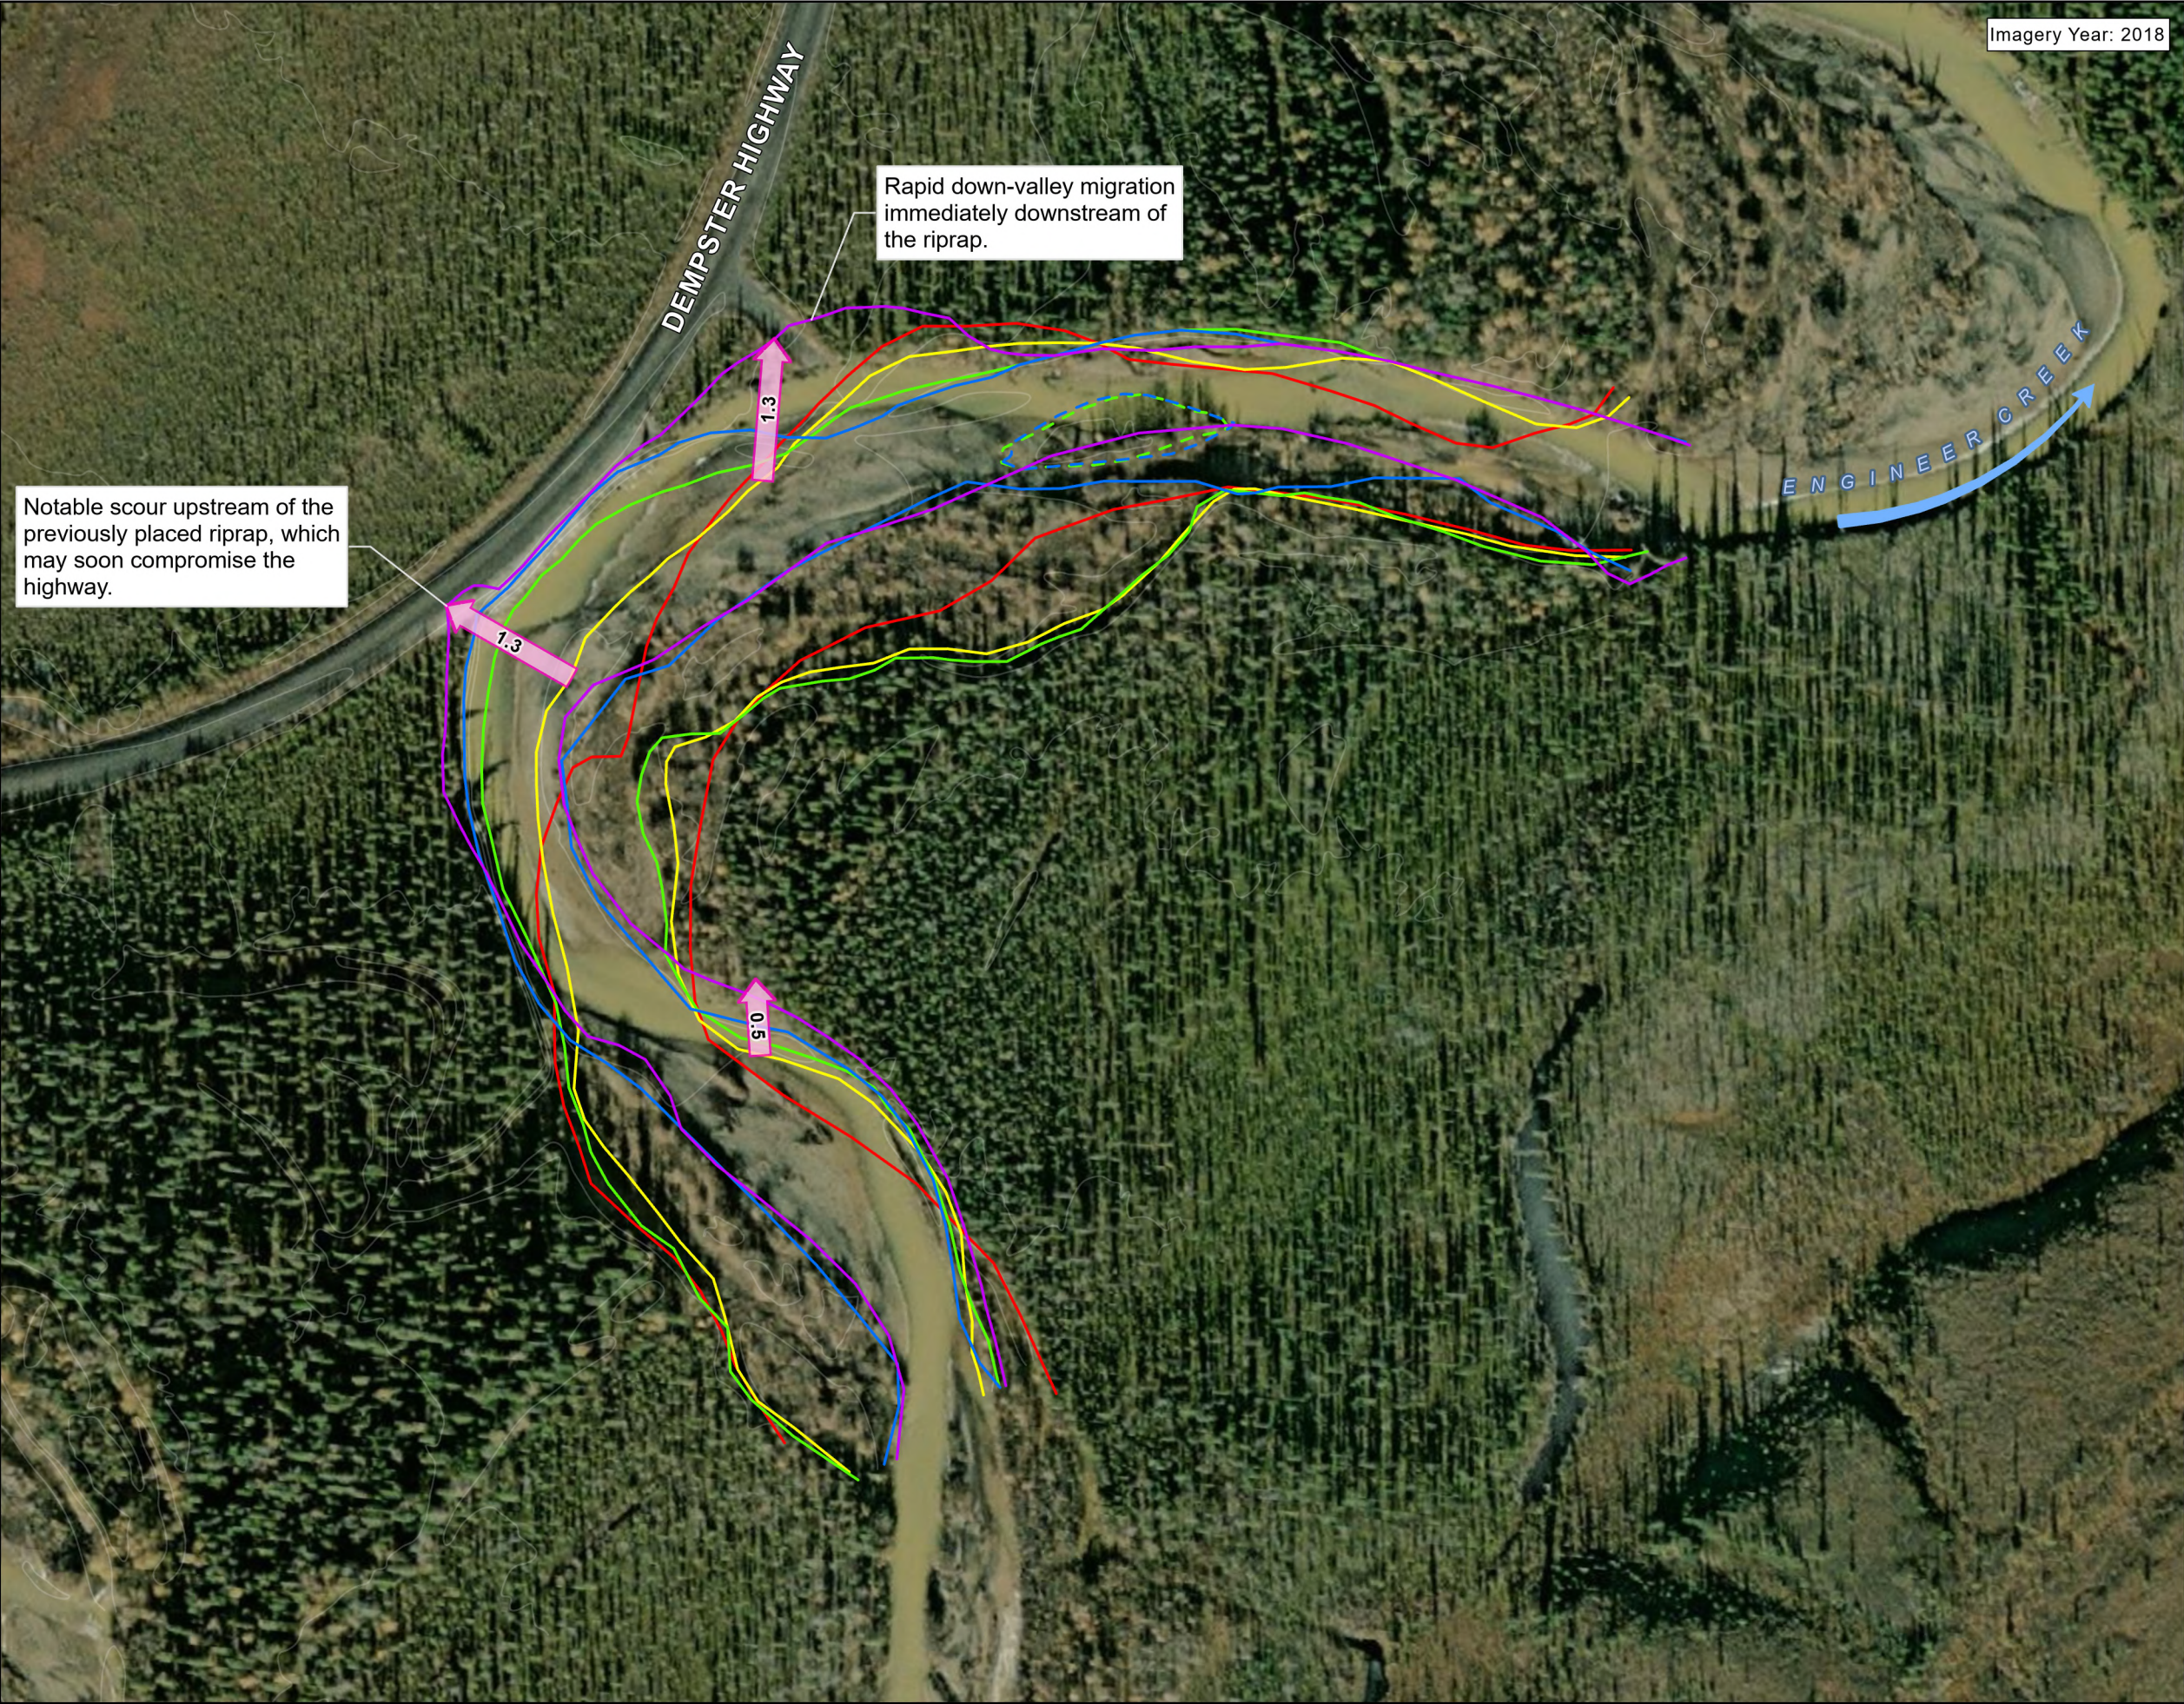
| | Appendix A-6 | |

Rapid down-valley migration immediately downstream of the riprap.

Notable scour upstream of the previously placed riprap, which may soon compromise the highway.

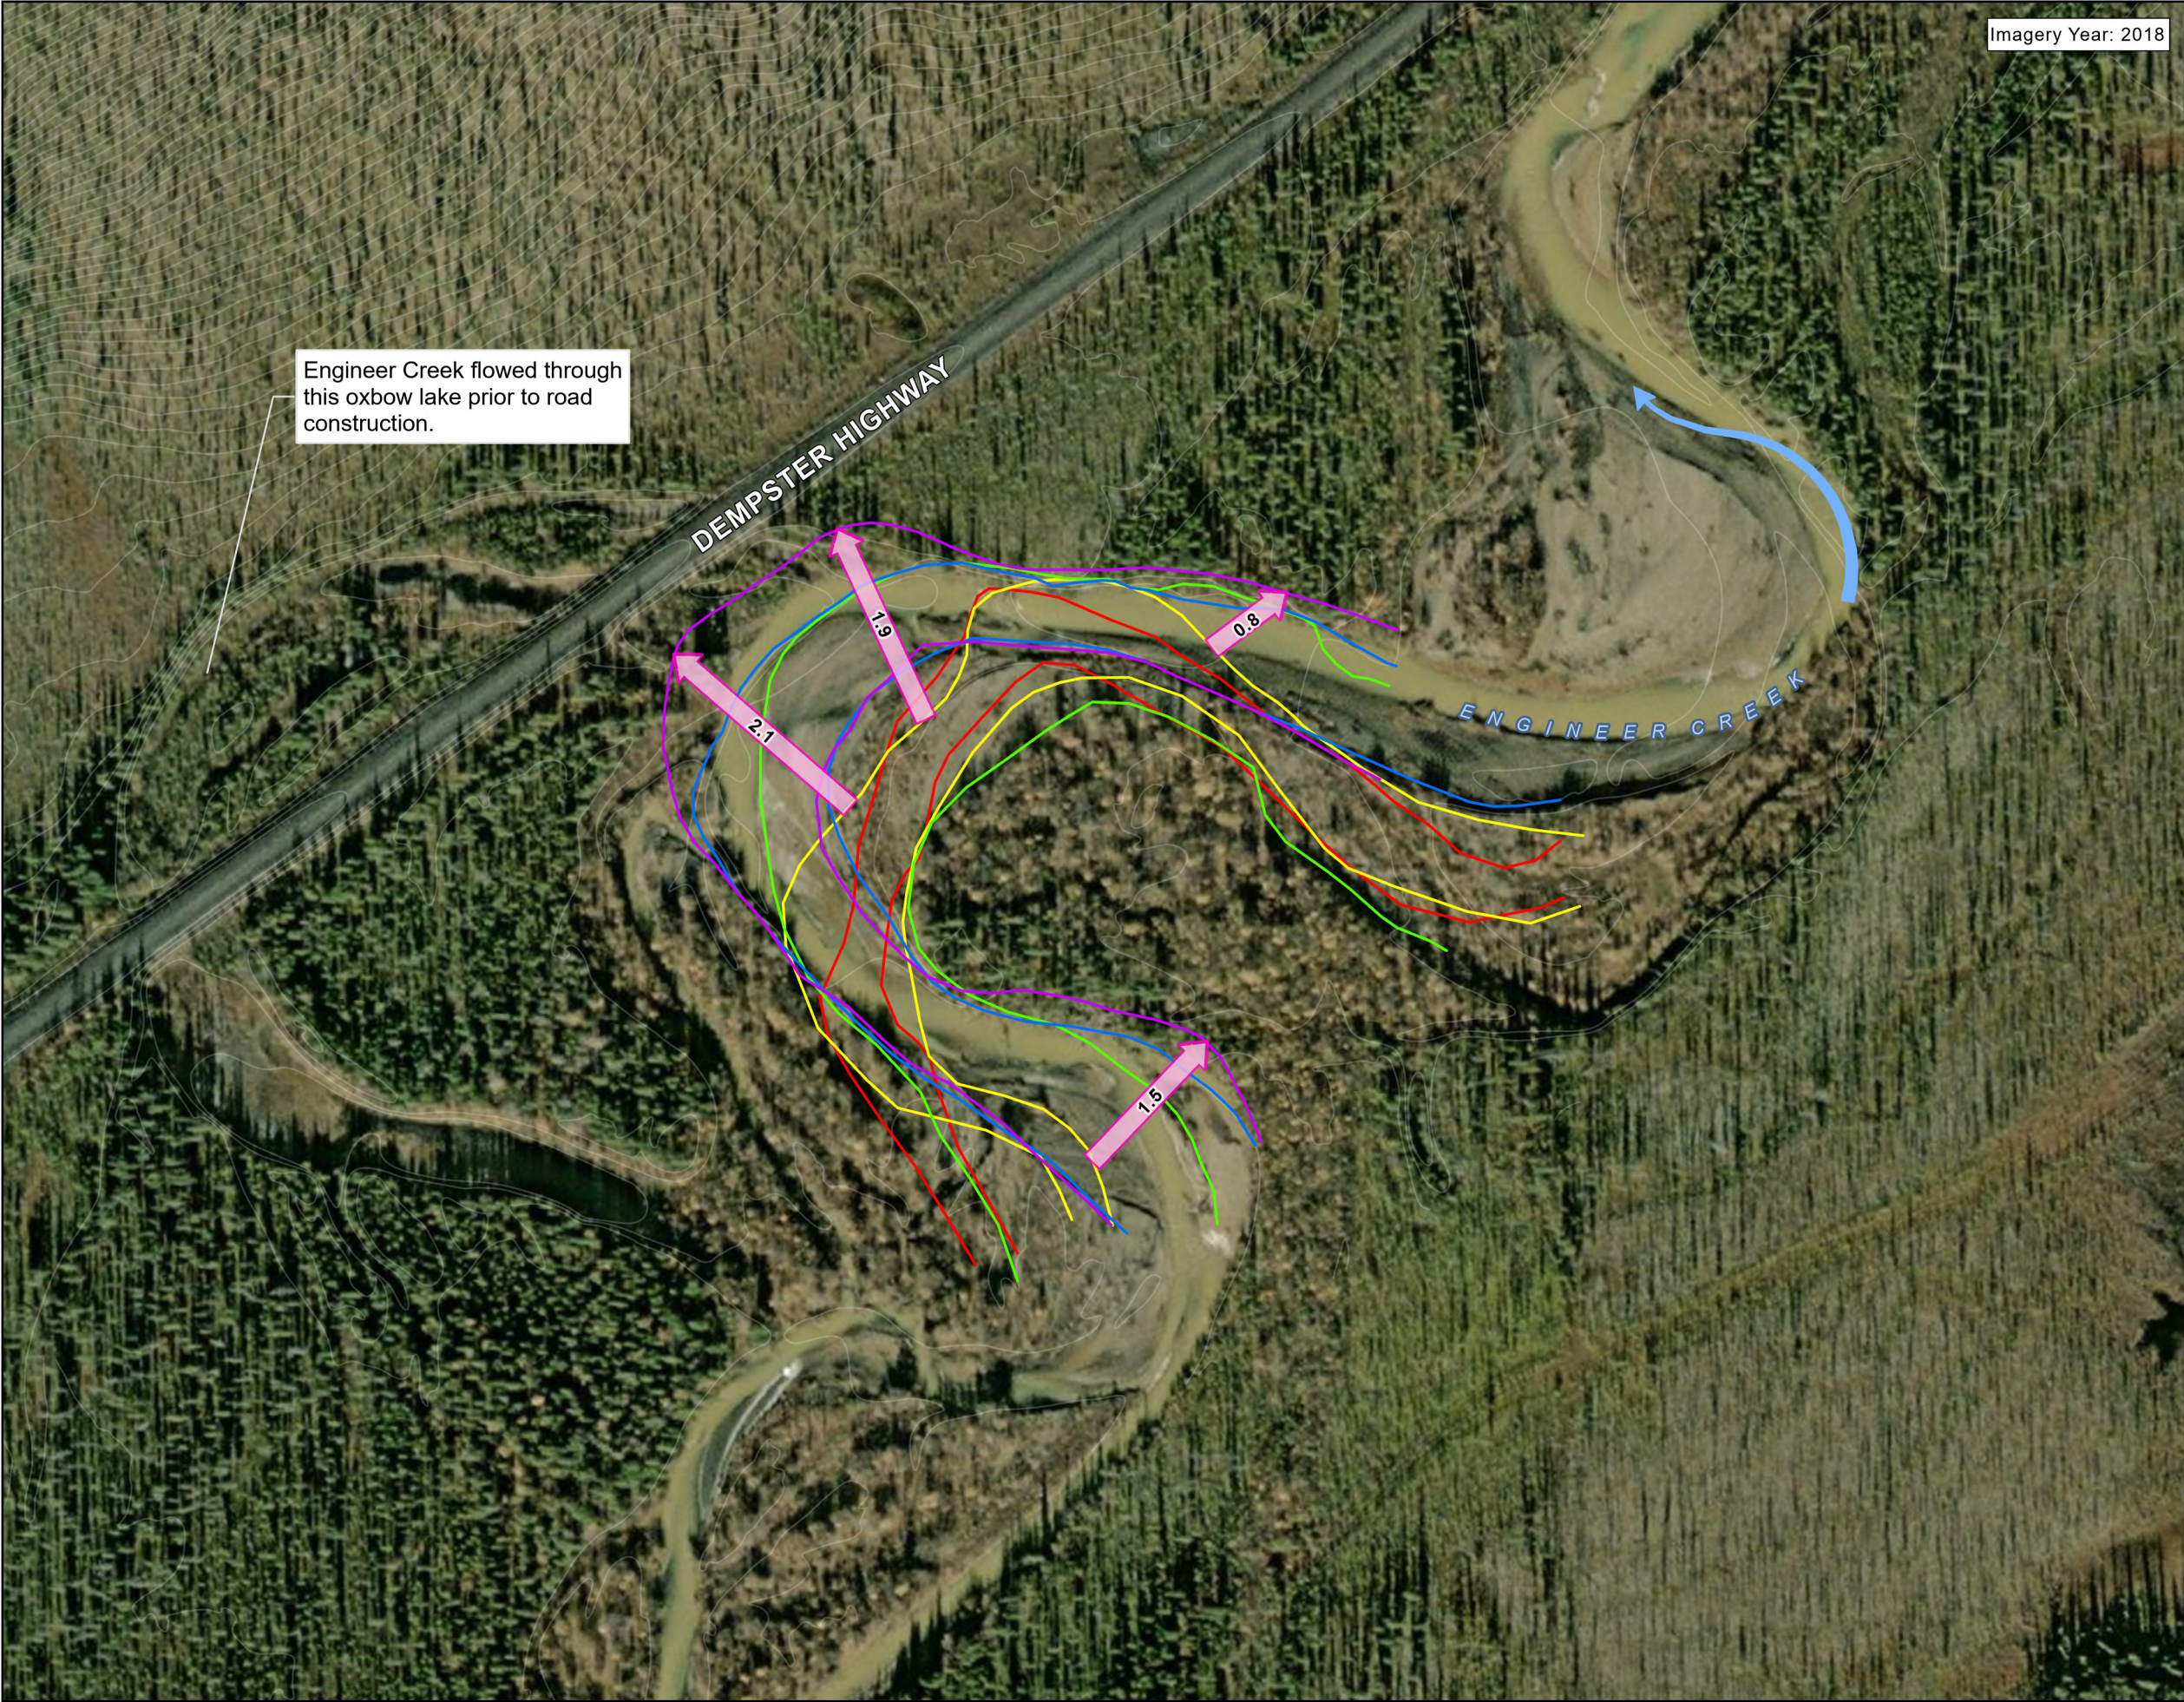
| | Appendix A-7 | |

Engineer Creek flowed through this oxbow lake prior to road construction.
