# Enhancing Yukon Trade Corridor Resilience to Northern Geohazards:

## Hydrology Report 3 - Erosion Assessment, Monitoring, and Mitigation

Final | September 2026

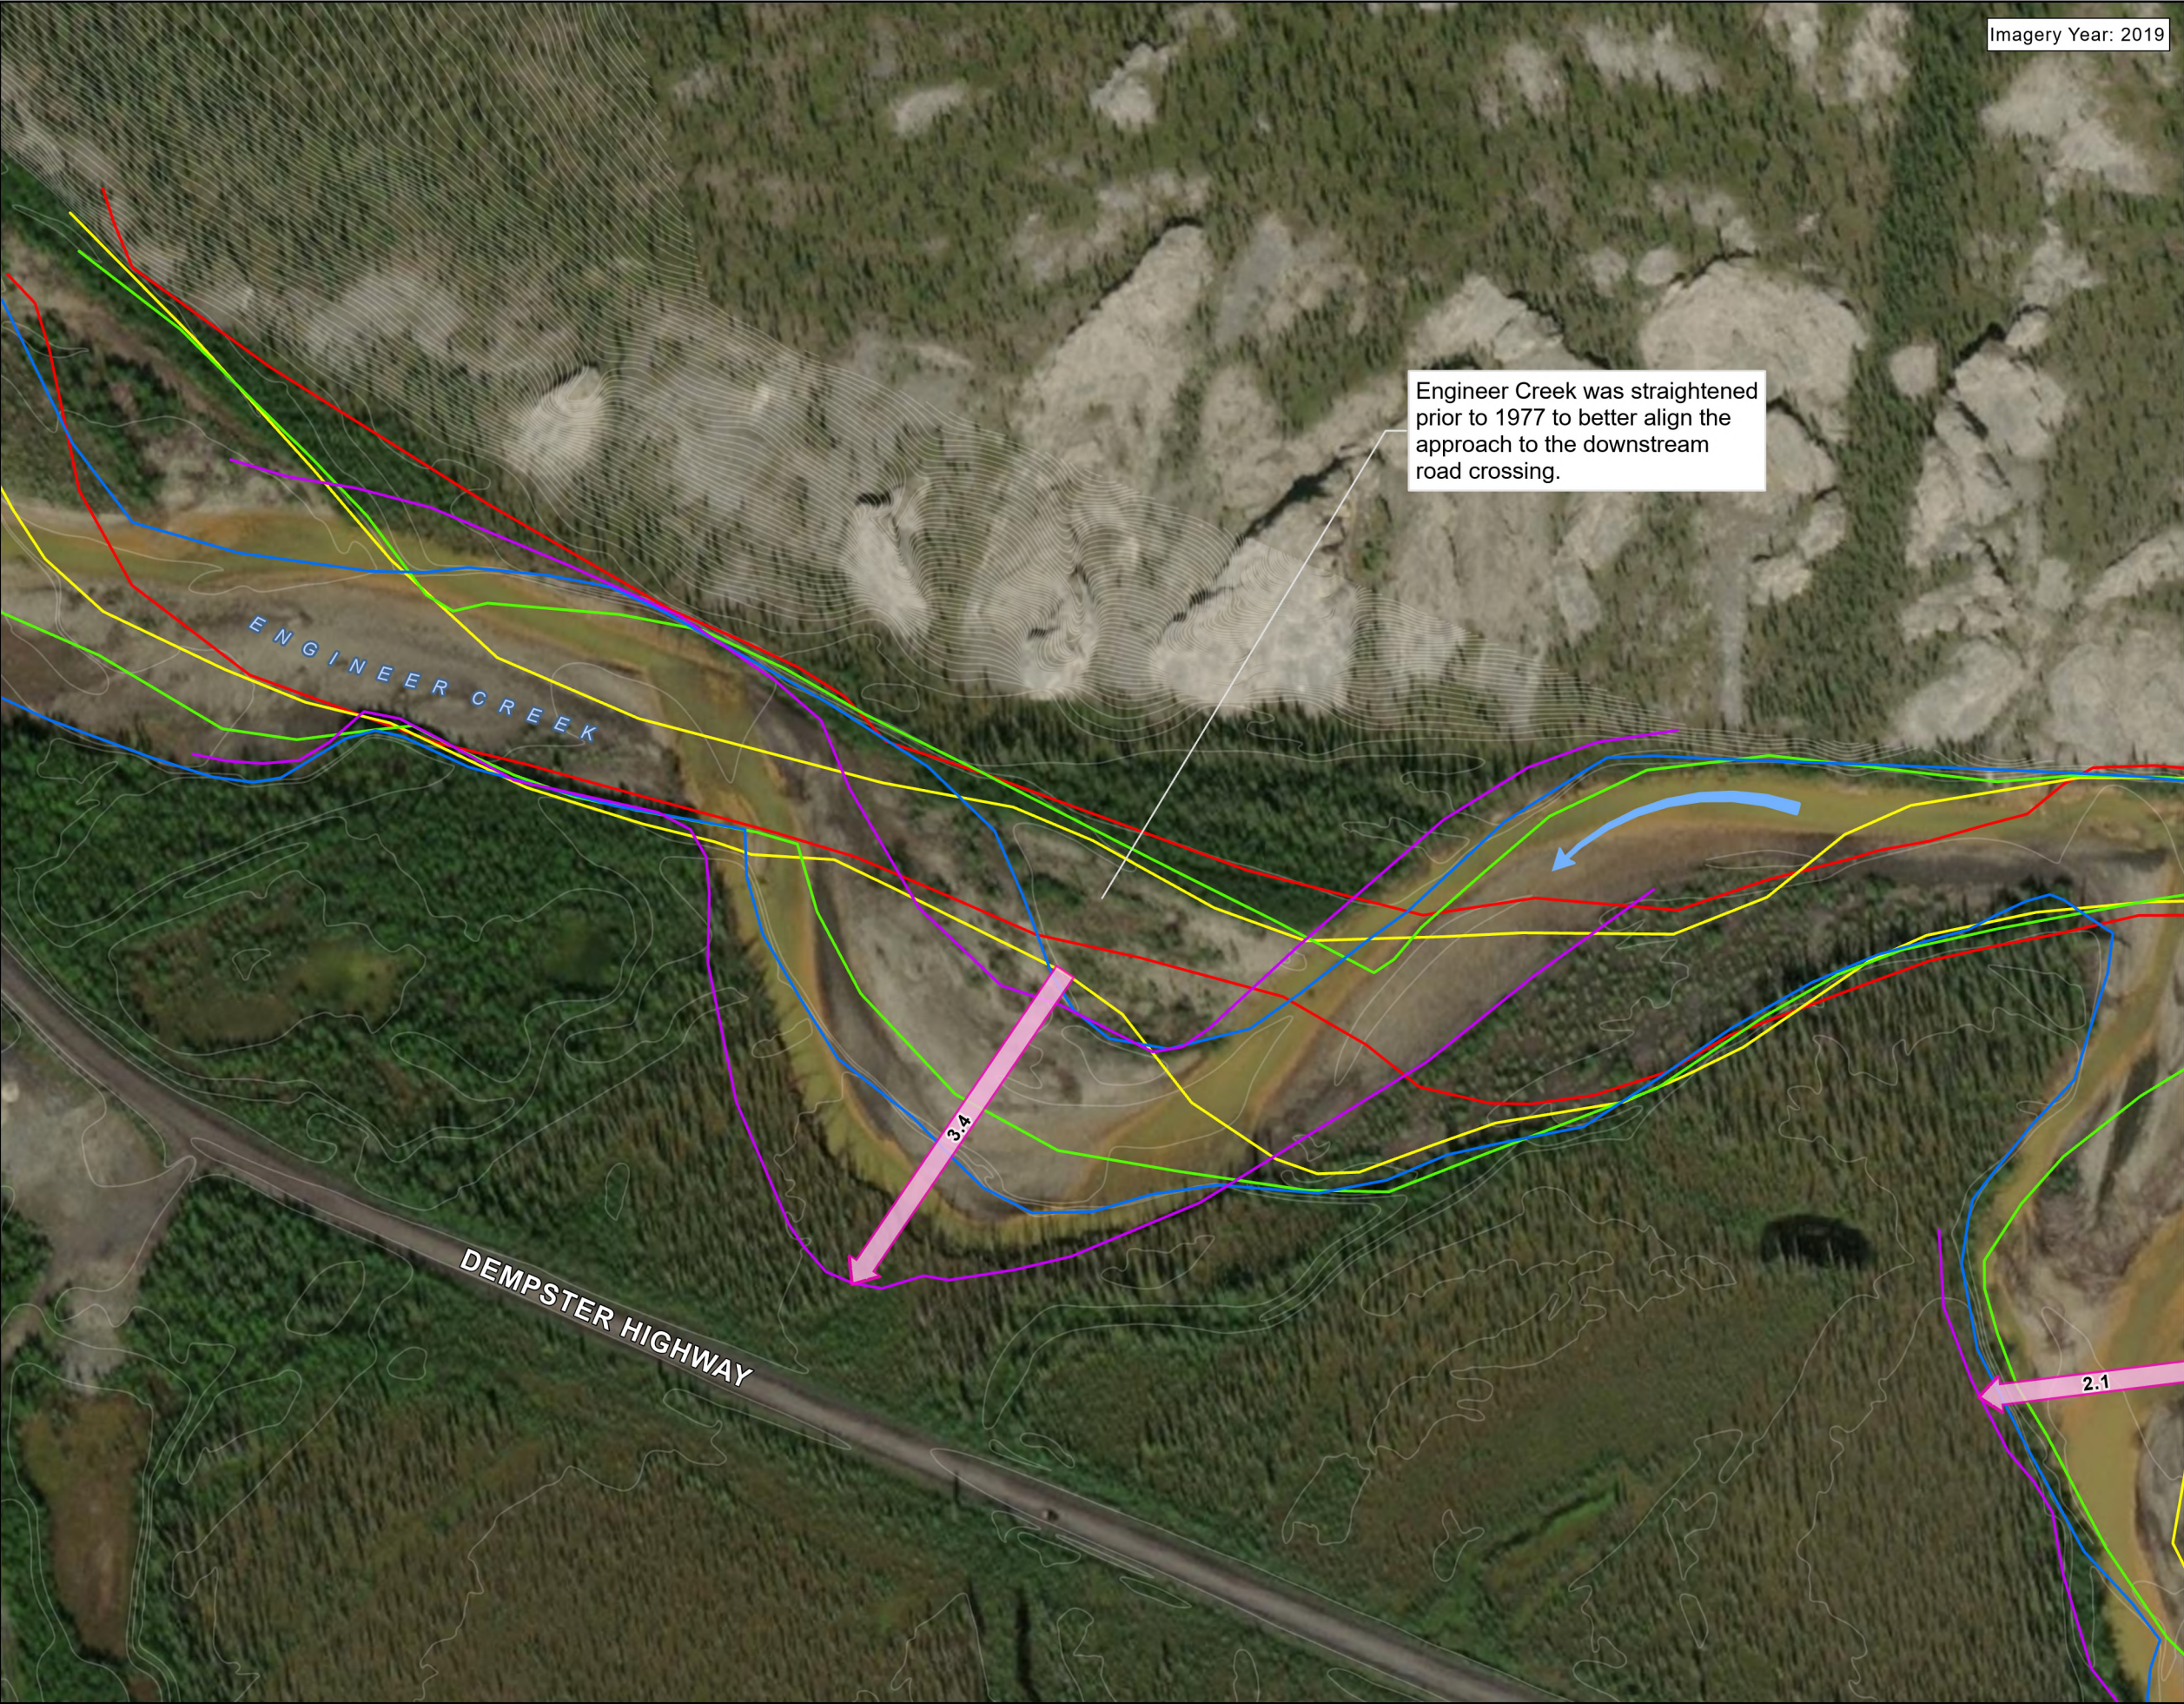
| | Appendix A-9 | |

Engineer Creek was straightened prior to 1977 to better align the approach to the downstream road crossing.

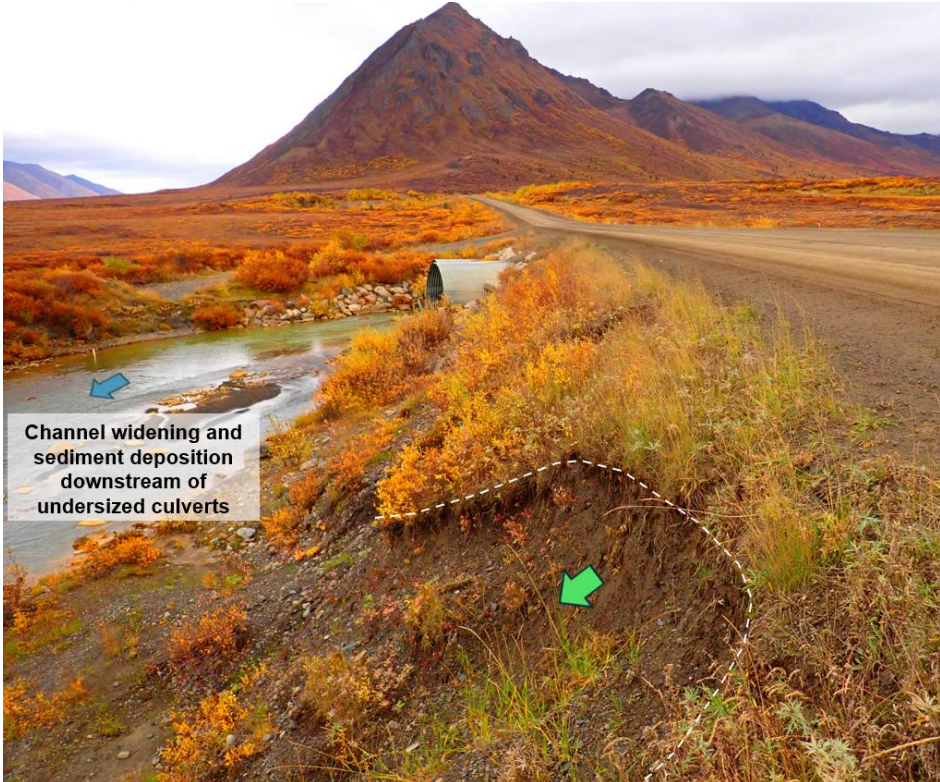
| Highway and KM | Dempster Highway KM 86.1 |
|---|---|
| Erosional Processes | <ul style="list-style-type: none"> <li>• Complex hydraulics downstream of undersized CSP culverts likely lead to toe erosion and induce bank slumping.</li> <li>• Aufeis formation may lead to overbank flows and erosion of the slope.</li> <li>• Drainage from highway and rip-rap on the opposite bank may contribute to instability.</li> </ul> |

| Highway and KM | Dempster Highway KM 86.1 |
|---|---|
| Mitigation Considerations and Recommendations | <ul style="list-style-type: none"> <li>• Undertake subsurface investigations to characterize materials and permafrost conditions.</li> <li>• Regrade the slope to 2H:1V or flatter and provide toe protection (e.g., vegetated boulder revetment).</li> <li>• Incorporate riparian plantings (e.g., willow staking) to improve near-surface shear strength.</li> <li>• Upgrading the upstream crossing may reduce aufeis formation and redistribute erosion power.</li> </ul> |

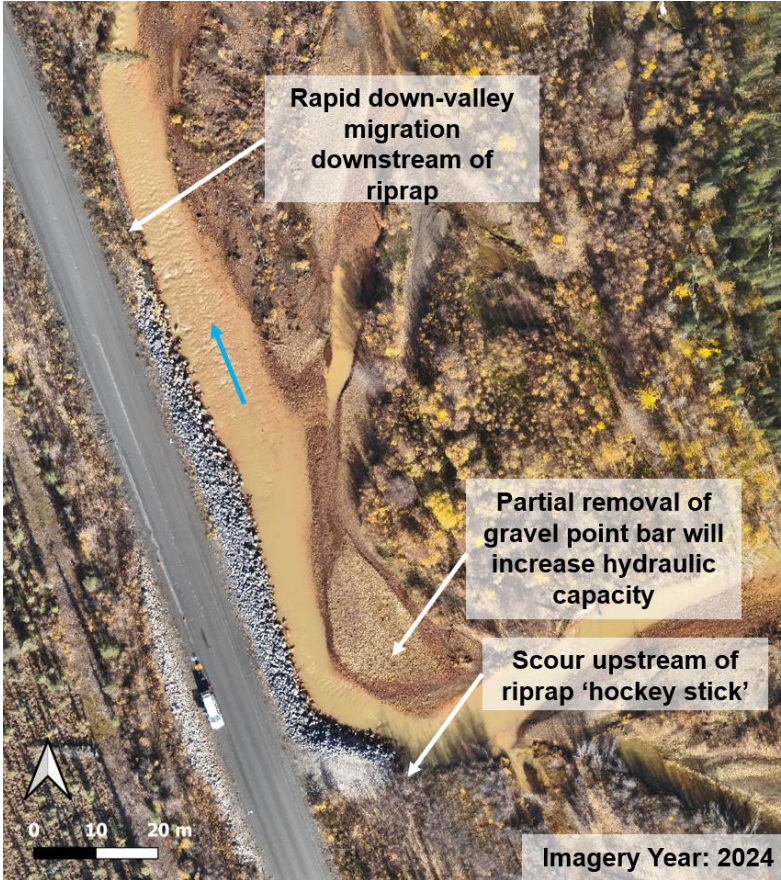
| Highway and KM | Dempster Highway KM 165.5 |
|---|---|
| Erosional Processes | <ul style="list-style-type: none"> <li>Channel migration is resulting in scour behind the riprap at the upstream end.</li> <li>Rapid downstream migration has occurred beyond the existing riprap protection.</li> <li>Based on channel planform geometry, an avulsion through the eastern floodplain is possible.</li> </ul> |

| Highway and KM | Dempster Highway KM 165.5 |
|---|---|
| Mitigation Considerations and Recommendations | <ul style="list-style-type: none"> <li>Consider removal of inner-bank gravel deposits to increase hydraulic capacity and reduce bend severity at least for the short-term.</li> <li>Remove or modify the riprap that extends upstream away from the highway to reduce outflanking risk; a deflector may be more effective near the downstream end of the revetment.</li> <li>Extend riprap downstream and/or add a deflector to shift the thalweg away from the highway.</li> </ul> |

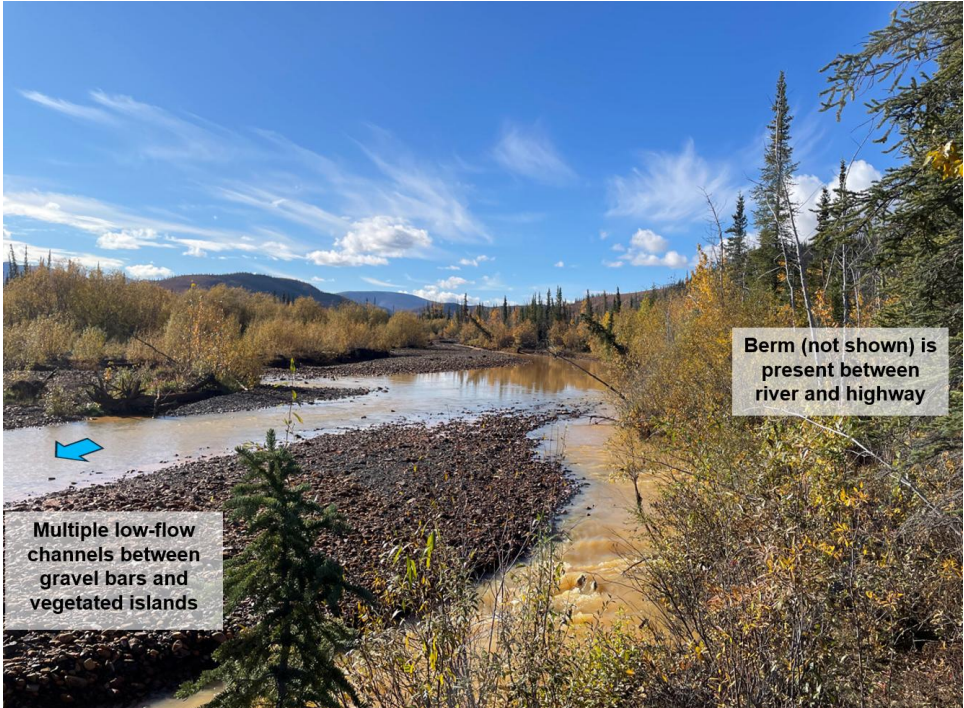
| <b>Erosional Processes</b> | <ul style="list-style-type: none"> <li>The site is located within a depositional reach prone to lateral migration and avulsion.</li> <li>An anthropogenic berm separates the channel from the highway; however, the berm appears to consist of erodible alluvial material, and it ends at Km 169.9.</li> <li>Bedrock along the outer-bank toe will likely limit further migration toward the highway, risk level may need to be reassessed.</li> </ul> |

| <b>Mitigation Considerations and Recommendations</b> | <ul style="list-style-type: none"> <li>Monitor using desktop methods or simple field approaches (e.g., monumented stakes).</li> <li>Consider trial implementation of alternative mitigation approaches such as wood deflectors; construction access is locally favourable.</li> </ul> |

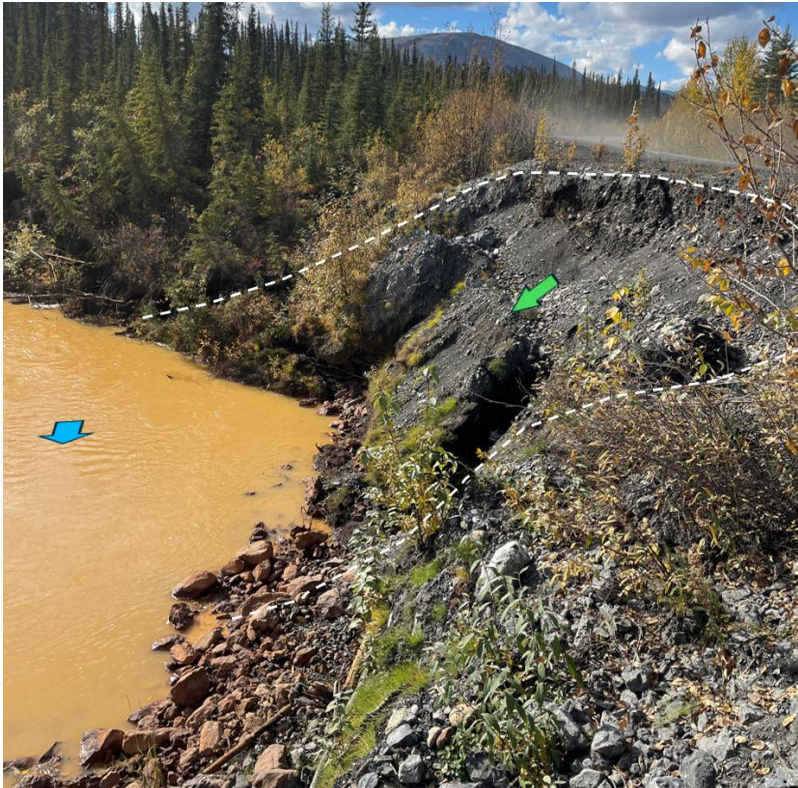
| Highway and KM | Dempster Highway KM 182.1 |
|---|---|
| Erosional Processes | <ul style="list-style-type: none"> <li>Scour around the upstream end of existing riprap (outflanking) contributed to embankment failure.</li> <li>Rapid, down-valley migration is occurring downstream of the revetment.</li> <li>It remains unclear whether channel incision is undermining the riprap toe.</li> </ul> |

| Highway and KM | Dempster Highway KM 182.1 |
|---|---|
| Mitigation Considerations and Recommendations | <ul style="list-style-type: none"> <li><b>Emergency:</b> address active scour at the upstream end of the riprap by regrading the slope and constructing a vegetated boulder revetment.</li> <li>Extend riprap farther upstream to reduce future outflanking risk.</li> <li>Monitor downstream migration to determine whether additional protection is required; a riprap or wood deflector may be warranted near the downstream culvert outlet.</li> <li>Consider removal of inner-bank gravel deposits to increase hydraulic capacity and reduce bend severity at least in the short-term.</li> </ul> |

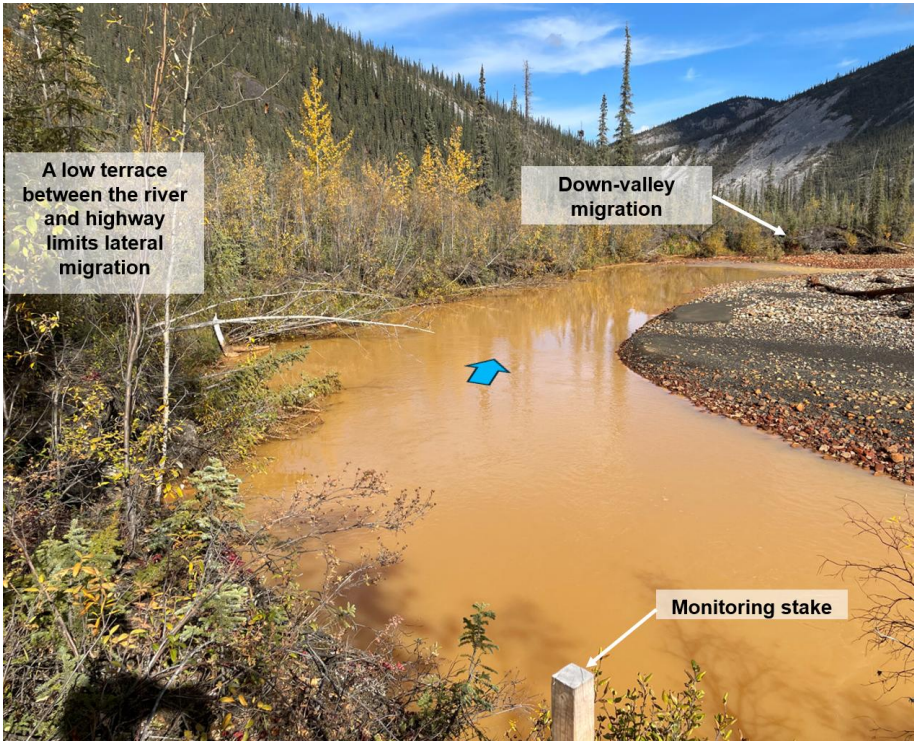
| <b>Erosional Processes</b> | <ul style="list-style-type: none"> <li>• Historical outer-bank erosion has resulted in rapid lateral migration.</li> <li>• The channel now abuts a low terrace that limits further outer-bank migration and may promote down-valley migration.</li> <li>• A meander neck cutoff or avulsion is possible.</li> </ul> |
| <b>Representative Visual</b> | <p>A photograph of Engineer Creek showing a low terrace between the river and highway, down-valley migration, and a monitoring stake. The image includes three callout boxes: 'A low terrace between the river and highway limits lateral migration' pointing to the left bank, 'Down-valley migration' pointing to the river's path, and 'Monitoring stake' pointing to a wooden stake in the foreground.</p> |

| <b>Mitigation Considerations and Recommendations</b> | <ul style="list-style-type: none"> <li>• Monitor using desktop methods or simple field approaches (e.g., monumented stakes).</li> <li>• Consider testing alternative mitigation approaches such as wood deflectors; construction access is favourable.</li> </ul> |

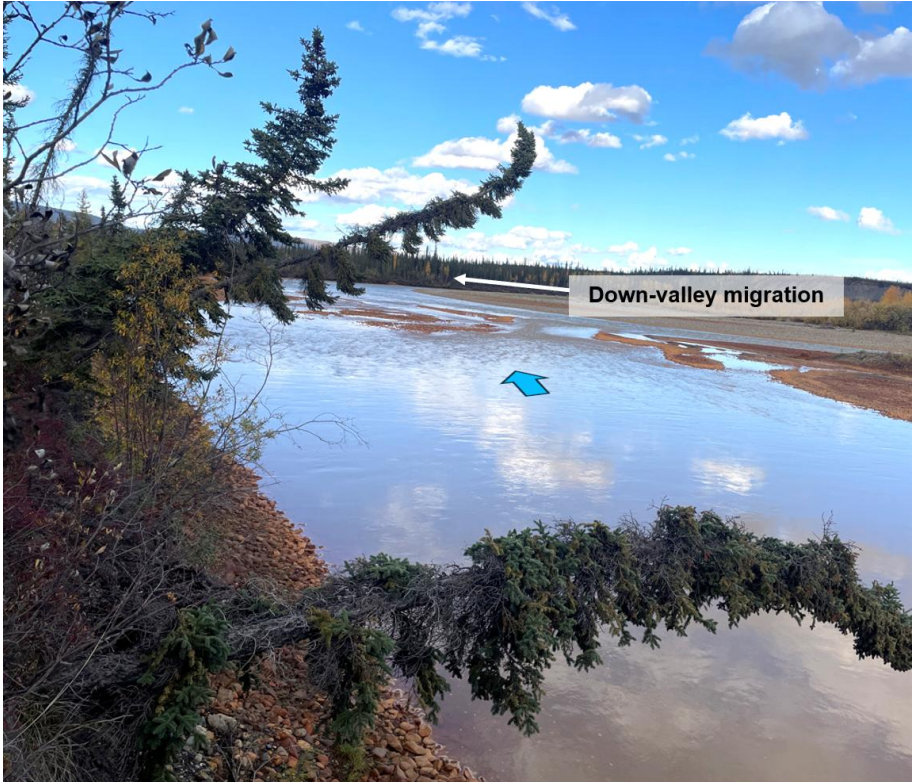
| <b>Erosional Processes</b> | <ul style="list-style-type: none"> <li>Channel migration is predominantly down-valley rather than toward the highway.</li> <li>The site is located within a multi-thread reach where flow distribution between channels controls erosion potential.</li> <li>Ice jams may modify the disposition of gravel bars in coming years and accelerate channel migration towards the road.</li> </ul> |

| <b>Mitigation Considerations and Recommendations</b> | <ul style="list-style-type: none"> <li>Monitor using desktop methods or simple field approaches (e.g., monumented stakes).</li> <li>Consider testing alternative (ice-run resistant) mitigation approaches such as large wood deflectors; construction access is favourable.</li> </ul> |
