Assessment of Risk to Infrastructure from Permafrost Degradation and a Changing Climate, Ross River

Calmels, F., B. Horton, L.P. Roy, P. Lipovsky and B. Benkert. 2016. Assessment of Risk to Infrastructure from Permafrost Degradation and a Changing Climate, Ross River. Northern Climate ExChange, Yukon Research Centre, Yukon College.

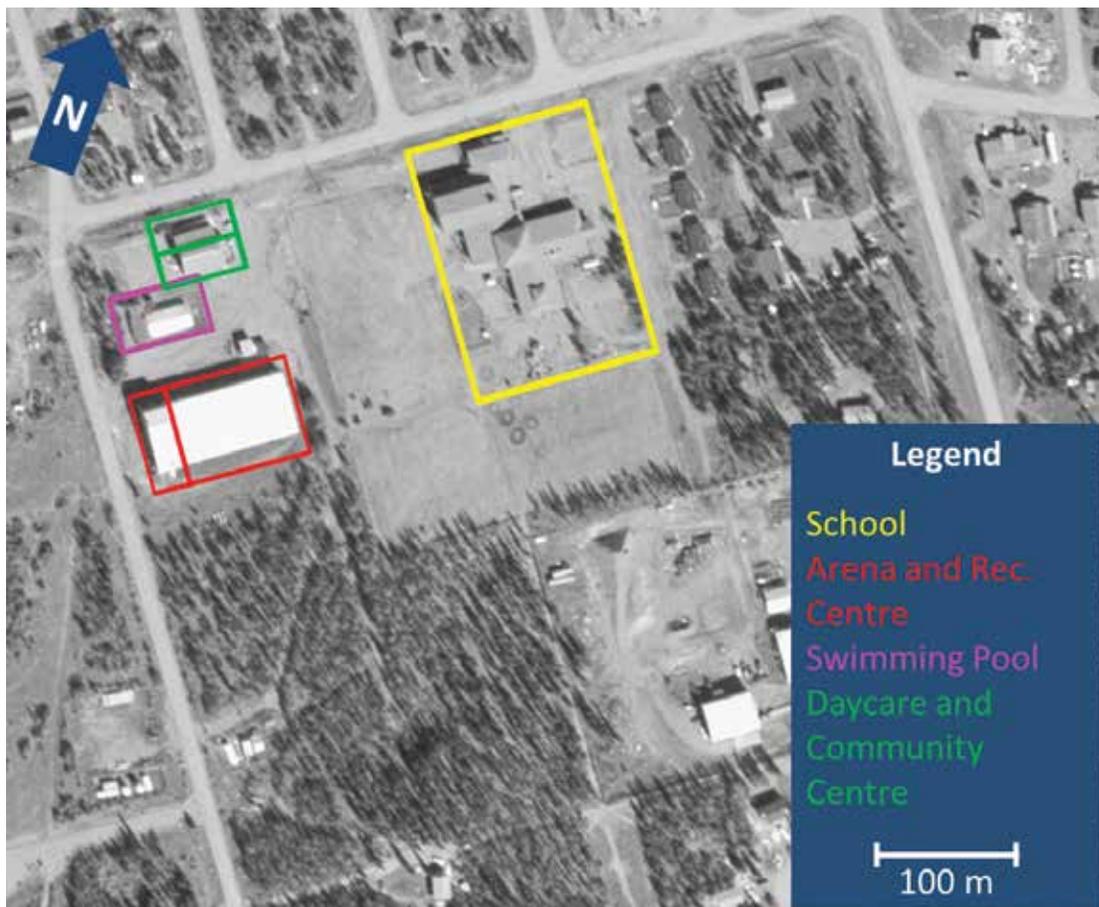
Figure 2.7.1 Four buildings being assessed

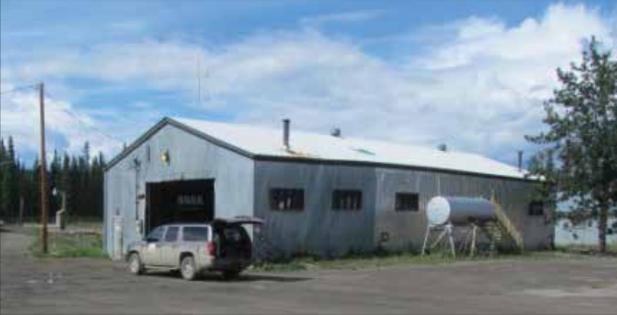
Year completed:	Original building in 1965; addition in 1969
	General site characteristics:	Flat gravel pad; no vegetation; poor drainage from site
	Foundation:	Concrete slab at grade; no cooling
	Use:	Grader maintenance shed
<p>Summary of damage from movement: Differential movement has caused siding to buckle and roofline to bow Substantial cracking in slab</p>		
<p>Site history (if known): No known history</p>

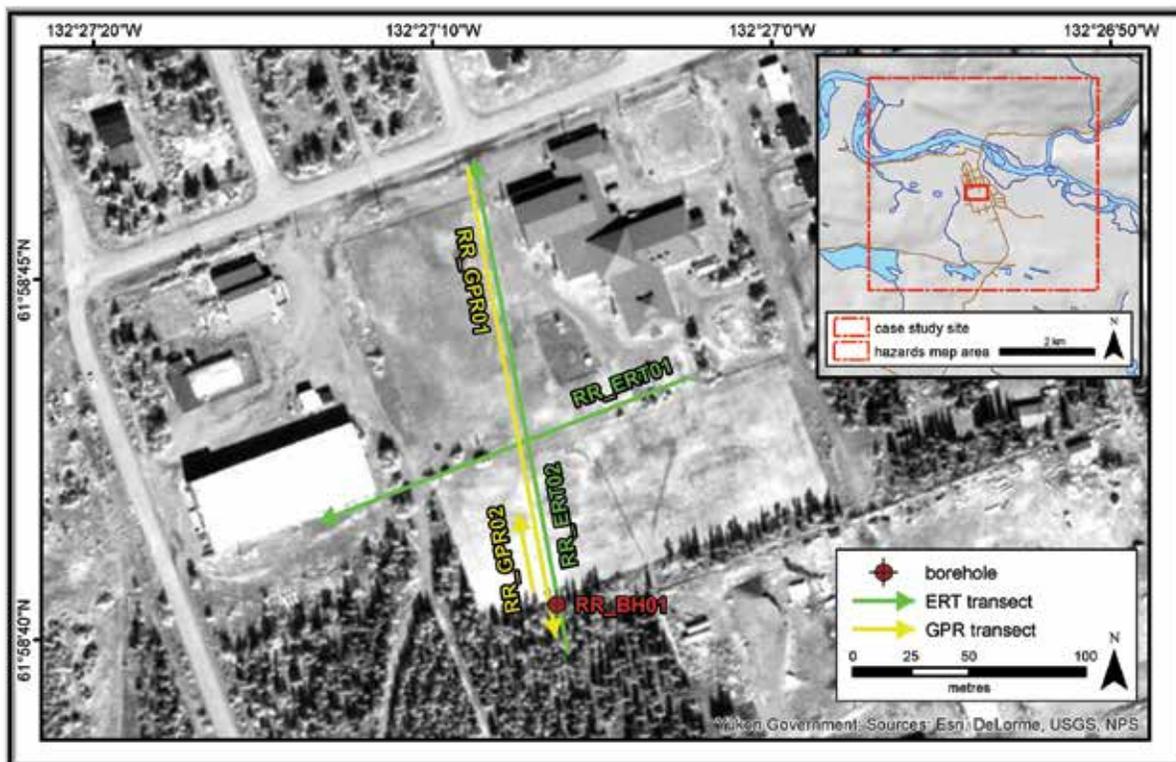
Figure 3.1.1 Locations of detailed site investigations Ross River area (Benkert et al. 2015)

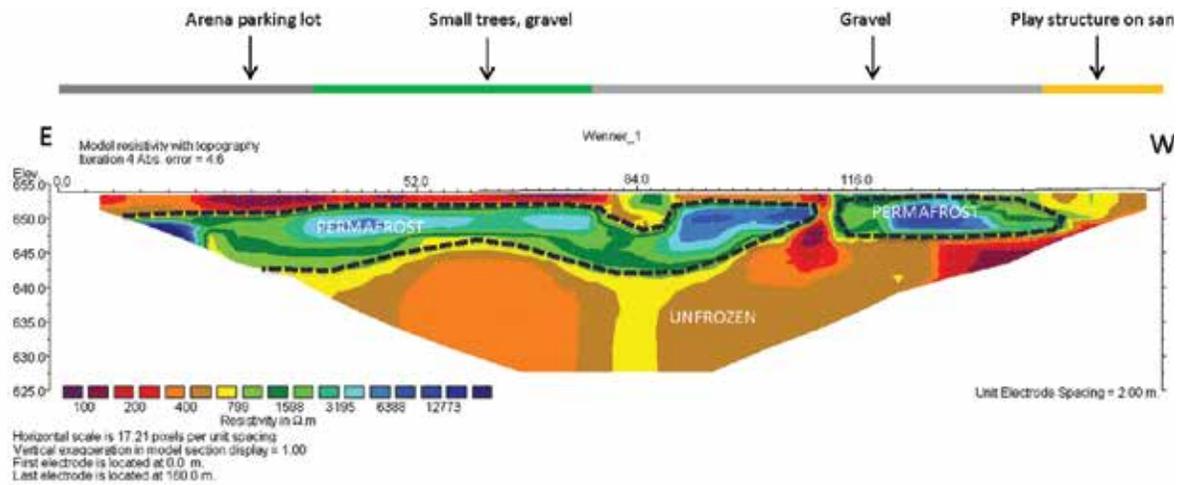
Figure 3.1.2 ERT profile RR_ERT01

Two ERT profiles were completed near the school: RR_ERT01 and RR_ERT02. RR_ERT01 (Figure 3.1.1 and 3.1.2), was 160 m long and oriented east/west from the arena parking lot to the playground structure south of the school. The profile shows a low-resistivity surface layer, inferred to represent an active layer 2 m thick that overlies a layer with higher resistivity (likely permafrost) that extends to depths of 10–12 m.

The base of the permafrost could be located at greater depths than those depicted in the profile. A through-going talik (i.e., unfrozen ground through the permafrost body) was observed from 108–112 m along the profile. Permafrost appears to be present beneath most of the profile, but is thinner to the west and subject to degradation overall.

Location: from the arena parking lot to the playground structure south to the school. Note: The profile has a maximum penetration depth of ~30 m. Likely areas of permafrost are shown as black dashed lines.

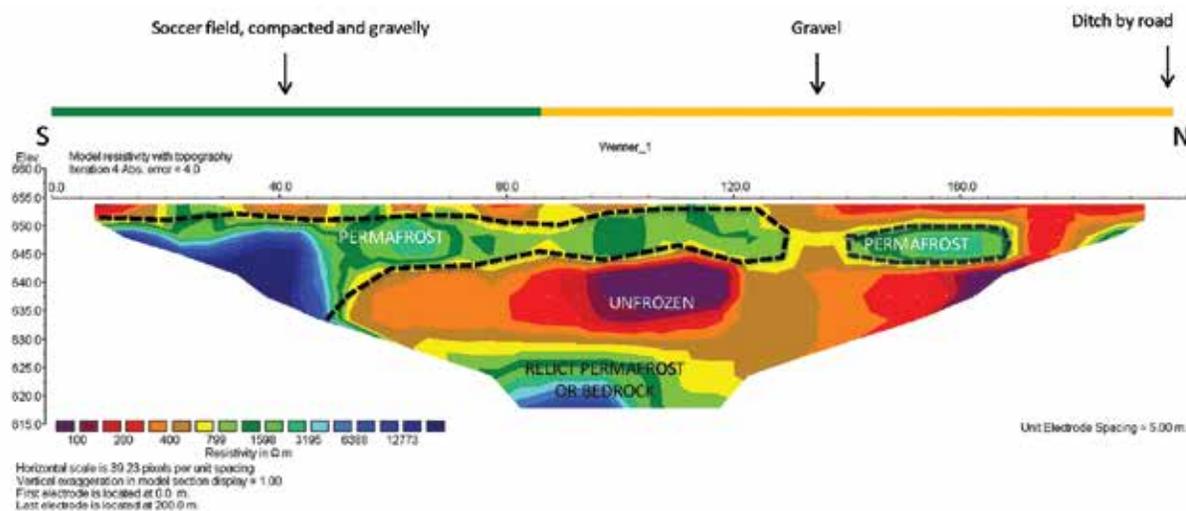
Figure 3.1.3 ERT profile RR_ERT02, on the west side of the school

RR_ERT02 (Figure 3.1.3) was 200 m long and oriented south/north. It was conducted west of the school, from the wooded area to the ditch beside Ross River Road (Figure 3.1.1). The profile is similar to RR_ERT01. It has a discontinuous low-resistivity layer (i.e., active layer) that overlies a higher-resistivity layer (i.e., permafrost), and a second low-resistivity layer that extends towards the base of the profile. However, there is an additional high-resistivity layer in the central part of this profile.

Note: The profile has a maximum penetration depth of ~30 m. Likely areas of permafrost are shown by black dashed lines.

Permafrost is believed to reach depths of up to 20 m at the southern end of the transect, decreasing to less than 10 m at about 80 m along the profile (near the transition to the surface gravel), and possibly disappearing or being overlain by a supra-permafrost talik within 30 m of the road. The high resistivity at depth at the southern end of this profile may represent high ice content or a stratigraphic change. The high resistivity below 30 m in the centre of the profile may indicate deep permafrost that is gradually thawing or a bedrock contact beneath the glaciolacustrine sediments.

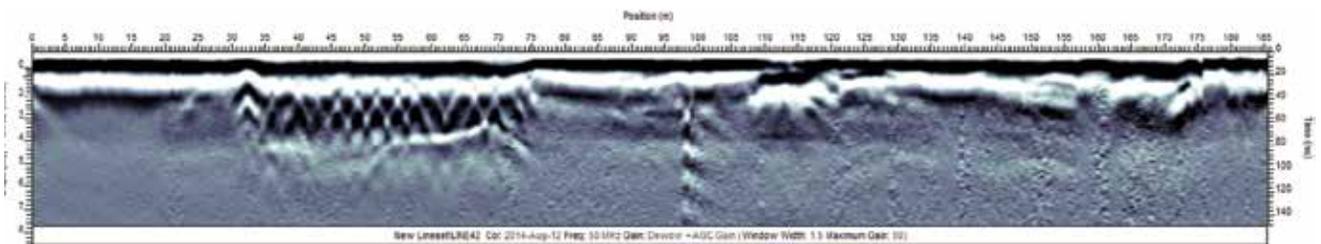
Figure 3.1.4 GPR profile (RR_GPR01) from the field next to the school

Two GPR surveys were performed in the central Ross River area. The first, RR_GPR01 (Figure 3.1.4), was 185 m long and ran parallel to ERT profile RR_ERT02. It was run from north to south. The signal penetrated to a depth of ~4 m. An irregular layer, believed to be the permafrost table, was observed at a depth of ~1.7 m at the beginning of the profile; it got deeper towards the forest, reached a maximum depth of ~3 m, and rose again to a depth of ~2 m under the forest cover.

Note: this illustrates a strong horizontal reflection at ~170 cm that likely corresponds with the top of the permafrost table.

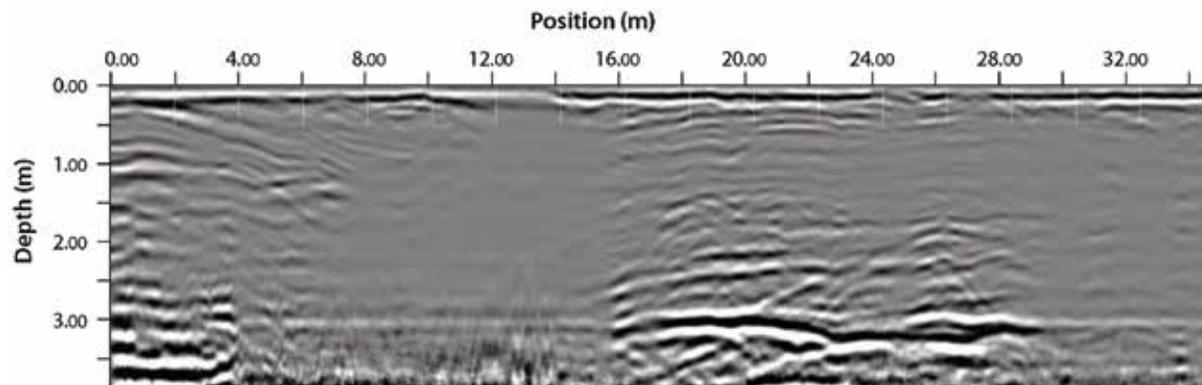
Figure 3.1.5 GPR profile (RR_GPR02) from the field adjacent to the school

The second GPR survey, RR_GPR02 (Figure 3.1.5), was run south-north, parallel to GPR survey RR_GPR01. It depicts the stratigraphic reflection at a depth of ~160 cm, which likely represents the contact between the active layer and permafrost. The hummocky appearance of the layers may correspond to the sand and gravel fill used in the construction of the playing field. This strong reflection could correspond to the change in resistivity visible on the south side of ERT profile RR_ERT02 (Figure 3.1.3).

Note: This runs parallel to GPR survey RR_GPR01 (see Figure 3.1.4), and shows a stratigraphic reflection at 1.6 m that likely corresponds with the top of the permafrost table.

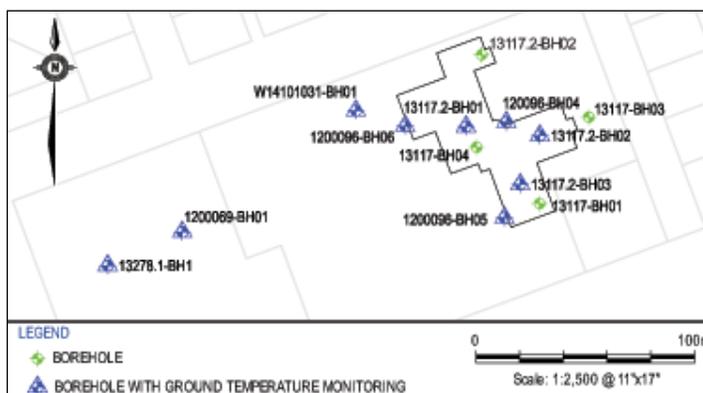
Figure 3.2.1 Location of boreholes in the study area

New development in central Ross River beginning in the late 1990s required several boreholes to be drilled. This work was completed by the private company Tetra Tech EBA between 1998 and the present. Figure 3.2.1 shows the locations of the 13 boreholes that were considered in this study; 9 of them were fitted with thermistor wires to monitor ground temperatures. Table 3.2.1 summarizes soil and permafrost properties observed in these boreholes. Borehole logs for the 9 boreholes with thermistor wires are presented in the Annex (Tetra Tech EBA, unpublished data).

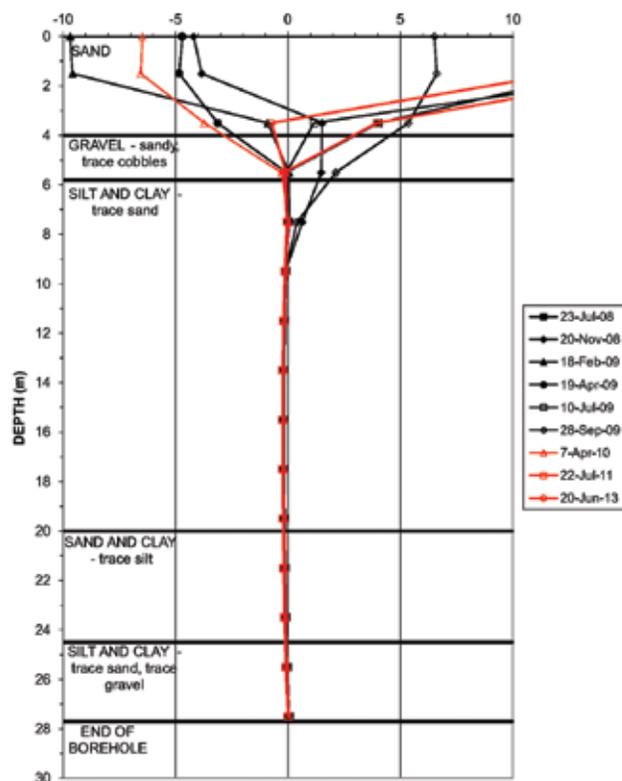
Figure 3.3.1 Ground temperature measurements ($^{\circ}\text{C}$) from the schoolyard borehole

The ground temperature measured at borehole W14101031-BH01, located in the schoolyard west of the school (see Figure 3.2.1), provides the most information about permafrost conditions in the study area. As shown in Figure 3.3.1 and Table 3.3.1, ground temperatures were measured from July 2008 to June 2013. Ground temperatures are presented overlaying the stratigraphy described in the borehole log.

The ground temperature measurements provide two crucial pieces of information. First, the measurements show that the ground is frozen ($T < 0^{\circ}\text{C}$) down to the bottom of the borehole at 27.7 m. This suggests that permafrost is thicker than 20 m and that its base could be as deep as 30 m. Second, permafrost temperature is warm: close to 0°C . This means that only the ice present in the fine glaciolacustrine sediment is preventing permafrost thaw. At this temperature, liquid water content is likely significant and permafrost is very sensitive to degradation.

The active layer appears to have thickened over time, with the top of permafrost deepening from 7.0 m to 9.5 m. These data suggest that permafrost in the study area might be thicker than previously reported. This will affect the magnitude and duration of any subsidence.

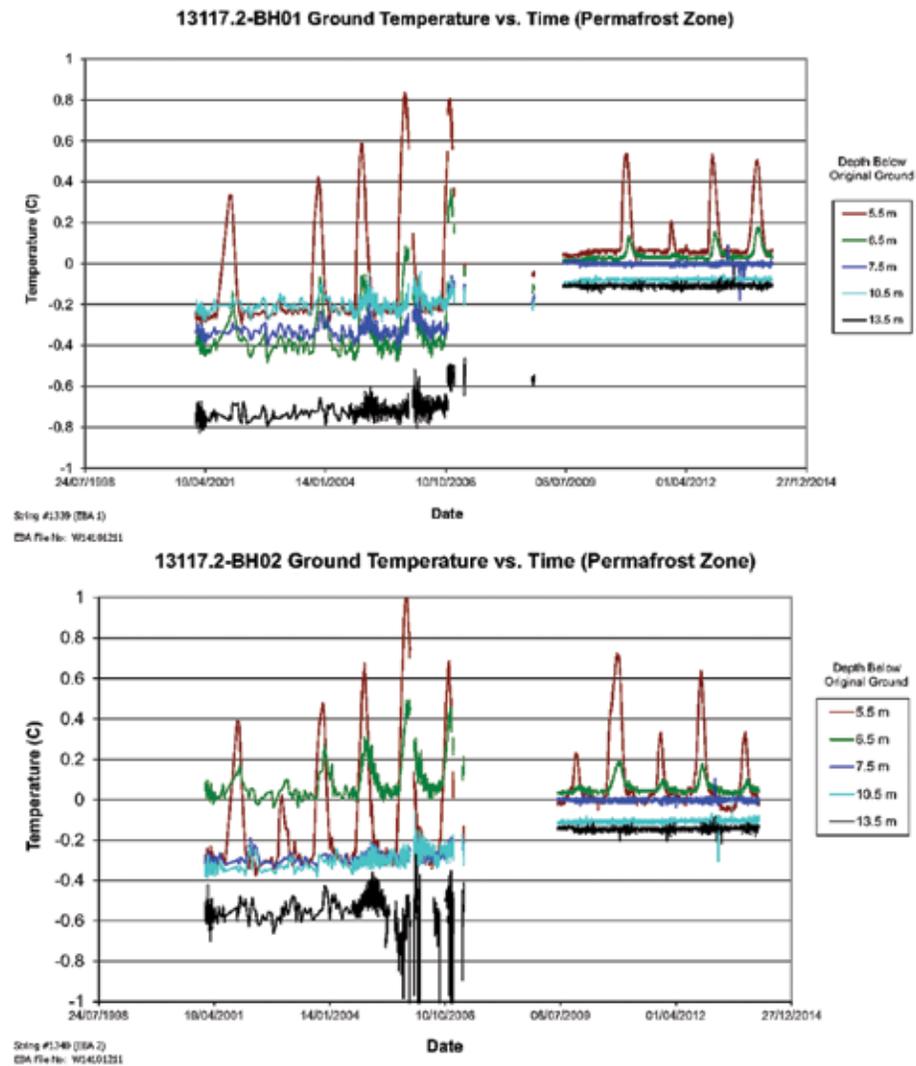
Figure 3.3.2a and b Ground temperatures recorded by Tetra Tech EBA below the school
Source: Boreholes 13117.2-BH01 and 13117.2-BH02

The first group of borehole temperatures (13117.2-BH01 to BH03) is presented in Figures 3.3.2a and b and 3.3.3a. The records show that the deepest temperatures, at 13.5 m, have increased between 0.5 and 0.6°C. These temperatures are now close to -0.1°C. It is revealing that while the early permafrost temperature curves showed fluctuations, more recent curves are almost flat and have no fluctuation. This indicates that permafrost is close to thawing. Typically, the freezing and thawing of the liquid water content prevent seasonal temperature fluctuation, but this is not occurring in these boreholes. Consequently, permafrost as deep as 13.5 m is close to thawing.

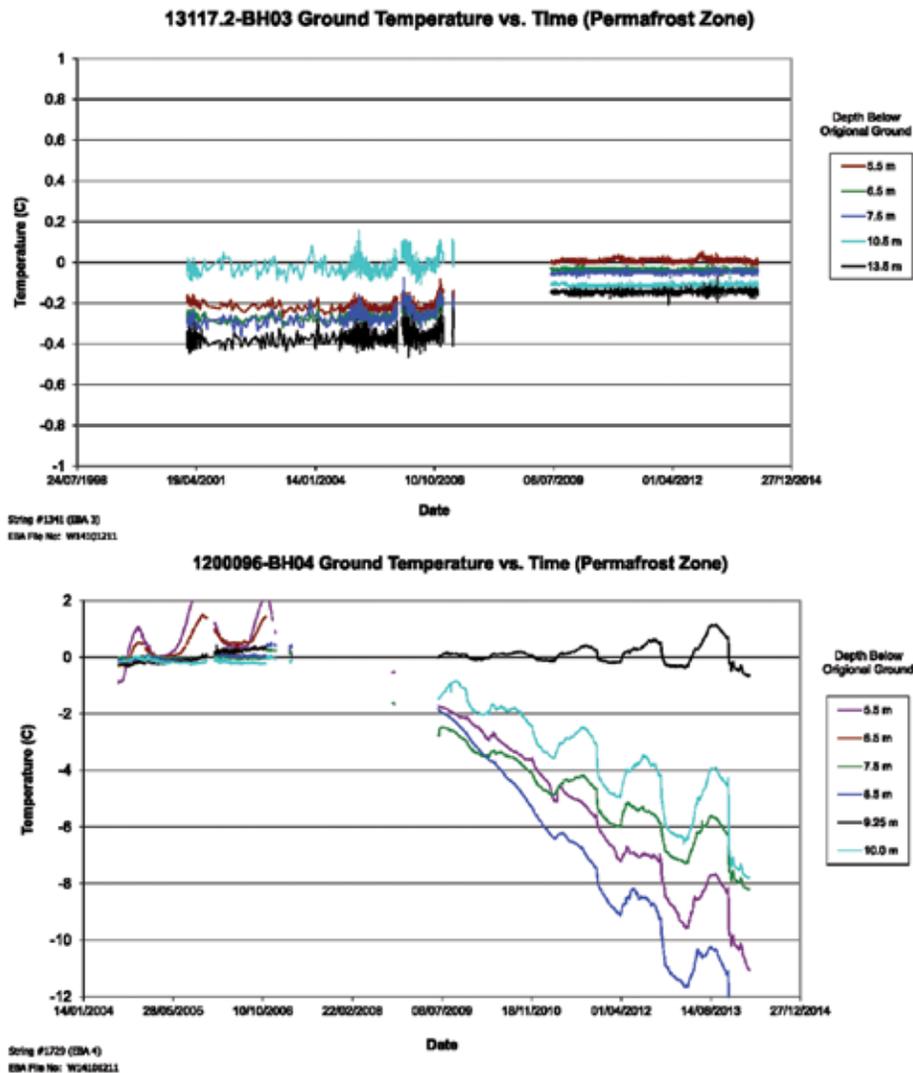
Figure 3.3.3a and b Ground temperatures recorded by Tetra Tech EBA below the school Source Boreholes 13117.2-BH03 and 1200096-BH04

The second group of borehole temperatures (1200096-BH04 to BH06) is presented in Figures 3.3.3b and 3.3.4a and b. These are more problematic to interpret: although the data recorded from 2004–08 seems rational, the data from 2009–14 seems questionable. The data from 2004–08 shows very warm permafrost temperatures — close to 0°C — in the three boreholes.

We hypothesize two possible explanations for the inconsistencies: 1) the depths may not be labelled properly in the logger program, since Figures 3.3.3b and 3.3.4a and b show cooling trends at all sensors, but at random depths; or 2) because all three boreholes show unrealistically cold temperature, there may be other issues with the setup. The resistors in the thermistors may be faulty, or the conversion of resistance to temperature may have errors.

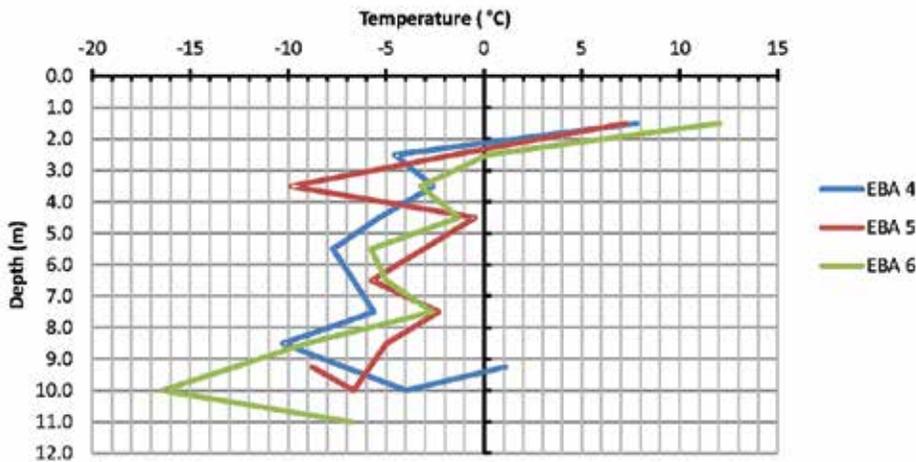
Figure 3.3.5 Ground temperature curves for wires EBA 4, 5 and 6 in 1200096-BH04, -BH05, and -BH06 Location: near the school, August 13, 2013

In 2009, after a period of inactivity, the thermistor wires were connected to new data loggers. Between 2009 and 2014, the data curves show a cooling trend that cannot be confirmed, considering inconsistencies in the recorded data. To better understand this, the temperature record from a single day (August 13, 2013) was plotted in a graph showing temperature vs. depth (Figure 3.3.5). The figure shows erratic temperatures as a function of depth, with a temperature variation of more than 17 degrees for a single depth for different boreholes. Some of the temperatures observed deep in the profile are three to four times colder than the MAAT. These data seem aberrant and should be verified.

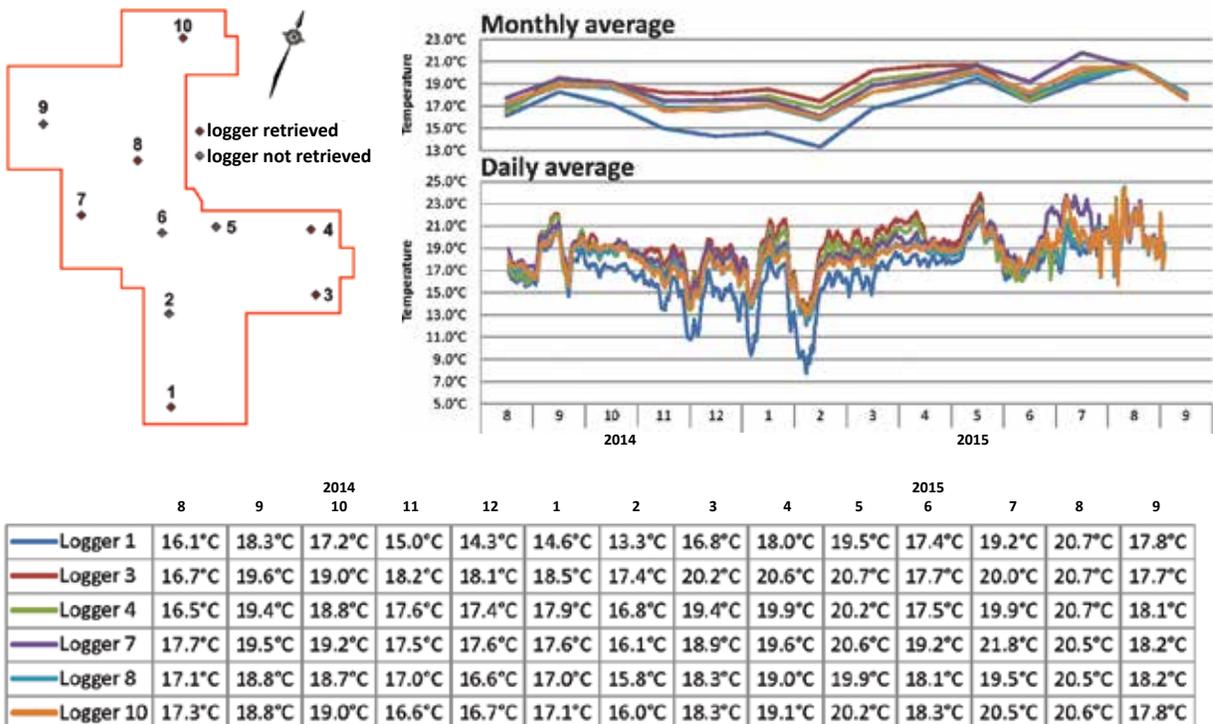
Figure 3.3.6 Temperature recorded at ground surface level in the crawlspace of the school

As described above, pendant loggers were placed on the floor of the school crawlspace. Figure 3.3.6 shows the location of the loggers and plots of the recorded temperatures. Logger 1 recorded the coldest temperatures, varying between 13.3 and 20.7°C during the period of the survey (about one year); other loggers show temperatures that vary between 16.0 and 20.7°C. The overall average of the air temperature at the floor surface during the period of the survey is 18.4°C. Temperatures this high are likely to disturb the underlying ground thermal regime.

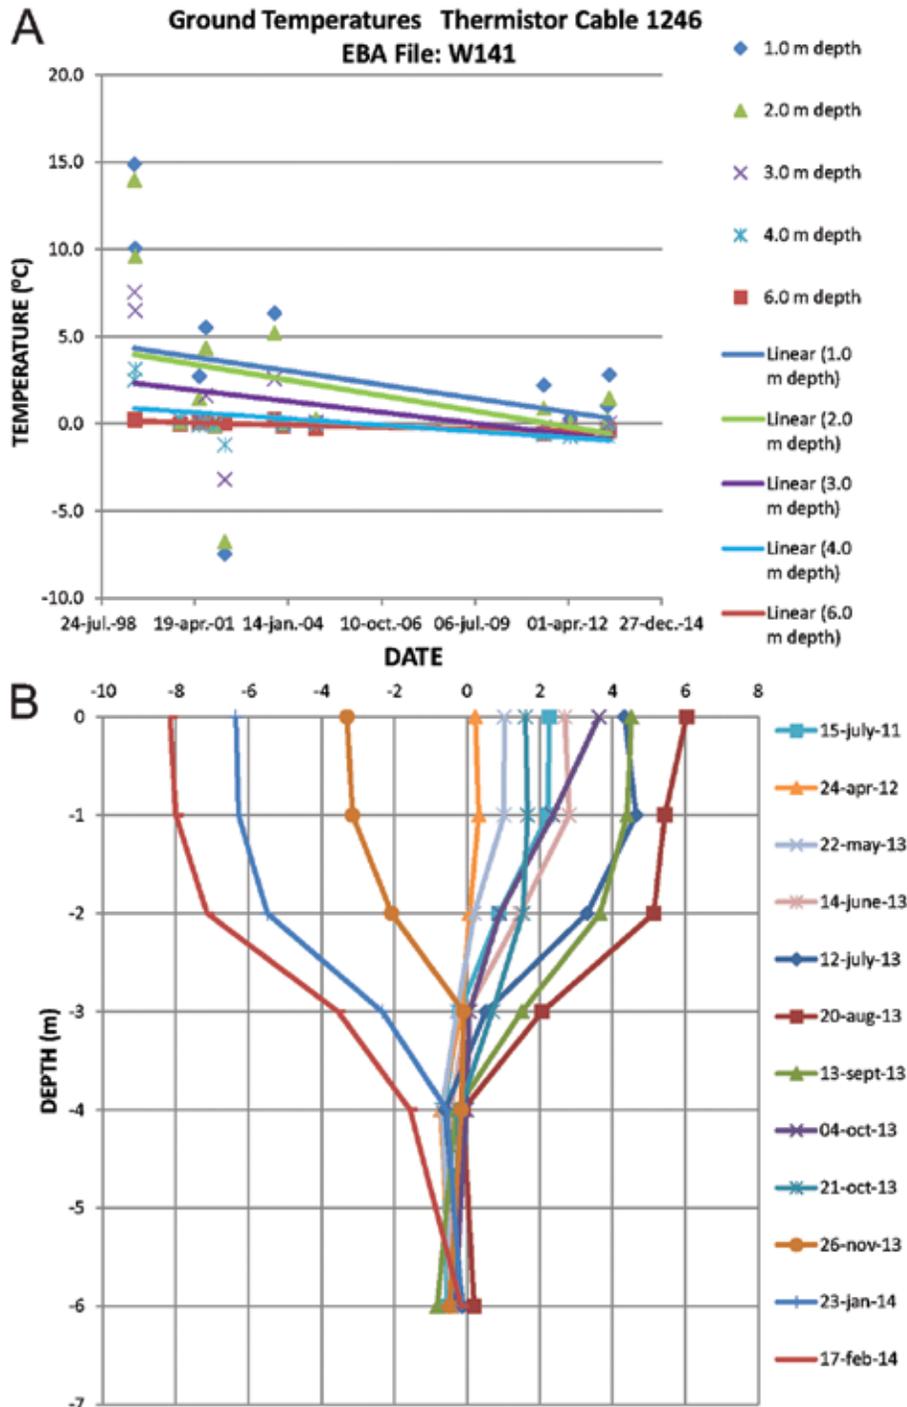
Figure 3.3.7a and b Ground temperature recorded at various times by Tetra Tech EBA under the pool

The thermistor wire below the pool measures ground temperatures to a depth of 6 m. Figure 3.3.7a and b shows the ground temperatures that were manually measured using a multimeter at various times between July 1998 to February 2014.

Figure 3.3.7a shows a trend of cooling from 1998 to 2014; Figure 3.3.7b shows that the deepest temperature (at 6 m) has warmed steadily over time.

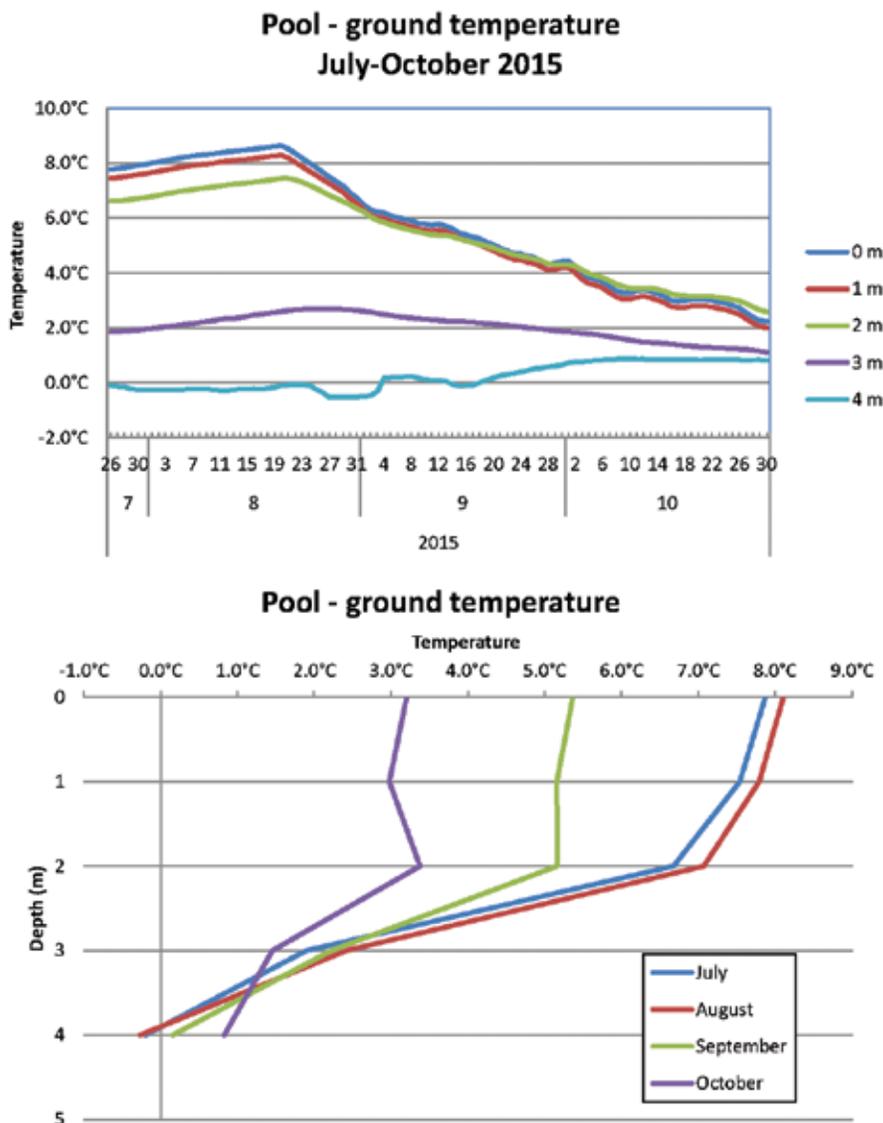
Figure 3.3.8a and b Ground temperature below the pool, July–October 2015

More recent data, acquired by means of a newly installed CR1000 logger from July to October 2015, are shown in Figure 3.3.8a and b. This shows that the ground is unfrozen down to 4 m deep. A bad connection with the logger prevented the temperature at 6 m from being recorded, but the curves suggest that the ground was likely unfrozen at 6 m in October.

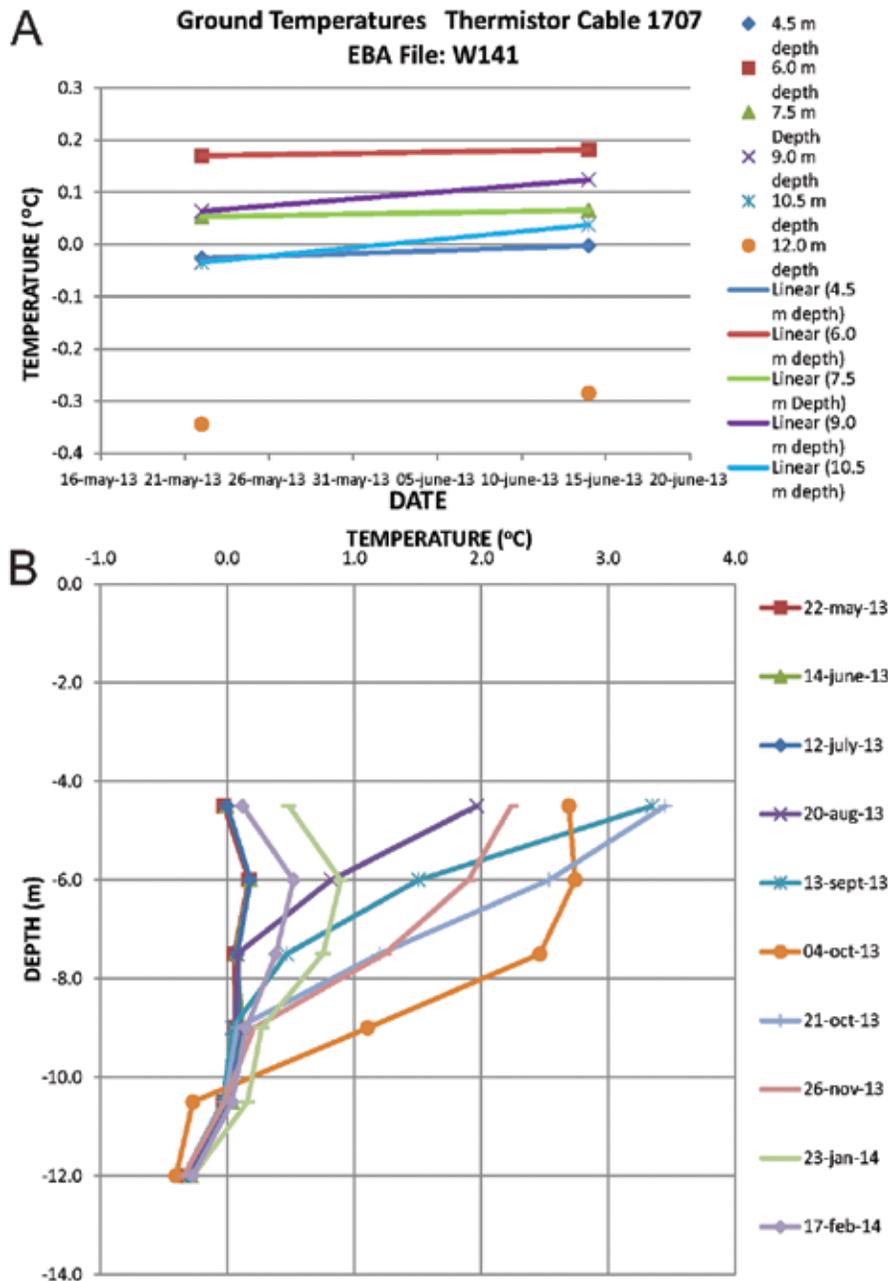
Figure 3.3.9a and b Ground temperature recorded at various times by Tetra Tech EBA
Location: the yard south of the Community Centre

The thermistor wire located in the yard south of the community centre measures ground temperatures down to the depth of 12 m. Figure 3.3.9 shows the ground temperatures that were manually measured using a multimeter at various times between May 2013 to February 2014. Both Figure 3.3.9a and Figure 3.3.9b show a warming trend. The record shows that the permafrost table has moved down to a depth of 10.5 m.

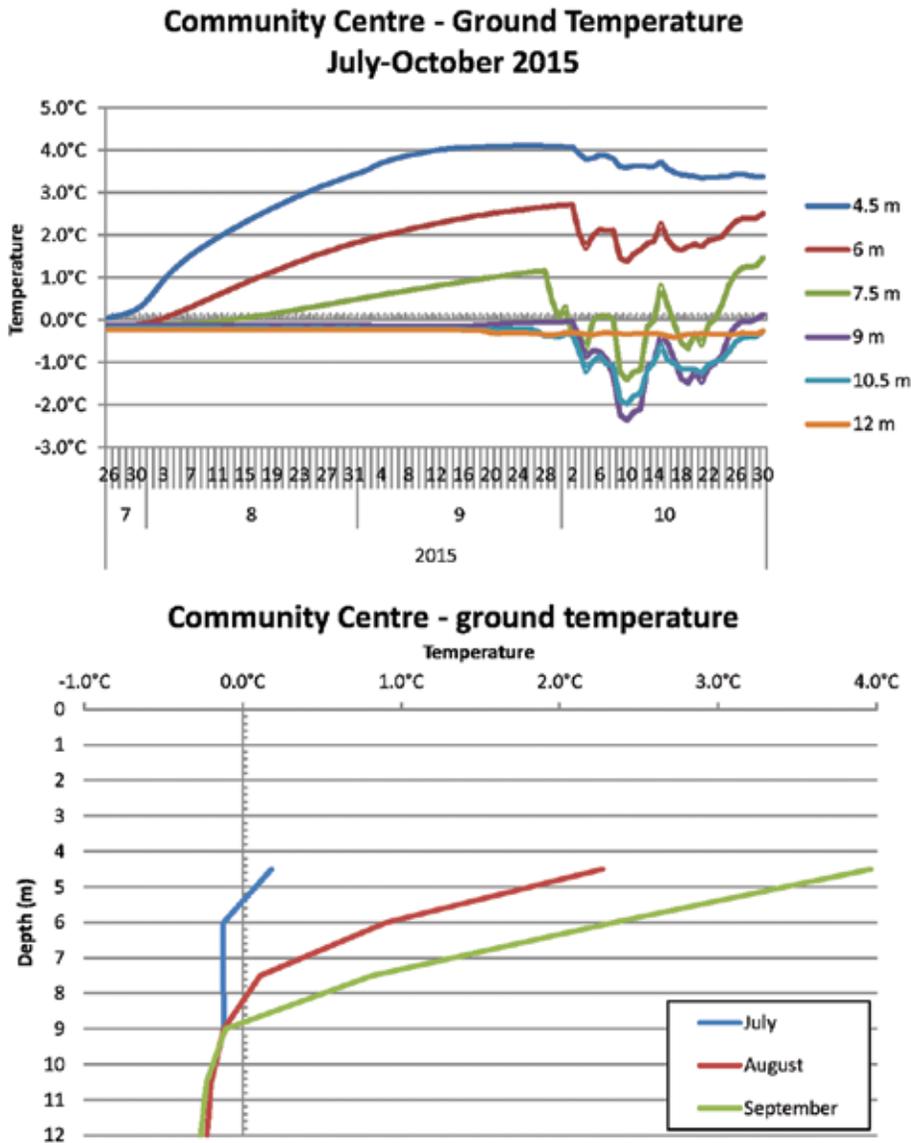
Figure 3.3.10a and b Ground temperature recorded July–October 2015

At the deepest sensor (12 m) the temperature is -0.3°C , but has steadily warmed over time. More recent data, acquired by means of a newly installed CR1000 logger from July to October 2015, are shown in Figure 3.3.10a and b. The figure shows that the ground is frozen down to 12 m depth. Water condensation on the logger made the temperature reading unstable.

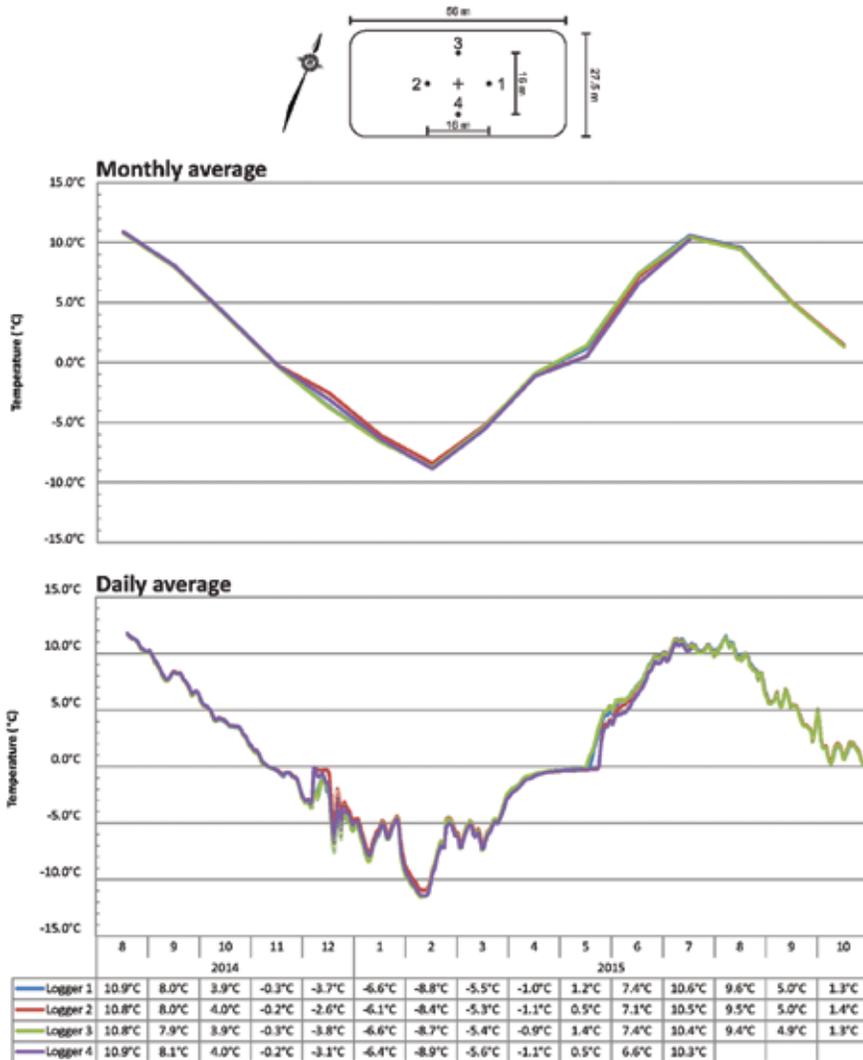
Figure 3.3.11 Temperatures recorded in the ice rink area of the arena, 15 cm below the ground surface
 Note: Locations of the loggers are shown in the upper part of the figure

The location and temperatures recorded by four U12 loggers buried 15 cm in the gravel below the arena are shown in Figure 3.3.11. The four records show the same temperature trend, demonstrating that the icing and thaw of the ice in the arena is the same everywhere in the ice rink

area. The mean annual temperature 15 cm below the ground surface is 1.2° C (from August 2014 to October 2015). These temperatures are well above 0°C and confirm that the arena ice prevents permafrost cooling. Permafrost is currently degrading below the arena.

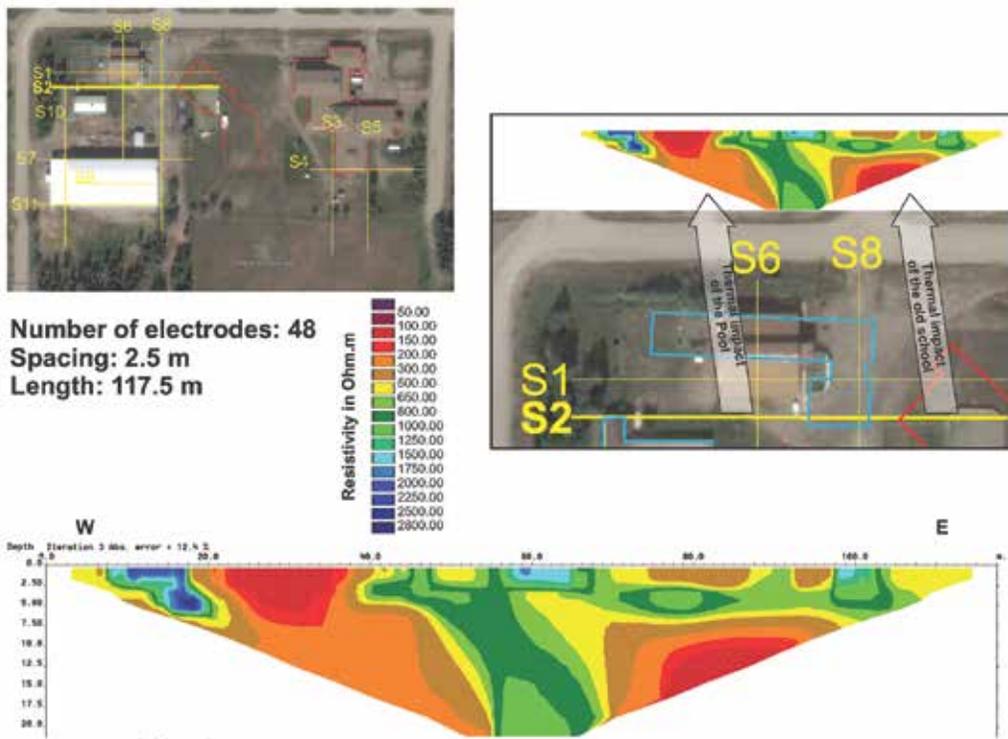
Figure 3.4.2 ERT survey S2, made south of the community centre, oriented west/east

Survey S2 (Figure 3.4.2) was made south of the community centre, and was oriented west/east. Low resistivity areas were detected between 20 to 40 m and between 80 m and the end of the survey line. The first area may be attributed to the reported leak of the pool. The second area coincides approximately with the location of the former school.

There are limited data, but based on evidence from other buildings in similar conditions elsewhere in the north, it is likely that permafrost warming was induced by the former buildings. This warming has resulted in an increase of liquid water content in the ice-rich glaciolacustrine silt.

Although this ground is frozen, the presence of liquid water has significantly decreased electrical resistivity at the location of the former buildings. At this site, frozen ice-rich silt may be less resistive than unfrozen alluvial gravel (which is unusual). These results raise the possibility that damage to the daycare is the result of ongoing thermal impacts from the former curling rink.

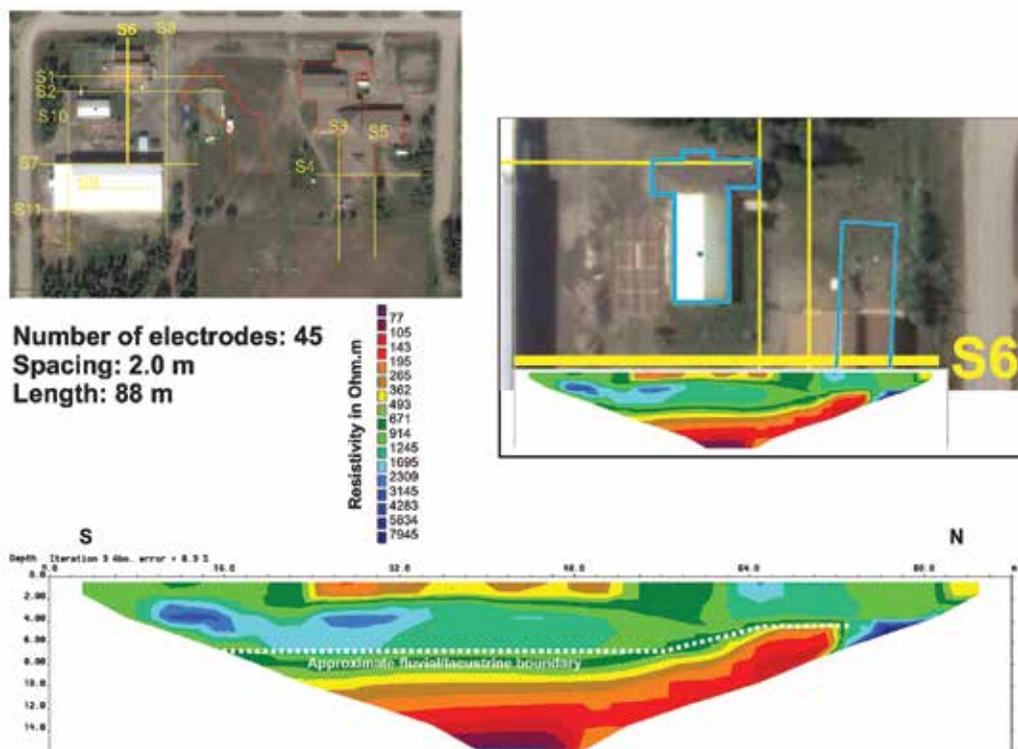
Figure 3.4.3 ERT survey S6, made east of the pool and community centre, oriented south/north

Survey S6 (Figure 3.4.3) was made east of the pool and community centre and was oriented north/south. Low resistivity areas were detected between 32 to 48 m (deeper in the profile) and between 66 to 74 m (closer to the surface) along the survey line. In this profile, the borehole logs indicate that the top of permafrost is at about 9–10 m depth and the contact between gravel and silt is less deep (about 7 m). This makes it difficult to distinguish the influence of the soil texture from that of the thermal state. The data suggest, however, that the first area of low resistivity coincides with the area where the pool has leaked, while the second area can be attributed to either the former curling rink and/or the present-day community centre. Some high resistivity sections were detected at the south and north ends of the profile. These coincided with open areas that are free of buildings and vegetation. The soil may still have been seasonally frozen at the time of the survey.

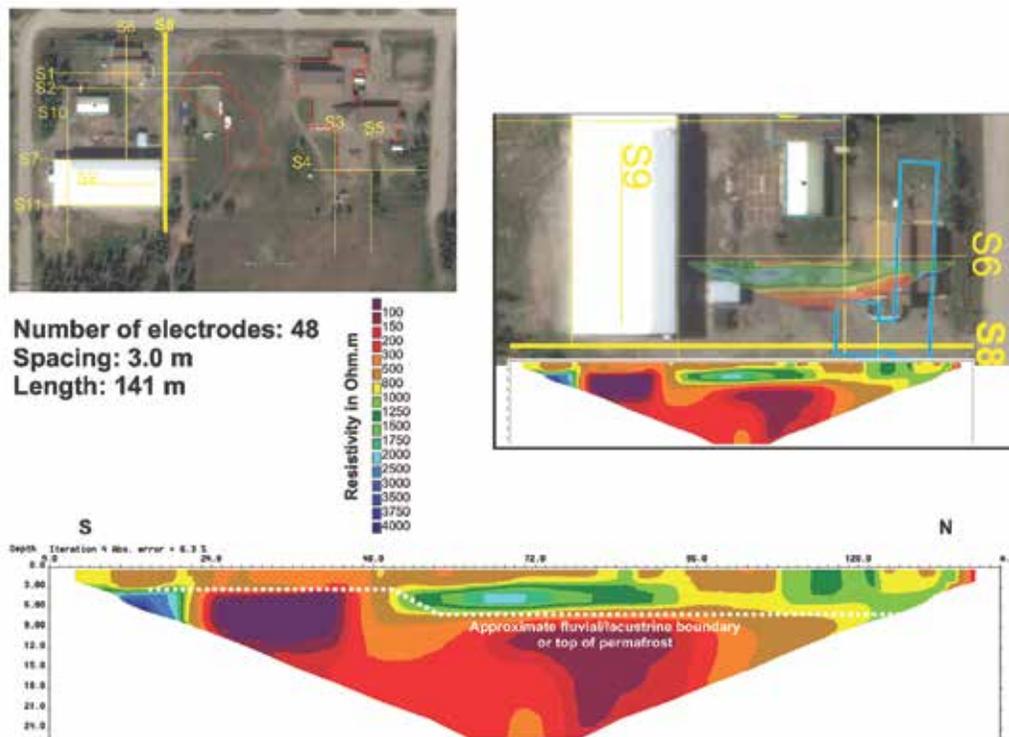
Figure 3.4.4 ERT survey S8, made 40 m east of the pool and community centre, oriented south/north

Survey S8 (Figure 3.4.4) was parallel to S6, but about 25 m east of it. The survey shows similar results to S6, but with a larger scope. Low-resistivity areas were recorded between about 24 to 45 m and about 70 to 95 m (deeper in the profile) along the survey line. The first low-resistivity area is located in front of the arena. This could be attributable to the presence of the building or/and disturbance by the meltwater from the skating rink each spring. The second low-resistivity area is consistent with the one observed in S6. It is bulb-shaped and starts at about 9 m depth. Although it is 40 m away

from the pool, it matches the shape of the low resistivity area observed in S6, indicating that it is also part of the zone that has been influenced by the pool. Disturbances from the former school may also contribute to this low-resistivity zone.

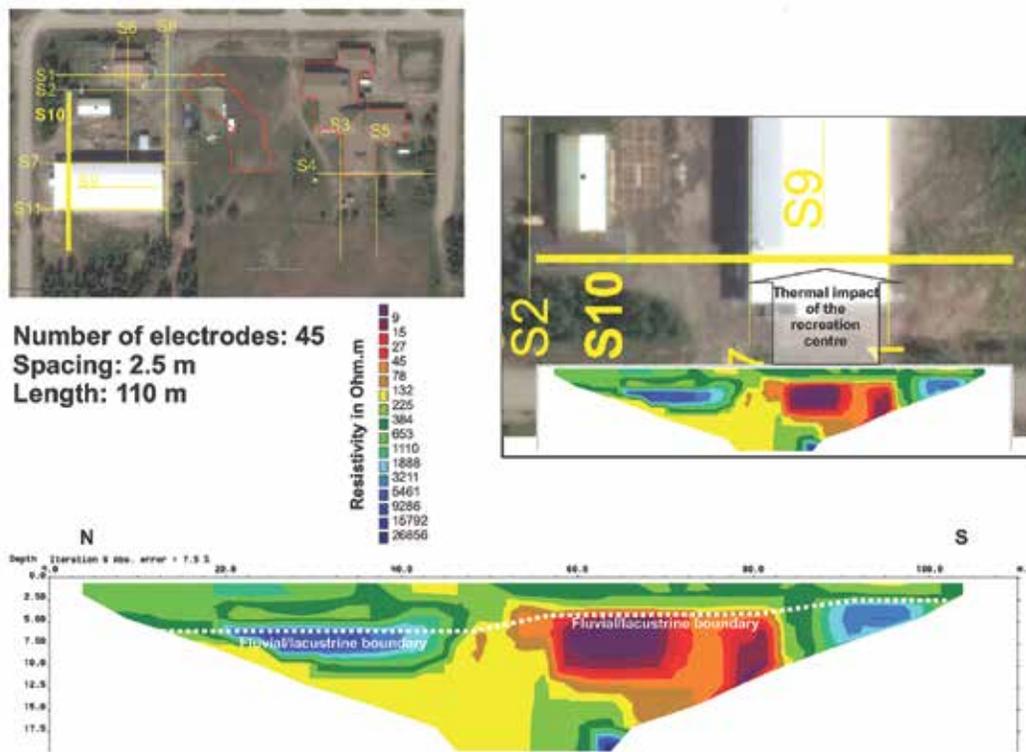
Figure 3.4.5 ERT survey S10, made west of the pool and arena, oriented north/south

Survey S10 (Figure 3.4.5), oriented north/south, clearly shows the impact of the recreation centre on the permafrost. Lower resistivity (red in the profile) is visible between about 60 and 80 m on the survey line. This impact appears to continue down to about 13 m. Two higher-resistivity areas occur from about 20 to 45 m and from 87 to 100 m. Those coincide with open areas where snow is not likely to accumulate in winter. The boundary between fluvial and lacustrine sediments is assumed to slope from about 2.5 m depth at the north end of the profile to about 6 m at the south end.

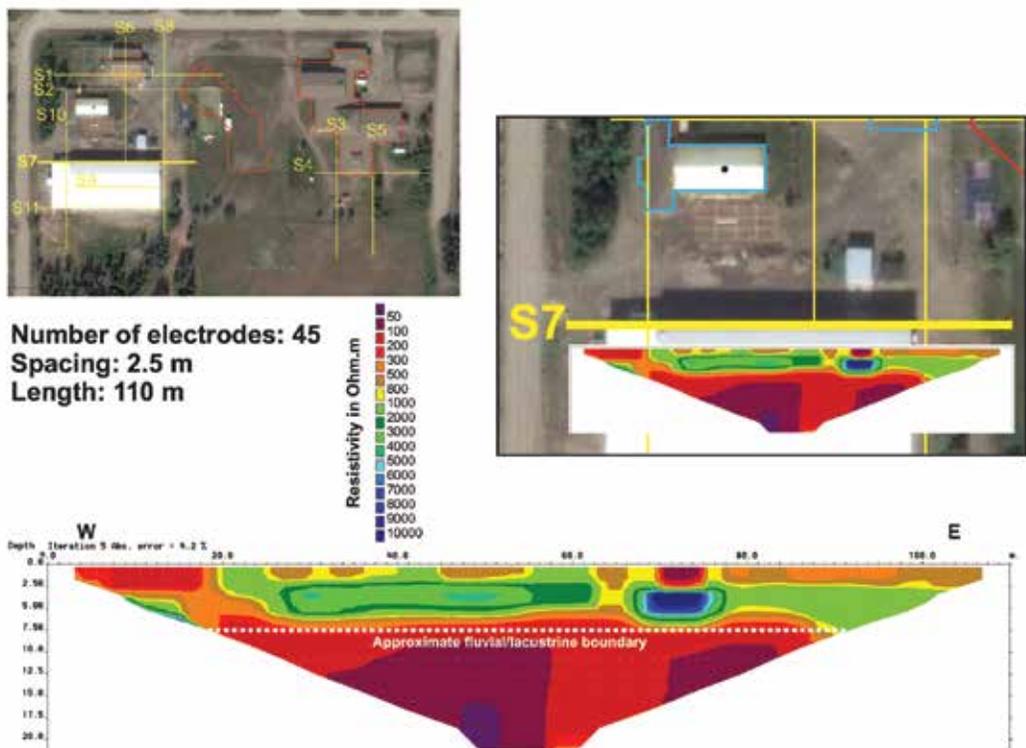
Figure 3.4.6 ERT survey S7, made along the north side of the recreation centre/arena, oriented west/east

Survey S7 (Figure 3.4.6) was done along the north side of the arena/recreation centre. It was oriented west/east. The profile shows a transition between resistive and less resistive material at about 7.5 m depth, around the 300 Ohm.m threshold. This transition may indicate the boundary between gravelly alluvial sediment and silty lacustrine material. Based on the observations around the community centre, permafrost may still be present, but very warm. Shade from the building may favour the preservation of seasonal frost (shown as higher resistivity) that was observed in the gravel in the upper part of the profile.
