Assessment of Risk to Infrastructure from Permafrost Degradation and a Changing Climate, Ross River

Calmels, F., B. Horton, L.P. Roy, P. Lipovsky and B. Benkert. 2016. Assessment of Risk to Infrastructure from Permafrost Degradation and a Changing Climate, Ross River. Northern Climate ExChange, Yukon Research Centre, Yukon College.

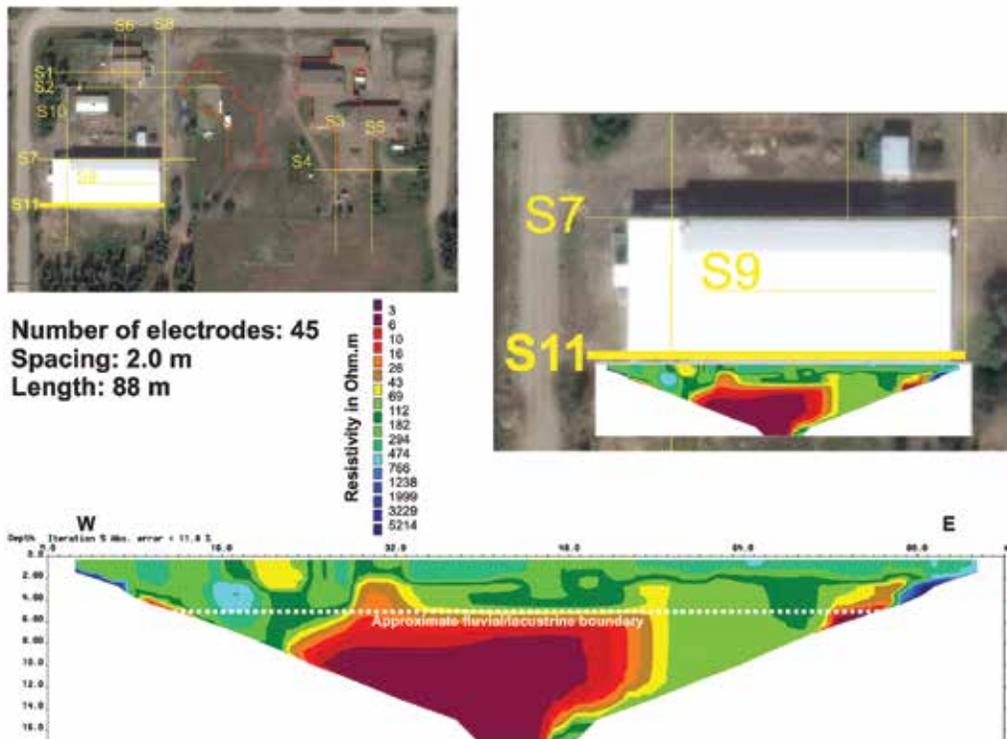
Figure 3.4.7 ERT survey S11, made along the south side of the recreation centre/arena, oriented west/east

Survey S11 (Figure 3.4.7) was done along the south side of the arena/recreation centre. It was oriented west/east. The profile is similar to S7, with a threshold between resistive and less resistive material. In S11, the threshold is shallower than on the north side (in S7); it is about 5 m depth and around the 70 Ohm.m threshold. The lower-resistivity threshold may be due to the south-facing aspect creating warmer ground temperatures and a deeper permafrost table. The higher gravel/silt boundary is consistent with the observations in survey S10. The low-resistivity area observed between about 20 to 50 m may be attributable to the drainage of the meltwater from the rink. External factors such as previous buildings or localized snow drifting may also be relevant.

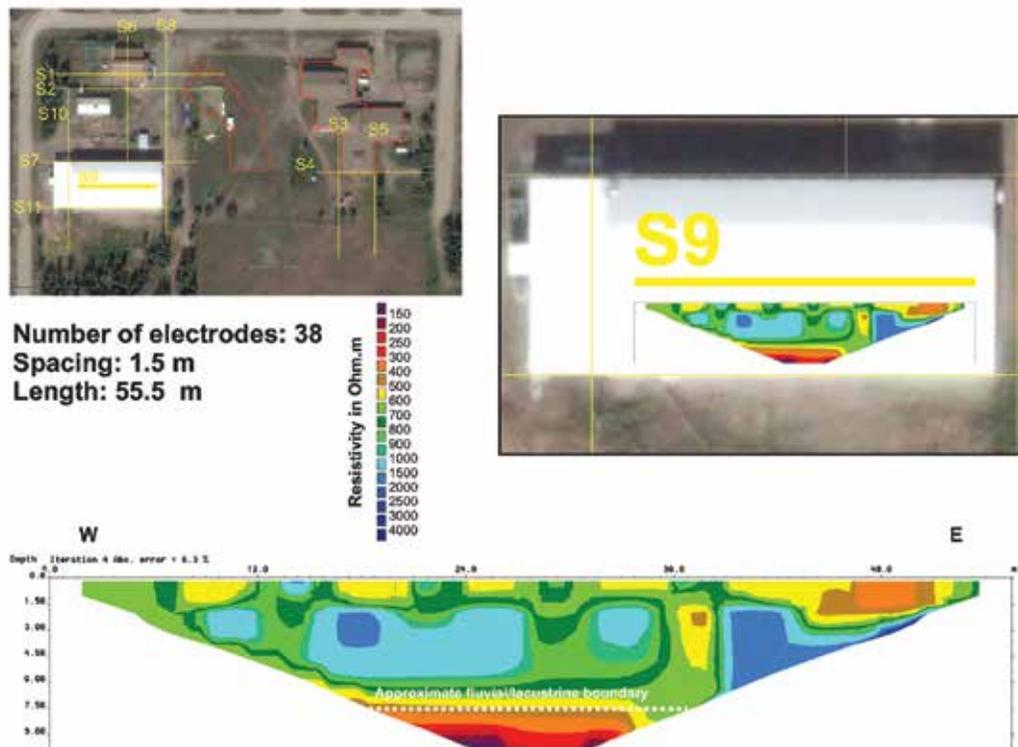
Figure 3.4.8 ERT survey S9, made in the middle of the arena rink, oriented west/east

Survey S9 (Figure 3.4.8) was made in the middle of the arena rink, and oriented west/east. This was a short survey, with electrodes placed closer together than usual. The resulting profile is limited in depth to about 10 m, but with higher resolution. Like several other surveys, this survey indicates a contact between gravel and silt at about 7.5 m. The resistivity is similar to that detected on the north side of the arena.

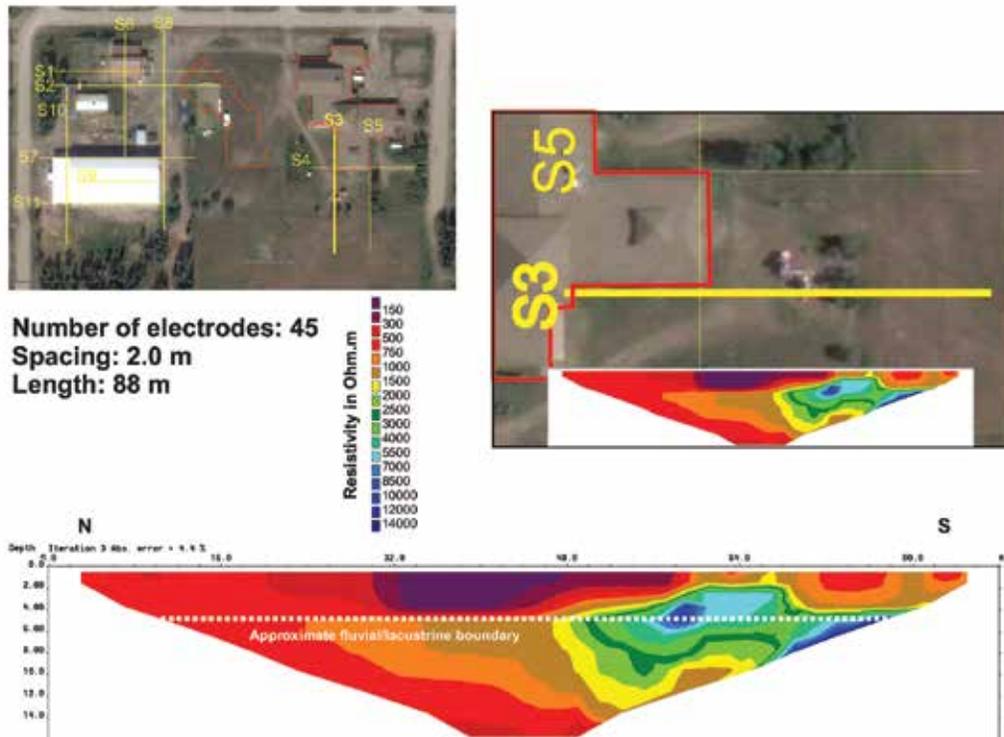
Figure 3.4.9 ERT survey S3, made on the west side of the school’s south wing, oriented north/south

Survey S3 (Figure 3.4.9) was performed on the west side of the south wing of the school, and was oriented north/south. A sharp transition is indicated at about 5 m, where resistivity is near 750 Ohm.m. The logs of nearby boreholes show the limit between fluvial coarse (gravel) and fine lacustrine (silt) sediment at 6 m depth (1200096-BH05) and 4 m depth (13117.2-BH03; see Figure 3.2.1 and Annex). As a result, it can be assumed that the threshold observed on the ERT profile is attributable to the gravel/silt limit. Resistivity values are very low in front of the south end of the wing. This may be due to moisture in the ground or/and the southern exposure. Resistivity values are higher at the southern end of the profile, beginning at about 50 m. This coincides with the playground and sports areas, where the field is exposed and not subject to the impact of the school; in addition, snow is likely either compacted here by wind and children playing outdoors or is blown clear of the area.

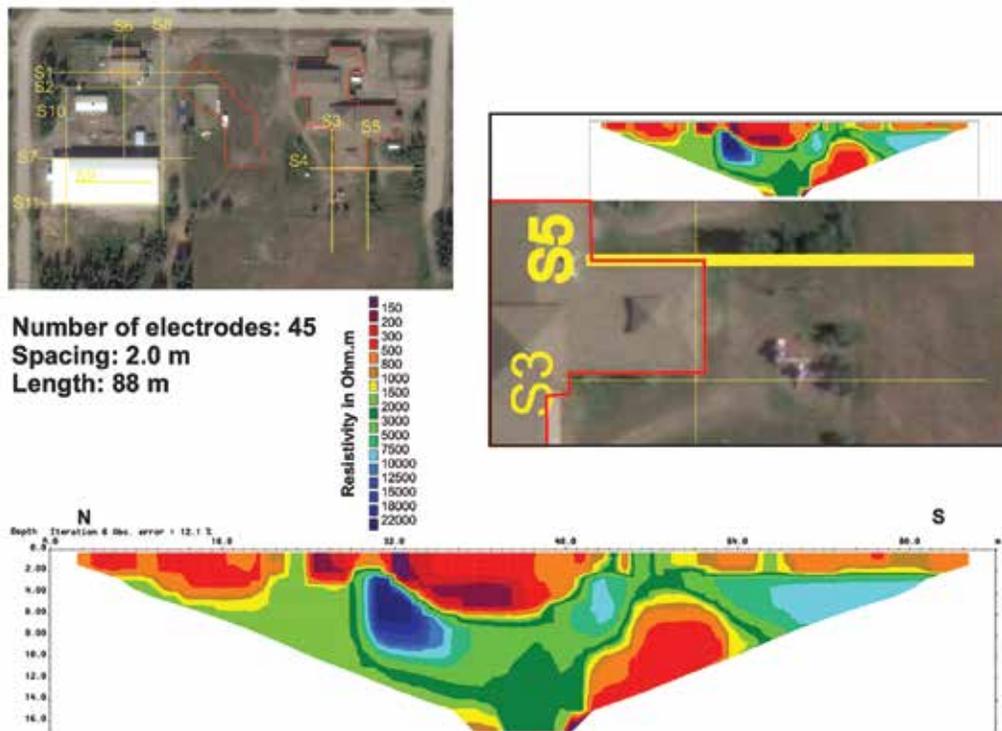
Figure 3.4.11 ERT survey S5, made on the east side of the south wing of the school, oriented north/south

Survey S5 (Figure 3.4.11), oriented north/south, was made on the east side of the south wing of the school. The low-resistivity area observed between about 0 and 20 m can be attributed to the thermal impact of the building. A high-resistivity area at about 30 m is located in an open area between the school and the fence. Lower resistivity characterizes the area between 32 and 52 m, where there is a fence and shrubs. Low resistivity is observed at about 60 m, where there is a south-facing slope from the schoolyard toward the baseball field, and where the exposure and the snow accumulation, packed by the wind during winter, may contribute to ground warming. High resistivity was observed in the open, where the baseball field is located.

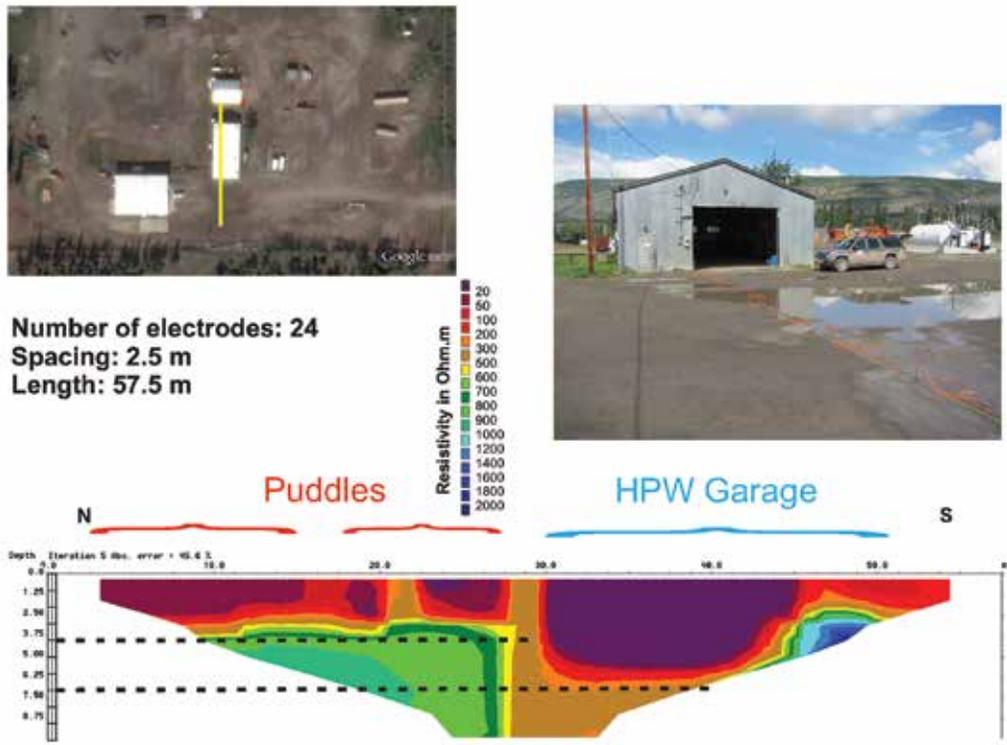
Figure 3.4.12 ERT survey made through the HPW grader station, oriented north/south

An additional ERT survey, oriented north/south, was performed in a garage of the HPW grader station, on the road entering the community (Figure 3.4.12). The building has been affected by permafrost thaw, and the objective of the survey was to see whether an ERT assessment was feasible across a building with a concrete slab foundation. Although it was difficult to get electricity to pass through the concrete slab, the data that was obtained suggest a permafrost table and/or a gravel/silt limit located at 4 m depth in the vacant lot and a permafrost table at 7 m depth below the garage.
